## Performance of a tied-back concrete pile wall for slope stabilization near Peace River, Alberta

**Leanne G McLaren & Donald W Proudfoot**

*Thurber Engineering Ltd., Edmonton, Alberta, Canada, lmclaren@thurber.ca*

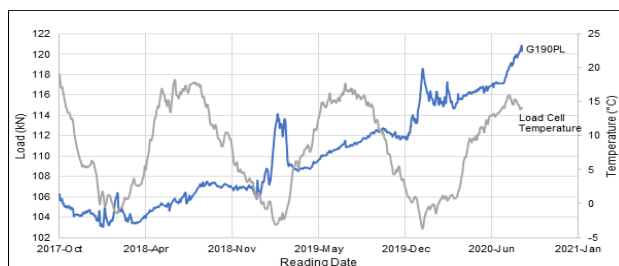
Figures 12 and 13 show plots of the waler anchors and the lower pile anchor, respectively. The waler anchors show a gradual decrease in load from the lock-off loads with seasonal fluctuations related to air temperatures. The lower pile anchor, which is buried, shows an increasing trend with small jumps in load as the surrounding soils freeze. The decrease in load of the waler anchors and the increase in load of the lower pile anchor are in line with the expected response, and no further loss of load has occurred since the end of construction.

Figure 13. Load cell at the lower pile anchor compared to temperature.
