The paper was published in the proceedings of the 20th International Conference on Soil Mechanics and Geotechnical Engineering and was edited by Mizanur Rahman and Mark Jaksa. The conference was held from May 1st to May 5th 2022 in Sydney, Australia.

Case studies of early warning system of unstable slopes using tilting sensor array

Lin Wang & Makoto Fukuhara

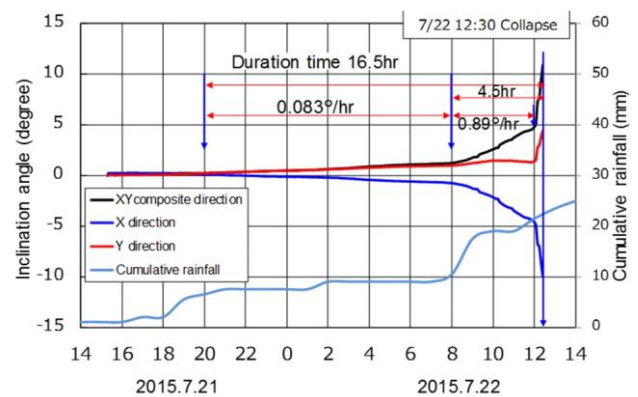
Figure 4. Time histories of monitored data at Fukuoka site.

Figure 4 shows the plot of the tilt angle and the rainfall data on July 21st and 22nd, shortly after the main slope collapse.

slope was considered to be prone to further failures during the restoration works. From 4 PM to 8 PM on July 21st, that is, immediately after the tilt sensor installation, the tilting rate of $0.083^\circ/\text{hour}$ was recorded and continued until 8 AM on July 22nd. Thereafter, the tilting rate accelerated to $0.89^\circ/\text{hour}$, possibly owing to rainfall amounting to approximately 10 mm from 8 AM to 9 AM. Furthermore, owing to further rainfall after 11 AM, the tilting rate sharply increased to $12^\circ/\text{hour}$ after 12 PM and the slope finally collapsed at 12:30 PM. Thus, the field monitoring helped control the traffic during the critical period and ensured the safety of human life.

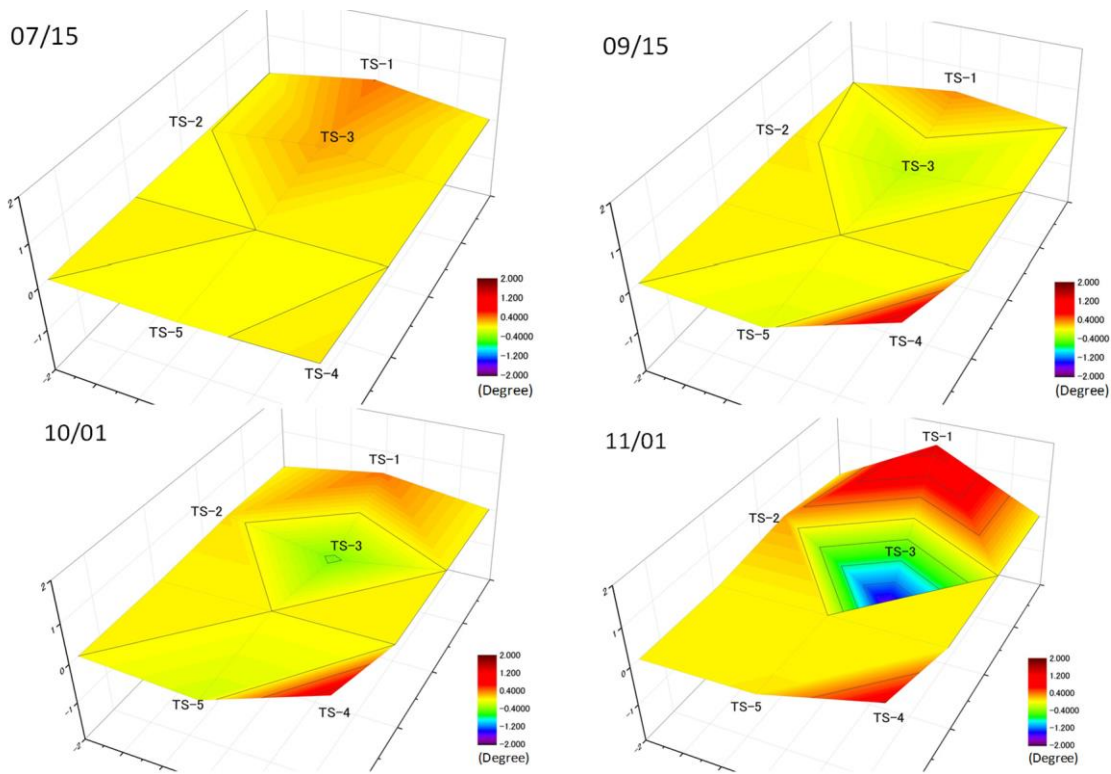
Figure 6. Distribution of accumulated inclination angle of year 2016

The tilt angles accumulated distribution due to each rain are summarized as Figure 6, which included the accumulated distribution results in (a) 15/Jul, (b) 15/Sep, (c) 01/Oct and (d) 01/Nov of year 2016. Red means the inclinometer is tilted in the direction of the landslide slope, and blue means the inclinometer is tilted in the opposite direction of the slope.

TS1, which is located at top of the slope failed area, tilted (rotated) more than 2 degree in slope-direction during this period. TS2 which is located outside the failed area did not respond to the failure of the slope. However, TS2 started showing minor rotation with the reactivation of the failure above its location, which could be due to overloading the area of TS2 by the failed soil mass above its location. TS3, which is located at center of the slope, tilted (rotated) more than 2 degree in opposite direction of landslide slope. TS5, which is located at bottom of the landslide slope, is rotating in the direction of the slope, was pushed by the top mass of slope failure.

These results clearly show the movement of the entire slope shown in Figure 6 as time order. It can be seen that the head and the bottom of the slope are inclined in the direction of landslide slope inclination, and the middle of the slope is a circular arc

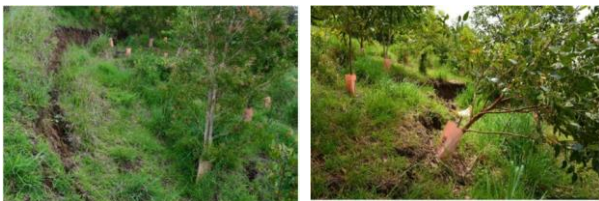
Figure 7. Areal view of the landslide area (28/10/2017)

Figure 7 shows the aerial view of the landslide area that the photos were taken in 28/Oct/2017, and Figure 8 shows the aerial view of the landslide deformation area that the photos taken in 20/Feb/2018. These photographs show that the results correspond to the landslide collapse measured by the sensor array.

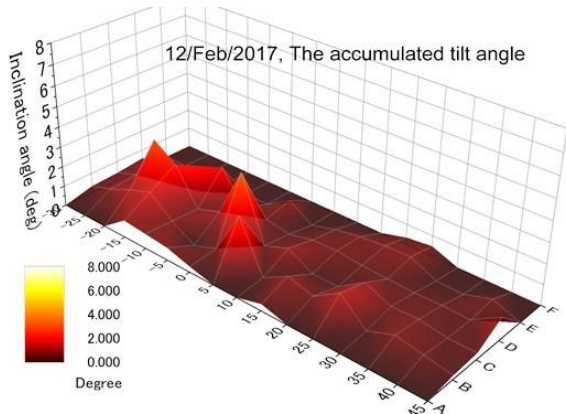
Figure 11. Distribution of accumulated tilt angle at Manzawa site.

The distribution of the accumulated tilt angle over the monitored area is shown in Figure 11, and its local variation is obvious. The rate of tilting during the respective precipitation events is shown in Figure 12. The precipitation events on April 20, 2017, June 3, 2017, and August 13, 2017 caused relatively higher tilting rate values, but these values did not exceed the precaution threshold of 0.01°/hour. Another issue is that higher

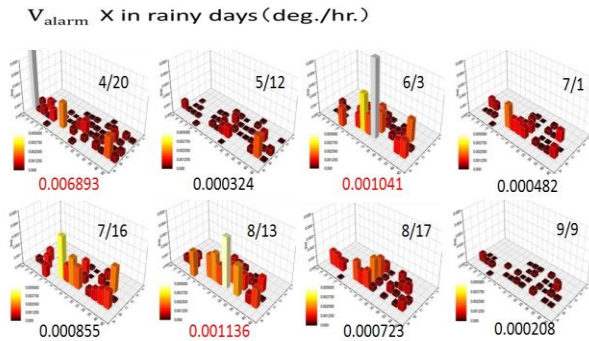
Figure 12. Distribution of tilting rates during each rainfall day at Manzawa site.

tilting rate occurs at different points during different precipitation events, as revealed by comparing the data obtained on April 20 to those obtained on June 3 and August 13. During the two-year field validation, there was no significant change in the tilting angle, and no alert was issued. Thus, the slope was assessed as stable.

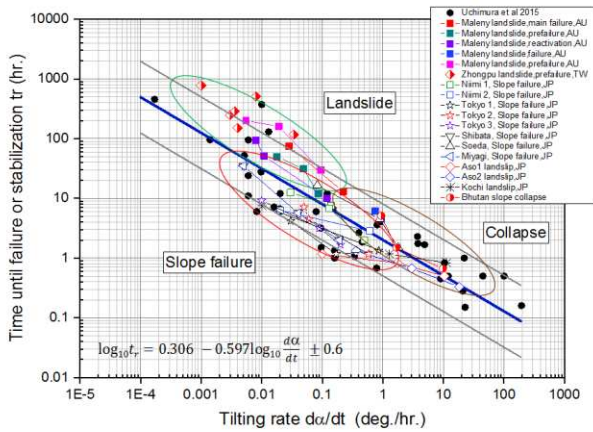
Figure 14. Relationship between time remaining until failure and tilting rate based on field monitoring.

Figure 14 summarizes the results of the authors’ slope monitoring projects since 2004 to now, which have considered landslides, slope failure, collapse, and field experiments. The authors define landslides as events that require months or years until failure, slope failures as events that require days or weeks until failure, and collapses as events that only require hours until failure. Thus, the case of rainfall-induced slope failure is classified as a collapse. As previously mentioned, the brief amount of time until failure makes it difficult to select a relevant monitoring method. While the overall trend of the obtained data in Figure 14 is similar to the relationship between creep time remaining until failure and strain rate or minimum creep rate based on results of geomaterial testing of Saito’s curve (Saito et al. 1961, 1965), it is further proposed that two different failure times may affect the plotted relationship.

where t_r denotes the time remaining until failure (hours) and da/dt denotes the rate of the tilting angle (degree/hour). The prediction using Equation 1 is indicated by the solid black line in Figure 14. To further improve the time prediction, the following measures are considered:

- i. Landslides have sufficient time until failure, and emergency caution and warning alerts are appropriate measures.
- ii. The failure of surface sediments (slope failure in Figure 14) has several hours until failure if a warning is issued when the rate is $0.1^\circ/\text{hour}$.
- iii. Collapse occurs suddenly and practical experience suggests that failure occurs within one hour or less. Hence, evacuation is not feasible and the reinforcement of the slope in advance using rock bolts, and so on, is advisable.
