*The paper was published in the proceedings of the 20<sup>th</sup> International Conference on Soil Mechanics and Geotechnical Engineering and was edited by Mizanur Rahman and Mark Jaksa. The conference was held from May 1<sup>st</sup> to May 5<sup>th</sup> 2022 in Sydney, Australia.*

## Jet grout column construction and quality controls for seismic strengthening Auckland's waterfront

**ABSTRACT:** The Quay Street Seismic Strengthening project was part of Auckland Transport's (AT) wider Downtown Infrastructure Development Programme (DIDP), which aimed to prepare downtown Auckland for the America's Cup and Asia-Pacific Economic Cooperation events in 2021. Previous seismic assessments of the seawalls that support Quay Street have shown that they are vulnerable to liquefaction/cyclic softening induced lateral spread. Seismic strengthening was proposed to provide seismic resilience to Quay Street for the next 100 years, providing post-disaster functionality for transportation services and protecting essential utilities located landward of the proposed strengthening alignment. To carry out the project, the Quay Street seawall was divided into four sections, with different strengthenin

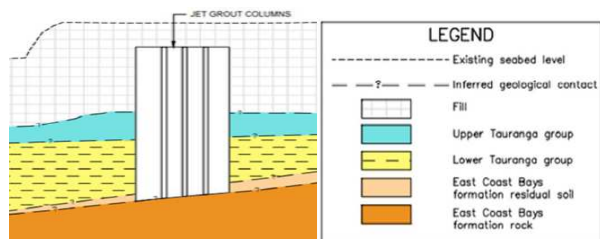
The Ground Conditions Report (T+T, 2019b) provided site-wide details on the ground conditions for the Quay Street Strengthening Project. This included information on published geology, and the geological model for the site including geological units. The relative position of jet grouting columns within the geological units is presented in figure 1. A short description of the geological units is given in Table 1.

Figure 1: Jet grout columns within the geotechnical units of the site.

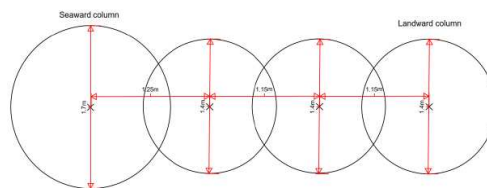
A typical row within the shear wall was formed of four jet grout columns at maximum 1.2 m centre-to-centre spacing and comprised one 1.7 m diameter seaward column and three 1.4 m diameter landward columns, as shown on figure 2.

Figure 2: Jet grout columns within the geotechnical units of the site.

The average overlap contact width between the columns adopted for design was 500 mm with a minimum of 300mm based on a maximum allowable verticality deviation of 0.5%.

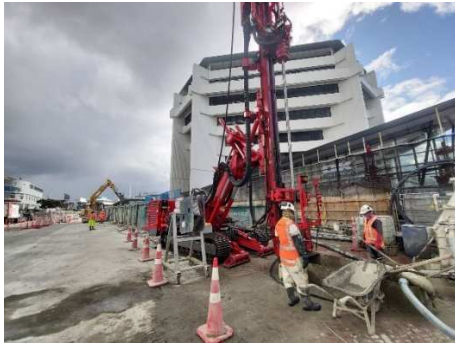
Such device was described in former articles listed in the bibliography (Mathieu and al., Morey and al.). The execution conditions of jet grouting on site are illustrated on figure 3.

Figure 3: Execution of jet grouting columns on site.

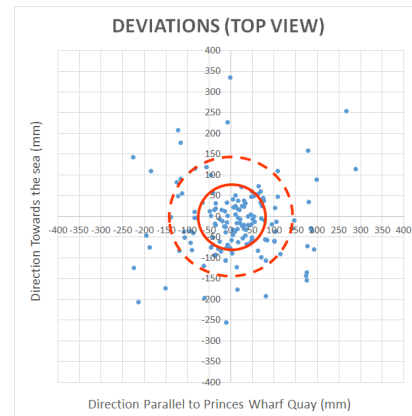
A verticality control report was provided with each construction report. The Shape Accel Array system was introduced inside the drill string at the end of the drilling phase. Figure 4 summarizes the deviation of the bottom of each column from a top view where the plain and dotted circles represent 0.5% and 1% verticality tolerances.

More than half of the drilling deviations were within the verticality tolerances of 0.5% specified in the project. Around 80% were within the typically accepted 1%. The presence of obstructions in the fill layer was the most probable source of the remaining deviations of these tolerances larger than 1%.

Figure 4: Column deviations (top view)

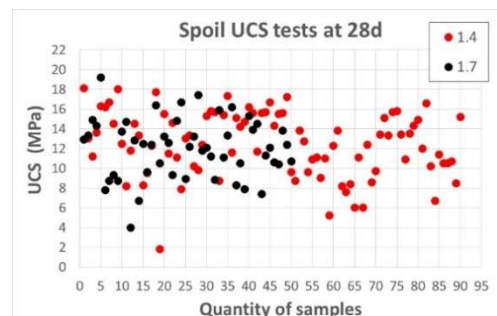
Spoil cylinders were regularly taken from the outflow of soil cement material during jet-grouting. A set of 3 samples was taken at 2 different depths on each tested column. Figure 5 summarizes the unconfined compressive strength (UCS) values at 28 days measured on 54 columns during both trial and production stages.

Dispersion of UCS values was relatively usual for this type of works and related to the quantity of natural soil eroded, driven by variations of soil nature and compacity. Despite these dispersions, almost all values measured were above 8 MPa for the 1.7m diameter columns and 6 MPa for 1.4m diameter.

Figure 5: Unconfined compressive strength on spoil samples

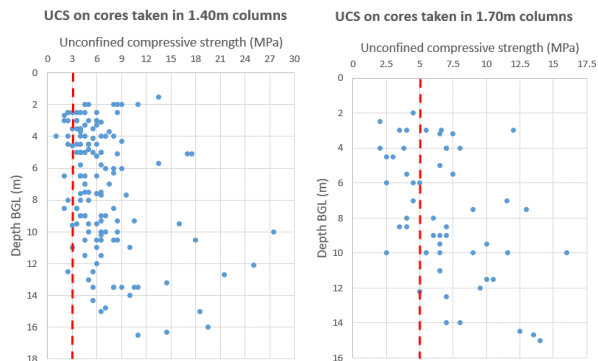
Parts of these cores were extracted to carry out UCS testing in laboratory. Figure 6 below shows the UCS values measured on cores, presented with respect of the sampling depth. A red dotted vertical line indicates the minimum strength requirement for each type of column.

As seen on wet grab samples, UCS values were relatively scattered, but mainly above the minimum requirement for 1.4m diameter columns. For 1.70m columns, core samples were mainly taken from the overlapping zones which could be the source of a greater quantity of values below the minimum strength requirement.

Figure 6: Unconfined compressive strength on cored samples

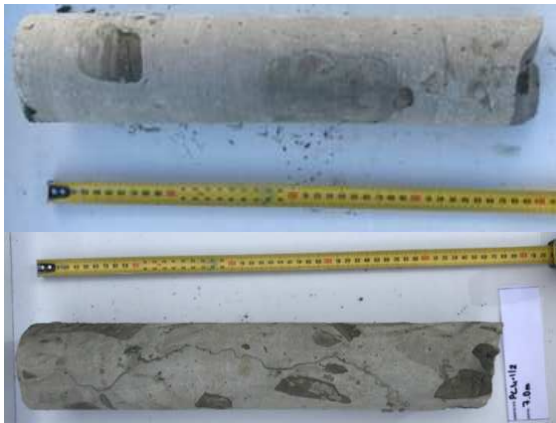
Visual inspection of the samples taken from the cores showed a soil cement material of a relatively good quality, with some inclusions and sometimes a visible joint when the core was taken from the overlapping zone.

in between columns. A few examples are provided in figure 7.

Figure 7 : Presence of inclusions (top picture) and joint between adjacent columns (bottom picture)

However, and as shown on figure 7, core samples comprised more coarse elements such as clay lumps or stones, and were subject to cracks linked to coring operations, or the location of the coring itself. This was a probable explanation of UCS values on cores being lower than expected.

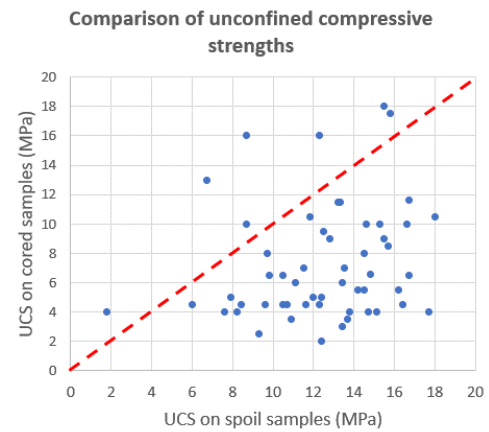
A comparison between unconfined compressive strength on spoil samples and cored sampled was done. When available, values were compared for the same column, at similar sampling depth. Figure 8 below summarizes this comparison and shows that UCS on spoils was almost systematically of higher strength.

Figure 8 : Comparison between UCS on samples taken from coring or from spoil sampling.

Considering the nature of the treated soils on site and accepting the absence of coarser elements in the spoil return, it was considered that both spoil and core sampled material were of similar nature and composition.

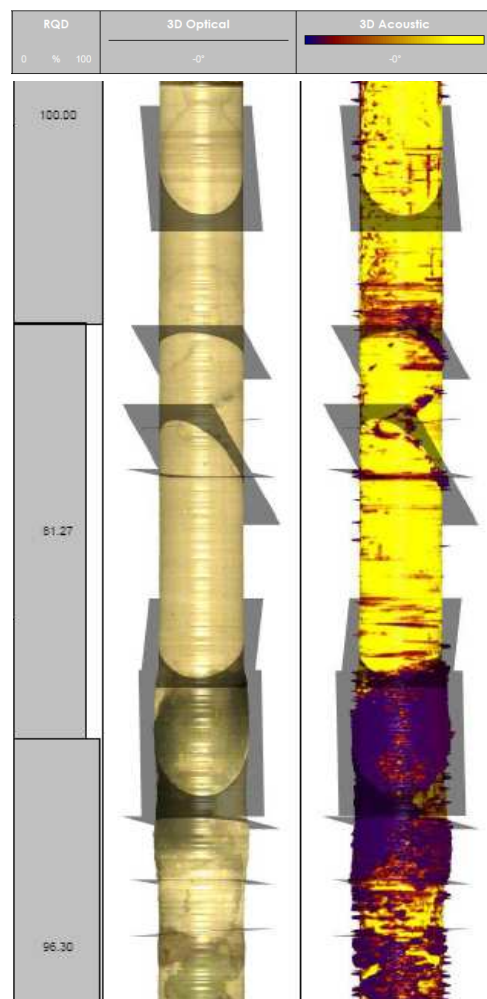
The optical tool gave a 360 degrees image of the borehole, whereas the acoustic tool provided another image of the borehole based on reflections of an acoustic signal on the borehole wall.

Both measures were correlated with depth and orientated to the magnetic North based on data measured by an embedded magnetometer in the tool. Figure 9 below gives a typical output provided by the televiewer.

Figure 9 : Example of OTV/ATV readings in a vertical core done in the overlapping zone between columns.

OTV/ATV measurements allowed the treatment continuity between columns to be checked and particularly highlighted the presence of local micro fissures within the treated mass, localized on figure 9 by more or less inclined plans on both optical and acoustic 3D image of the borehole walls.
