In situ chemical oxidation/reduction using the jet grouting technique (HaloCrete®)

Peter Freitag & Alexander Zöhrer

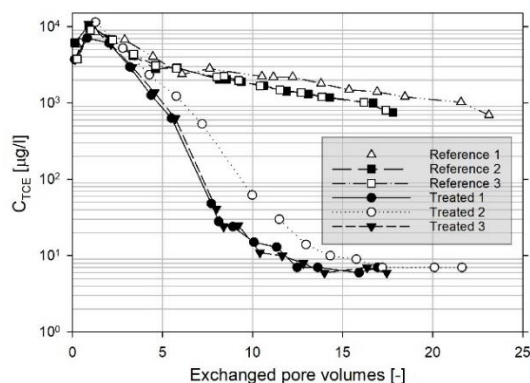
Figure 1. TCE concentration in column effluents (Logarithmic scale). After reaching a peak shortly after experiment start, they begin to decrease. The gradient differs significantly between treated and reference columns

After the conclusion of phase 1 column experiments were conducted in phase 2 to take groundwater flow and real soil behavior into account. The high vapor pressure of TCE led to problems during the setup of the experiments. To circumvent them an approach similar to tremie concreting was chosen. A hard impermeable core was placed in glass columns, surrounded by a permeable annulus. To monitor the effectiveness of the reaction, treated as well as untreated tests were performed. The results presented in Figure 1. show significantly lower contamination concentrations in the treated columns.

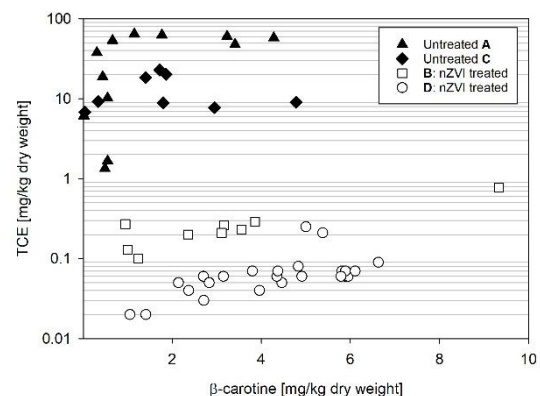
Figure 3. Results of the correlation between β -carotene and TCE (logarithmic scale).

After the treatment, the measurement of the concentrations was continued until no significant changes were observed. The columns were excavated, and samples were taken across the cross sections at various depths. As the TCE had been colored with β -carotene it was possible to correlate contents of colorant and contaminant (Figure 3.).

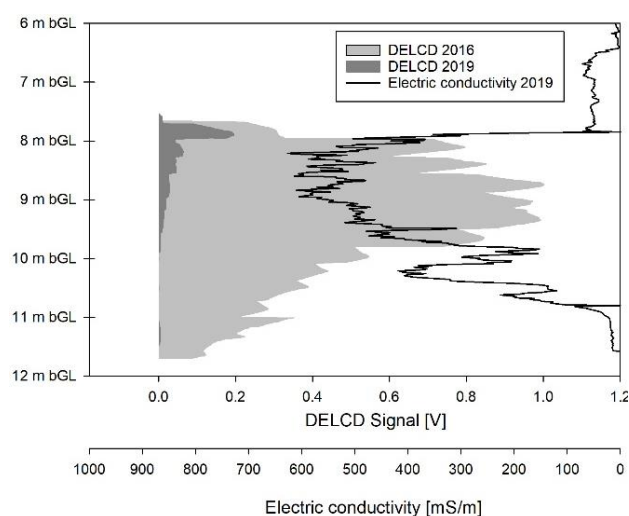
Figure 5. Comparison of MIP soundings from 2016 and 2019 indicating reduction of TCE in the subsoil. Electric conductivity shows top and bottom of the column.

As only low strength requirements had to be met by the JG body, the slurry was designed to result in UCSs which allowed CPT soundings in the jetted subsoil zones. Figure 5. shows the results of a repeated MIP sounding at the same spot pre and after treatment. The DELCD signal - an indicator for chlorinated compounds - was reduced significantly. As a side effect of the OPC the electric conductivity was raised in the treated zone indicating the top and bottom of the JG column.

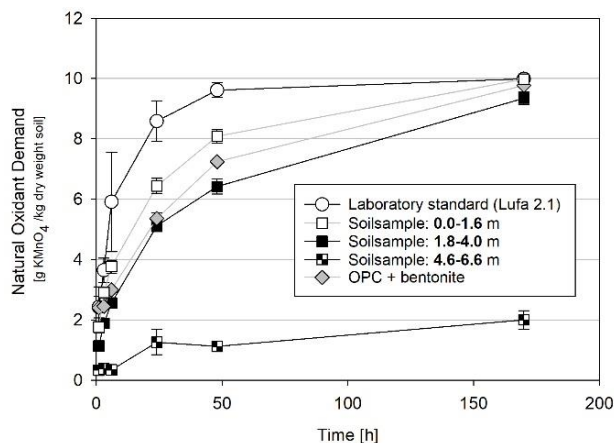
Figure 6. Results from experiments determining NOD of subsoil and binder. Note the difference depending on depth in the soil samples.

During this stage of the project, also possible oxidants were tested for suitability under the given soil conditions. Mainly KMnO_4 as well as Sodium permanganate (NaMnO_4) were examined. The advantage of the latter is that it is available as a highly concentrated liquid, however, the disadvantage of the higher cost was even more critical. For the final formulation of the slurry recipe both, the NOD values and the PCE concentration in the field were taken into considerations. Figure 6. summarizes the results of NOD tests.

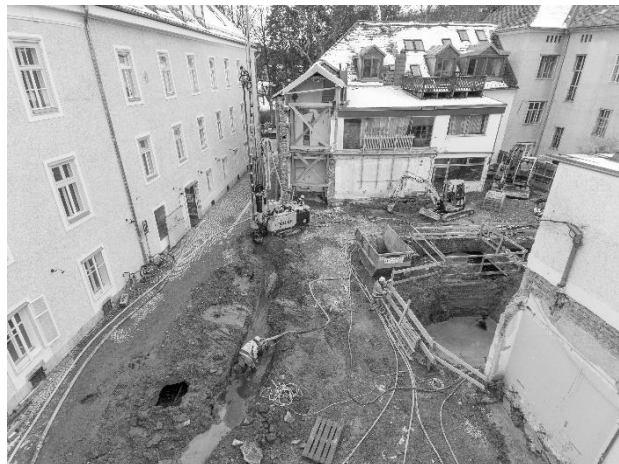
Figure 8. Picture of the site. The direction is towards central park, with a view into the partially demolished building. The Rittergasse is situated to the left.

After finishing the planning stage, the duration of actual execution on site was comparably short. Along the narrow street ("Kirchengasse") and under the existing building HaloCrete® columns were installed (Figures 7. and 8.). Those columns had to fulfill the same mechanical requirements than the non-HaloCrete® columns. Available space on site was very confined, a part of the site installation had to be placed in adjacent gardens. The organic compounds in the soil, detect during preliminary tests, caused problems of the hardening of the cement for the conventional JG. This issue was solved using C_3A free cement.

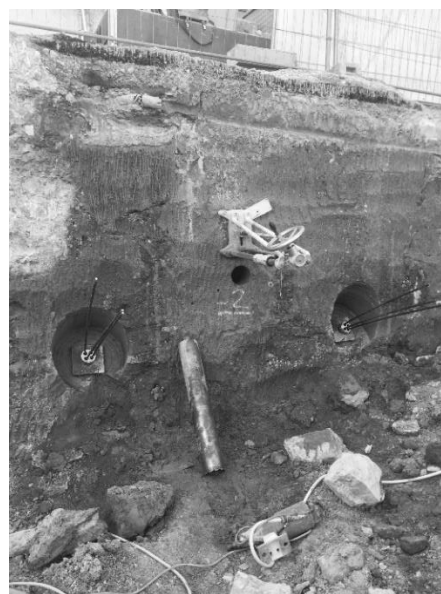
Figure 9. Core drilling being taken from the jet grouting wall at the Rittergasse site. The upper level at -2.0m bGL is shown. The location is directly below the eastern washing machine as shown in Figure 7.

At the Rittergasse site the HaloCrete® columns were part of the excavation pit support. Therefore the UCS required was too high to allow for soundings in the columns. The success of the remediation measures was proven by means of core drillings taken from the jet grouting wall at different depths (Figure 9.). According to the contract with the client, a decrease of concentration related to a predefined reference value had to be achieved. The reference concentration was defined by the environmental consultant based on measurements on site as well as experience from previous projects.

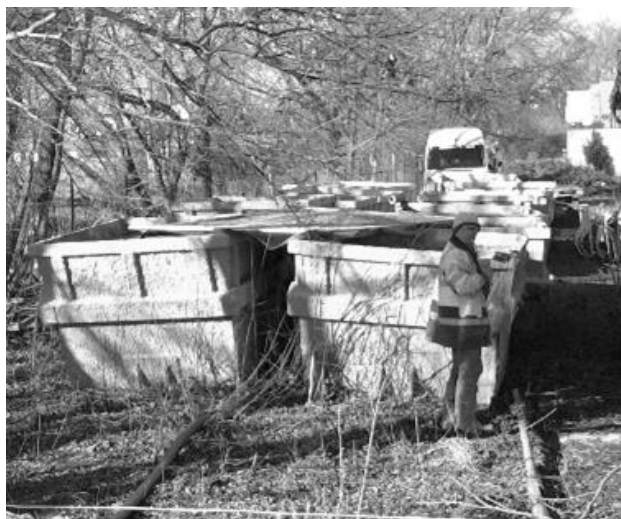
Figure 10. Transport skips as backwash storage. They had to remain on site for over a month.

The question of backflow treatment is a very special one in this context and influences logistics on site tremendously. According to Austrian law, excavation material from registered, heavily contaminated sites is declared to be “dangerous”. This classification leads to the necessity of storing the material on site until it has been reclassified as “not dangerous” by an accredited chemistry lab. This can be circumvented by dedicated interim storage areas, but the material must remain separated until reclassification. Figure 10. shows the storage on site at Zwölfaxing.
