The paper was published in the proceedings of the 20th International Conference on Soil Mechanics and Geotechnical Engineering and was edited by Mizanur Rahman and Mark Jaksa. The conference was held from May 1st to May 5th 2022 in Sydney, Australia.

Investigation of the deformation mechanism and the stability of deformable body in the reservoir area based on the D-InSAR monitoring

Yujie Wang, Long Jiang, Ping Sun, Xinchao Lin

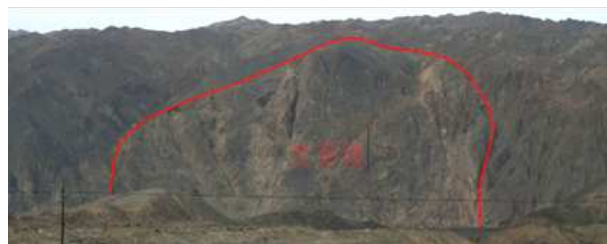
Figure 1. The geographic location of the deformable body on the left bank

The topographic and geomorphological characteristics of the deformable body on the left bank are shown in Figure 1. The construction of the project started in April 2011, and the reservoir was officially impounded in November 2014. The water level reached 935m~940m elevation from October 2015 to April 2016, and briefly dropped to 921m from May to June 2016. From July to August, it restored to the highest elevation of 942.0m, which was close to the normal storage level of 944.5m. In the process of water release from September to mid-October 2016, it was found that the left bank slope began to deform. In the following two years, the reservoir water level was mainly maintained at an elevation of 916m to 932m, and the deformation of the left bank continued to collapse, and the slope deformation increased significantly.
