## Screw displacement pile shaft deformations measured by vibrating wire and fiber optic systems during a static load test

**Mateusz Wiszniewski & Adam Krasinski**

**ABSTRACT:** This paper describes a full scale static load test performed on a 400 mm diameter screw displacement pile equipped with four different strain measuring systems. Three types of vibrating wire strain gauges (VWSG) were used: global - retrievable, local attached to steel pipe and local concrete embedded. The fourth system was distributed fiber optic sensors based on Rayleigh back scattering (DFOS) - three in the pile cross section. It is generally assumed that the combined cross section deforms equally. However, especially in the upper part of the pile, stress and therefore strain distribution might be non-uniform. In the case of steel tube (installed centrally in the pile axis), additional sliding effect may occur. Pile bending and local shaft imperfection may also affect strain readings, therefore using multiple gauges in a single plane might be necessary for proper result interpretation. Those assumptions were verified in the paper as the differences in readings have significant influence on final load di

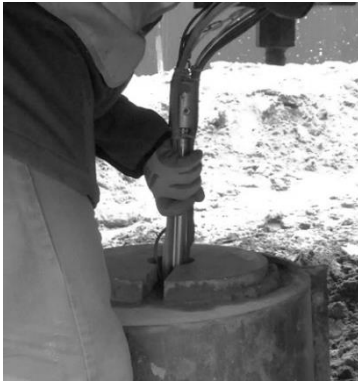
1. Model 1300 (A-9) Retrieable Extensometer System, which consisted of 7 strain gauges that were installed just before the test in a steel tube casted in the pile structure (see Fig.4). The tube was placed centrally in the pile, which allowed to assume that measured strain is the average strain of the whole cross section (to be verified later in the paper). System certainly has some advantages, first of all, it is reusable (strain gauges can be used multiple times), as only the steel tube is “lost” in each test and that makes it economically viable and very efficient; allows to measure total shortening of the pile shaft; generally, only one tube placed centrally is used to determine the average cross section strain, that cuts the costs, makes it easier and faster to operate, but at the same time it might be a system’s disadvantage,

Figure 4. VWSG Model 1300 A-9 installation in a pile.
