The paper was published in the proceedings of the 20th International Conference on Soil Mechanics and Geotechnical Engineering and was edited by Mizanur Rahman and Mark Jaksa. The conference was held from May 1st to May 5th 2022 in Sydney, Australia.

Unique characteristics of silty soils of loess soil in Kazakhstan, silty rock at Bamiyan in Afghanistan, and manmade platform mound in Angkor, Cambodia

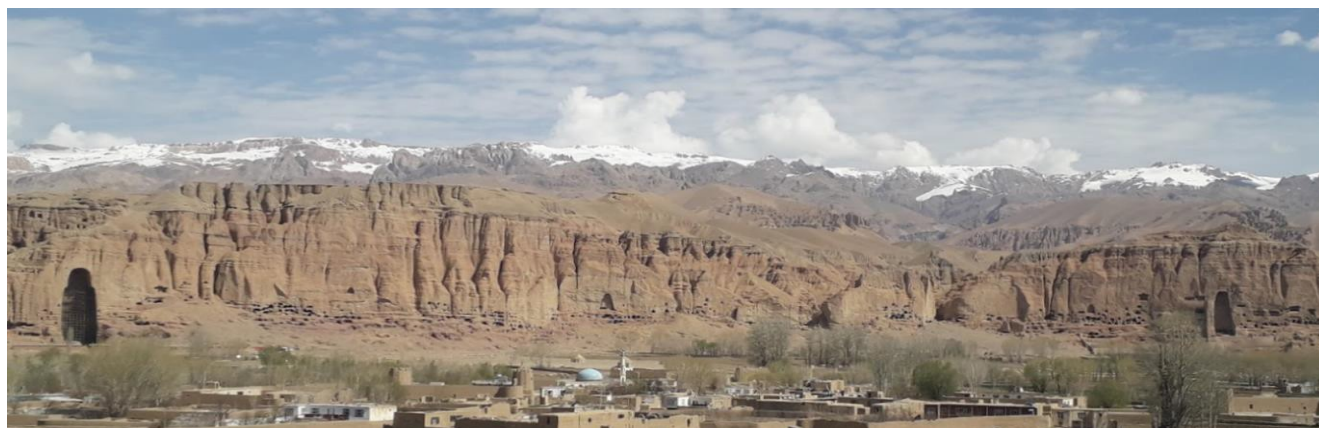
Figure 1. Splitting process of vertical cliff at Bamiyan

The horizontal formations of alternative layers are seen in Figure -1 and 2. The height of the cave is 53m and 35m at western and eastern side, respectively.

The process of creation of high and vertical cliff is considered as follows,

1. vertical crack formation behind the front face
2. siltstone near the bottom surface meets with surface water
3. siltstone degrades by water and results horizontal void
4. vertical front block falls off and new face will appear

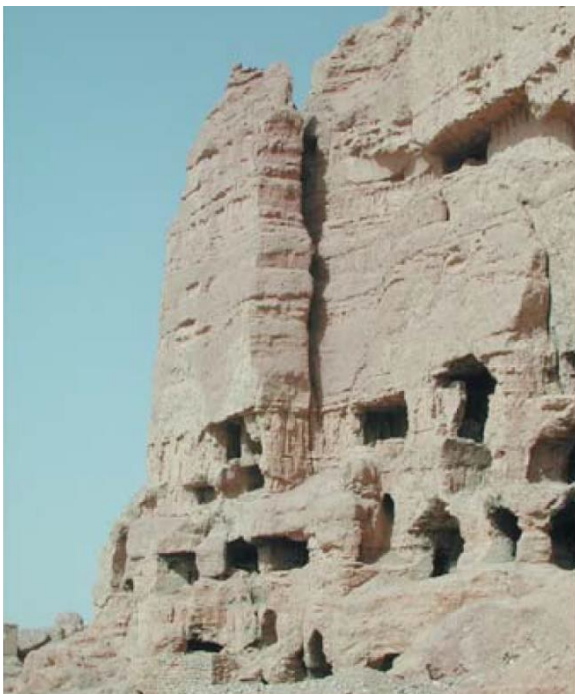
As shown in Figure- 3, vertical cracks are recognized behind the front surface of the cliff, probably because of the extension stress caused in the surface zone at some depth from the vertical surface.

Figure 3. Cliff with crack behind the surface (Margottini, 2004).

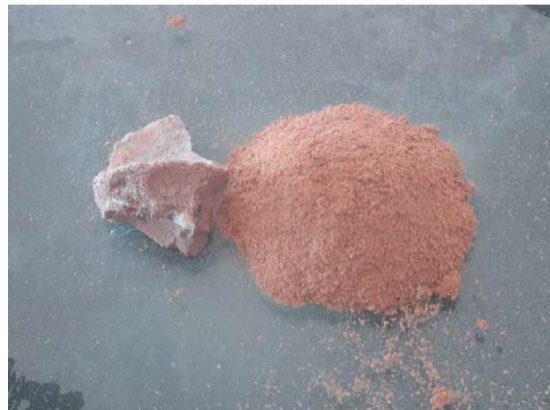
When the two materials are treated with water, the response is quite different. The conglomerate stone keeps its strength; however, the siltstone loses the solid structure and its strength after only a few minutes of immersion in water as shown in the comparison of two materials in Figure-4.

Figure 4. Comparison of Conglomerate (left) and siltstone after immersion of water (Margottini, 2004)

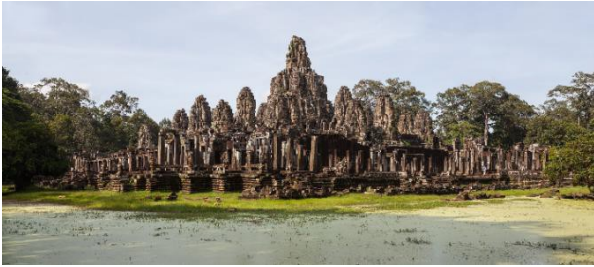
The temple was constructed in Buddhism style. Bayon means Ba Yon (beautiful tower) in Khmer and Thrones for Gods in Sanskrit. Many four face towers stand surrounding the main tower as shown in Figure 6.

Figure 6. Bayon Temple, Angkor Thom from South

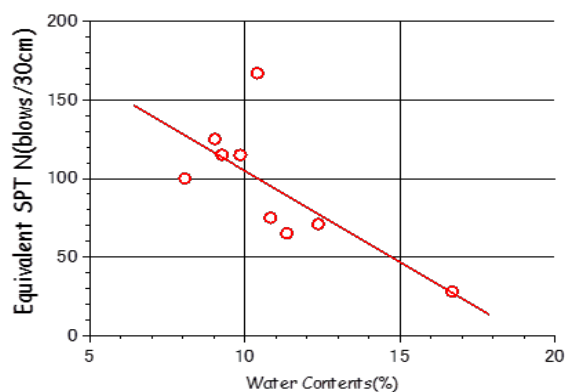
Figure-11 SPT-N-values and water contents

The SPT, N-value for the filled sand is extremely large value around 200. The SPT, N-values are plotted against water contents as in Figure-11. The figure shows that the decrease of the water contents increases the SPT, N-values. A small block of the sampled sand was put in water and it gradually soaked water and finally collapsed in 10 min. as shown in Figure 7.

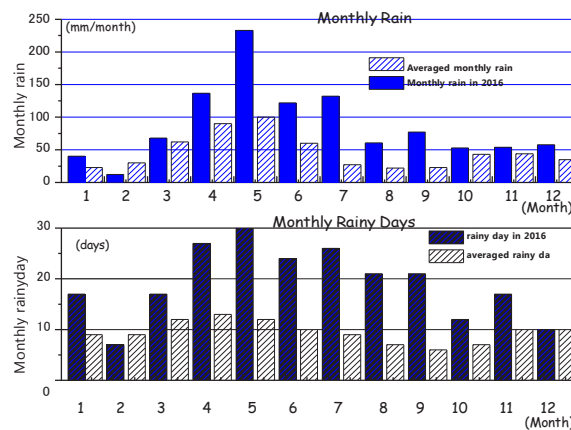
Almaty, the old capital of Kazakhstan experienced heavy rain in 2016. As shown in Figure 16, which shows monthly rainfall and rainy days for every month in 2016 compared to the averaged values, it rained as much as 210mm for May 2016 more than two times larger than the yearly averaged value of 100mm/month.

Figure 16. Monthly Rainfall in Almaty in 2016

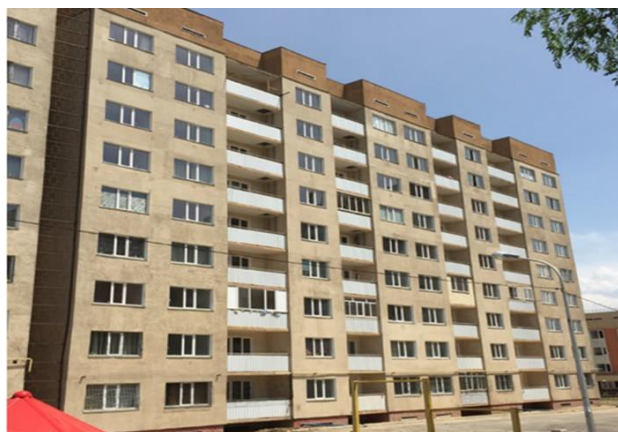
Figure 18. Tilted RC Apartment House with 9 stories (Bespaev,2019)

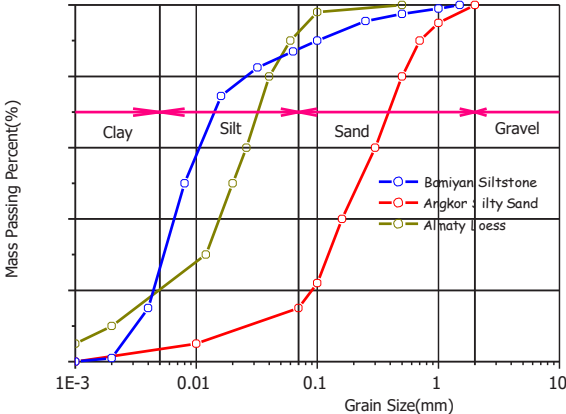
Three different types of soils with silt and sand are introduced to compare the effects of the water upon the soil strength. The grainsize distributions are compared in Figure 21.

Figure 21. Comparison of particle size distribution of the soils
