# The Influence of wildfires on soil and rock slope risk

**Tim Thompson**

Associate Geotechnical Engineer, Arup, Brisbane, Australia.

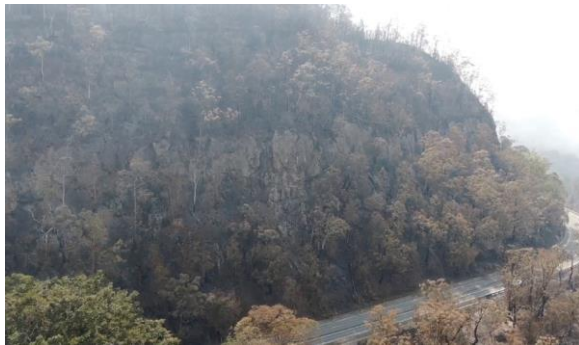
Photo 1: View of site following Nov 2019 wildfire (source: TMR)

The vegetation at Cunningham's Gap predominantly comprises moist to dry eucalypt open forests and woodland transitioning to rainforest near the top of the road segment (State of Queensland 2021). An image of the site taken in November 2019 immediately following the first fire is presented in in Photo 1. Noteworthy from this image is the canopy of a single fig tree evident at the bottom left that was relatively unaffected.

- Significant loss of vegetation including trees that had fallen onto the road;
- Voids in the ground due to burnt out root systems;
- Significant variability of burning on trees in close proximity (see Photo 1 and Figure 5); and,
- Erosion with significant gravel and some cobbles falling on the road surface.

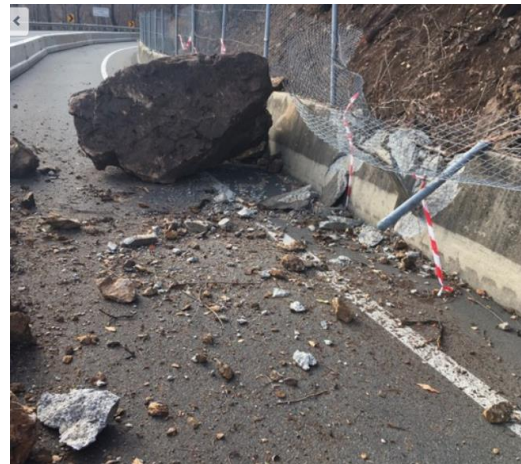
Photo 2: Boulder crash through concrete barrier into closed uphill lane following 23 mm / 24 hours rainfall event of 26 December 2019 (source: TMR)

Based on these observations and a concern for rockfall risk, TMR closed the uphill slow lane closest to the slope. On 26 December 2019, approximately two weeks following the second fire, and after a 23 mm rainfall event measured 3 km from the site, a 1.5 m diameter boulder fell towards the road, crashing through a concrete barrier and into the closed lane (see Photo 2). Causation of the rockfall due to the wildfire cannot be absolutely confirmed, however, the connection is considered to be highly likely.

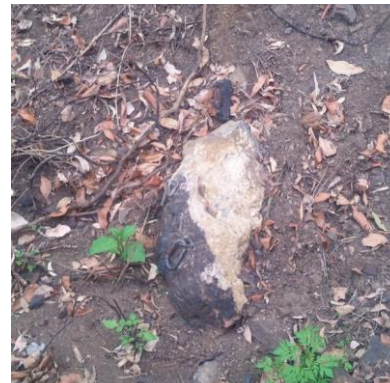
Photo 3: Heat-affected rock encountered behind concrete barrier at base of the slope with two carabiners exposed

While much of the eroded rock debris observed at the base of the slope in the weeks following the wildfires showed no obvious indication of fire exposure, some did. The rock presented in Photo 3 not only provides a clear indication of exposure to fire on one side, but also reveals its previous use as an anchor point for two carabiners which warrants reflection. Recent remedial

stabilisation projects have included rock bolting at heights, and one of these projects was the likely source of the carabiners.

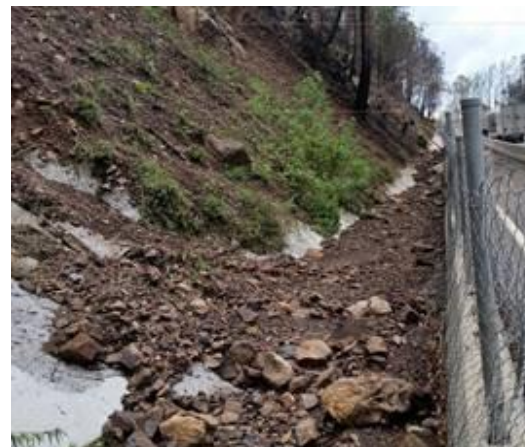
Photo 4: Erosion against barrier following 256mm of rainfall over 3 days in January 2020

Approximately six weeks following conclusion of the second fire, 256 mm of rainfall fell between 18-20 January as reflected by the abnormally high early 2020 rainfall data presented in Figure 1. The rain resulted in very large volumes of erosion from the accumulations of talus as well as weathered rock on the slope surface. The erosion effectively converted some concrete barriers into small retaining walls as reflected in Photo 4. This erosion also not surprisingly blocked several cross-drain inlets.

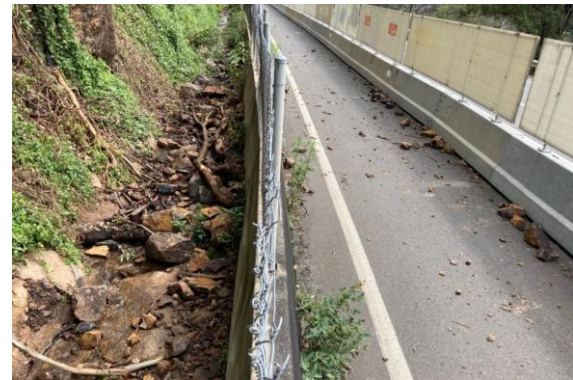
Photo 5: Rock debris accumulated behind concrete barrier at left and some over-topping evident against the temporary barrier at right observed on 24 March 2021 following high intensity rainfall

Ultimately, judgement and observation of the site and ecosystem response over time can influence adopted risk levels. The reversion of a site to its pre-burn level of stability or equilibrium is best monitored by active maintenance procedures and records of instabilities. In late March 2021 following a rainfall event that exceeded 240 mm in 48 hours, inspection identified rock debris that overtopped the existing concrete

barrier and fence as presented in Photo 5. Notable is also the accumulation of a greater volume of rock debris retained by the concrete barrier.

A fair question to pose noting the intensity of the rainfall event is how much of this material might have 'detached' or been released from the slope had there been no fire events approximately 16 months prior. Overall, inspections through 2020 and into 2021 observed a high frequency of rockfalls of around 200 to 700 mm in diameter, mostly retained behind the existing concrete barrier. While it is plausible that some of these rockfalls may have occurred independent of the fire events, it is believed that most are associated with the ongoing ecosystem response and recovery, and that they are reflective of escalated risk associated with larger and more menacing hazards. The observations and uncertainty underscore the importance of ongoing inspections and record-keeping to inform long-term risk.
