Insights into Landslide Reactivation: Monitoring and analysis of failure mechanisms using instrumentation

Asiri Karunawardena, Sanchitha Jayakody, Mihira Lakruwan
National Building Research Organisation, Colombo, Sri Lanka, asiri13@hotmail.com

ABSTRACT: A devastating rain-induced landslide occurred in Athwelthota, Sri Lanka, in May 2017, claiming multiple lives, causing severe infrastructure damage, and disrupting transportation in the area. In response, monitoring instruments were installed in 2022 on the adjacent slope under the Project RRL, implemented within the SATREPS framework. This instrumentation setup, comprising surface inclinometers, borehole water level meters, tensiometers, and weather stations, was strategically deployed to assess the behavior of the slope identified as vulnerable to adverse weather conditions. While instruments are in place, the slope reactivated in June 2024 following prolonged rainfall, leading to further instability. Observations revealed that rainfall infiltration acted as an immediate trigger, but subsurface hydrology played a critical role in the slope failure. These findings corroborated the results of finite element analysis conducted for

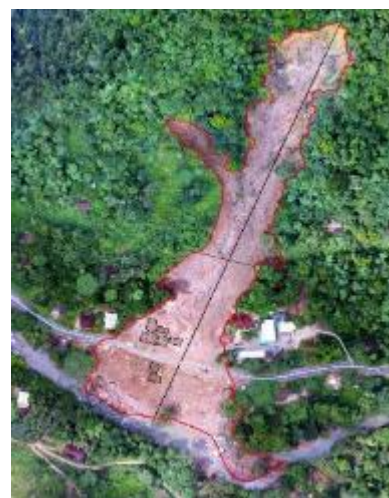
Figure 1. Athwelthota Landslide happened in May 2017.

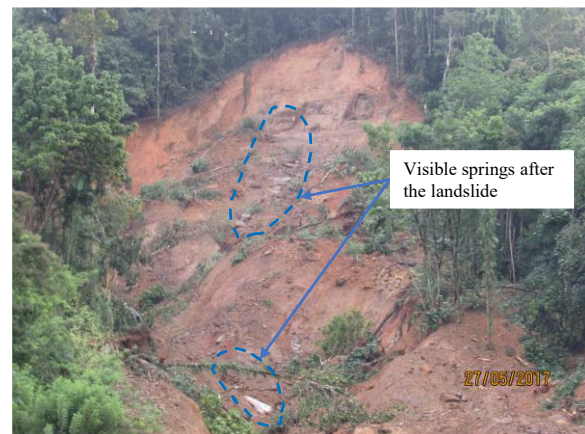
The landslide area is underlain by highly jointed, moderately to highly weathered bedrock that influences both groundwater behaviour and slope stability (Dissanayaka et al. 2024). The rock mass contains three main joint sets along with weak foliation planes, creating an interconnected network of fractures. These fractures provide pathways for water movement, affecting how groundwater flows through the slope and contributing to instability. The landslide catchment covers about 5 hectares, with a gentle slope, dense forest cover, and loose, organic-rich topsoil. Such conditions allow rainwater to infiltrate easily and recharge the underlying groundwater system. Compared to intact rock, the fractured bedrock has much higher permeability and porosity, enabling water to move and be stored more effectively. In this way, the jointed bedrock acts as a natural aquifer, retaining water near the unstable slope and releasing it gradually through springs into the valleys below. After the landslide, streams were observed emerging from fissures and fractures near the crown and discharging more heavily at the toe (Figure 4).

Figure 4. Springs emerge after the landslide

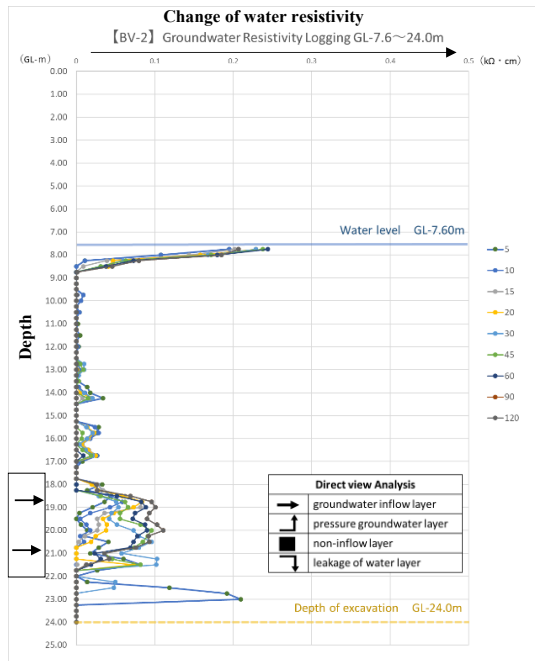
Groundwater monitoring conducted through borehole investigation revealed important characteristics of groundwater behavior under the weathered rock and bedrock regions, which are crucial for understanding hydrological behavior. As shown in Figure 5, groundwater is found at 7.60 m below the slope surface. However, water resistivity logging indicated specific depths within the hard rock strata where groundwater flows preferentially through fissures, termed the "fissured water" flow type. These observations validate the assumptions made during the numerical simulations in section 3, where nodes were adopted to apply groundwater flows that can emerge through the fissures and fractures.

Figure 5. Groundwater monitoring in borehole

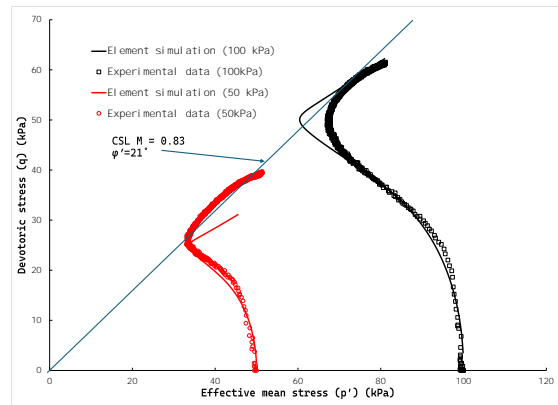
numerical modelling, soil–water characteristic curve (SWCC) parameters based on the van Genuchten (VG) model were assumed from previous tests conducted on similar Sri Lankan soils. The SWCC was estimated using the modified Kovacs method proposed by Aubertin et al. (2003), which derives the function from the soil’s saturated water content, particle size distribution, and liquid limit; the predicted curve was then calibrated to the VG model. Saturated consolidated undrained (CU) triaxial tests were performed under confining pressures of 50 kPa and 100 kPa to determine the shear strength parameters for use in slope stability analysis, using samples collected from Location 1 and Location 2 shown in Figure 3. Material parameters were calibrated through the element simulation method and results are presented in Figure 6 and Figure 7 (Jayakody et al. 2023).

Figure 6. Stress path plots

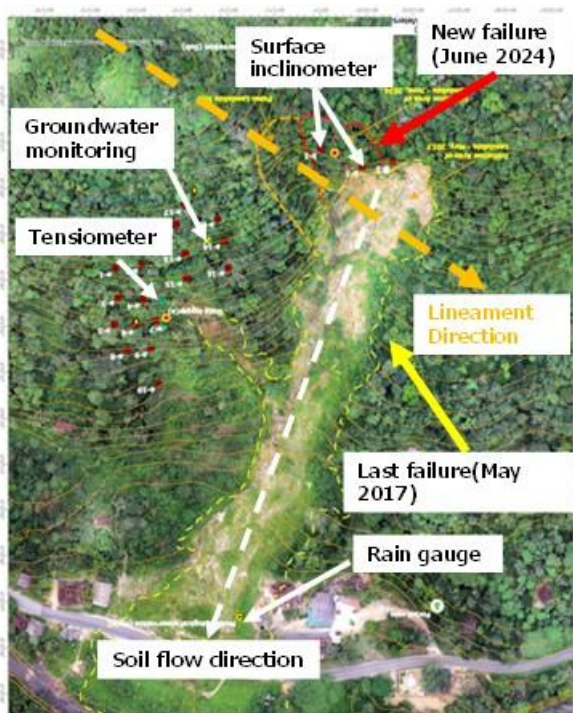
Understanding the hydromechanical processes that lead to landslides is critical for risk assessment and disaster mitigation in mountain and forested environments. This section focuses on monitoring rainfall-induced hydrological dynamics and surface as well as subsurface displacement on the slope adjacent to the Athwelthota landslide, which is susceptible to failure. The primary objective is to elucidate the relationship between rainfall characteristics, groundwater fluctuations, and slope movements to inform early warning and mitigation strategies. The monitoring network comprised borehole inclinometers and extensometers, surface extensometers, tensiometers, groundwater resistivity logging, and a meteorological station. Table 3 presents a summary of the instrumentation placed at the Athwelthota landslide site, as shown in Figure 11.

Figure 11. Instrumentation plan
