Enhancing Sustainability in Geotechnical Engineering Projects: A Case Study of Old Thaba Nchu Road

ABSTRACT: The Old Thaba Nchu Road (A56) in the Free State, South Africa, is experiencing significant pavement deterioration primarily due to geotechnical factors. This case study, presented by the Civilab@CUT Research Group, examines the underlying causes of degradation, with a focus on the inadequate drainage system and suboptimal roadbed composition. The existing road structure consists of a single layer of moist silty sand and silty clay, which lacks the necessary strength to support both light and heavy traffic loads. This weakness leads to severe rutting and cracking, particularly exacerbated by the passage of heavy trucks transporting construction materials. Water infiltration is identified as a critical factor contributing to pavement failure. The absence of adequate drainage allows water to accumulate beneath the surface, softening subgrade materials and leading to further structural damage. The study highlights that any repairs made will be susceptible to premature deterioration unless these drainage issues are addressed. Additionally, the analysis reveals that the current p

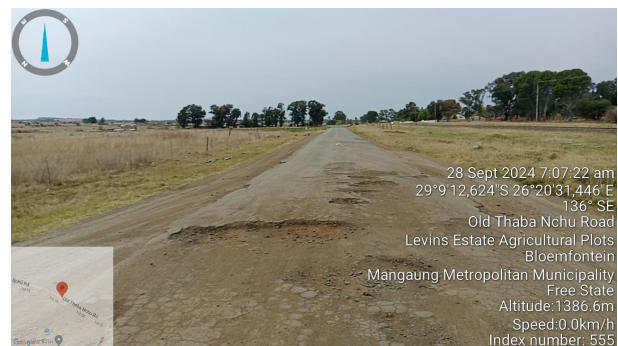
Figure 2. Pavement failure of the A56

When saturated, weathered shales and mudstones rapidly lose shear strength, making road embankments susceptible to slope failures and shoulder slippage after heavy rainfall (SAHRA, 2020). The alternating occurrence of soft

sedimentary rocks and rigid dolerite bodies complicates construction and maintenance by causing uneven compaction and differential movement, which can perpetuate pavement distress and maintenance needs (Johnson et al., 2006). Finally, the fine-textured, reddish soil generated by the weathering of these rocks are highly erodible, and heavy rainfall can induce erosion along road shoulders and embankments, undermining pavement support and contributing to ongoing edge and support failures (Free State Department of Water Affairs, 2010).

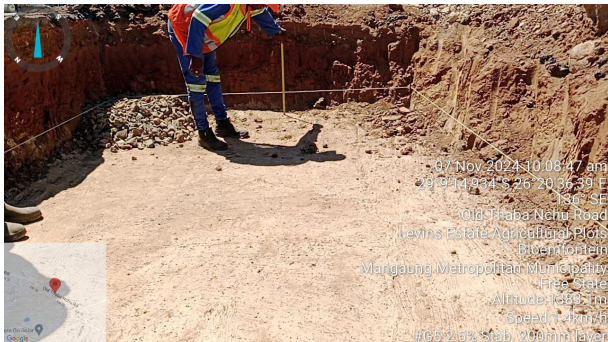
Figure 3. The excavated area of the A56

A forensic assessment of the Old Thaba Nchu Road (A56) has revealed that the original pavement structure consisted of a relatively thin, chemically stabilised base layer—measuring only 150 to 200mm in thickness—constructed directly above highly expansive clays of the Adelaide Group (see Figure 3). This base was surfaced with a notably thick asphalt layer, 80–100 mm in depth, which was intended to enhance load distribution and moisture protection under the region’s prevailing climatic and traffic conditions. The design approach reflected the common engineering philosophy at the time, aiming to minimise construction costs while providing sufficient bearing capacity for the forecast traffic volumes and expected rainfall patterns. Chemical stabilisation of the base was selected to improve its resistance to moisture ingress and to increase its structural strength, despite the inherent challenges posed by the reactive nature of the Adelaide Group clays. The substantial thickness of the asphalt was anticipated to counter the effects of seasonal moisture fluctuations and thermal movements, providing a durable surfacing layer to reduce the risk of surface cracking and rutting.

While this configuration initially provided an effective solution for the traffic volumes predicted during the design period, it did not sufficiently mitigate the risks posed by the active clay subgrade. The limited thickness of the stabilised base allowed seasonal moisture fluctuations to induce significant vertical and lateral movements in the underlying clays, leading to considerable subgrade instability. Over time, these cyclic changes resulted in differential heave and settlement, which manifested as reflective cracking, rutting, and surface distress in the asphalt layer above. The inadequate drainage provisions further enabled water ingress into the pavement structure, amplifying the swelling and shrinking behaviour of the expansive clays.

To rehabilitate the failed section of the A56, a systematic reconstruction methodology was adopted, emphasising high-quality materials and staged stabilisation for long-term performance. Pavement construction commenced with the importation of substantial quantities of high-quality G5 material. The new pavement layers were constructed in increments of 100 mm, following a carefully designed stratification as detailed below:

- 0–620 mm: This foundational layer consists entirely of compacted, neat G5 backfill material, providing a uniform and stable base.
- 620–720 mm: The subsequent layer comprises G5 material chemically modified with 1.5% additive, enhancing resistance to moisture and load-induced deformation.
- 720–970 mm: This section incorporates G5 material stabilised with a soil fix (@CiviLab) product, further improving structural integrity and durability against expansive clay movement.
- 970–1,000 mm: The uppermost layer consists of a 30 mm cold asphalt binder (@CiviLab), offering a moisture-resistant cap and establishing a strong interface with the final asphalt surfacing.

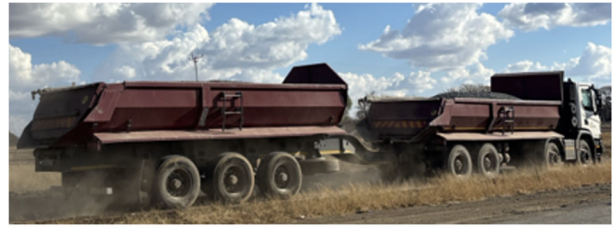
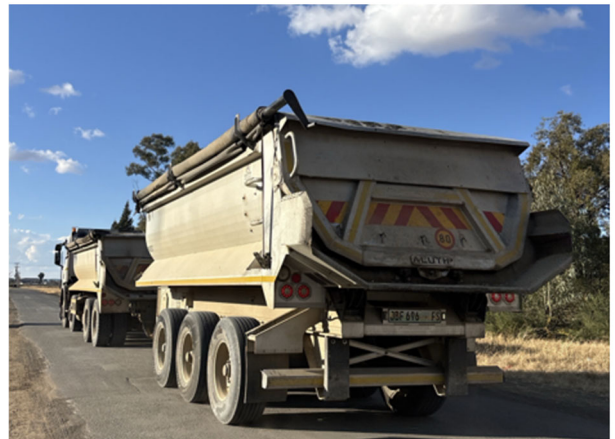
Figure 4. Heavy quarry trucks traveling along the A56

The situation was worsened by substantial increases in both traffic volume and axle loads, particularly after the opening of the Bloemspruit Quarry in 2017. Heavy quarry trucks (Figure 4) and increased commuter traffic imposed loadings far beyond those envisaged in the original design, accelerating the rate of pavement failure. Consequently, maintenance interventions became more frequent and expensive, while the overall serviceability of the road

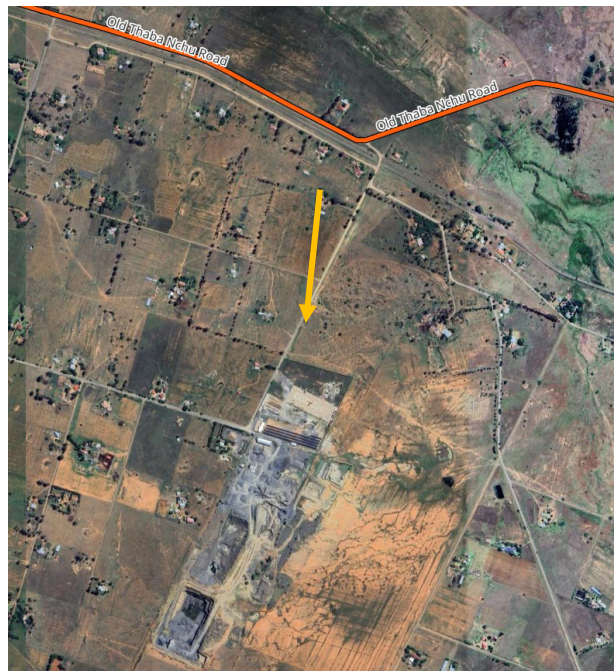
Figure 5. Location of the quarry relative to the A56

deteriorated, negatively impacting safety and user satisfaction for both local communities and commercial roadway users. Figure 5 illustrates the location of the Bloemspruit Quarry relative to the A56.

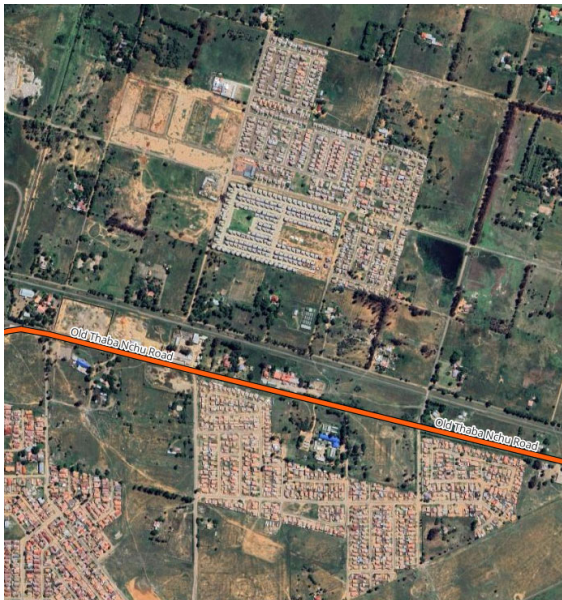
Figure 6. Location of the new housing developments relative to the A56

The construction of new housing developments adjacent to the A56 has had a profound impact on the road’s structural performance and overall functionality (Figure 6). These residential estates have significantly increased local traffic volumes, introducing a constant flow of commuter vehicles, school transport, and service deliveries to what was historically a lower-traffic corridor. The addition of frequent access points, turning movements, and peak-hour congestion has placed added stress on the pavement—stress that was not considered in the original design.

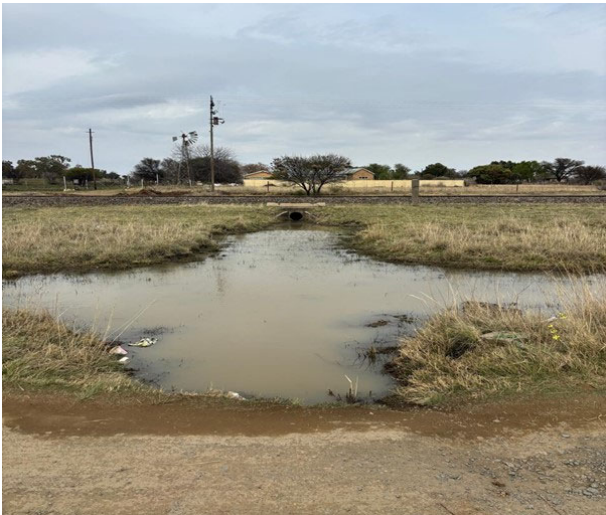
Figure 7. Blocked drain, pooling water and overgrown vegetation.

Compounding these structural challenges, inadequate drainage infrastructure contributed significantly to the road's progressive deterioration. Blocked and undersized drains led to frequent surface water pooling and saturation of the shoulder and subgrade layers (see Figure 7), particularly in low-lying zones underlain by expansive clays. Persistent wet conditions weakened the pavement support, increased the occurrence of potholes and edge breaks, and further hastened the loss of pavement integrity. Overgrown vegetation on the road edges exacerbated these problems by impeding water flow, trapping moisture at the pavement edge, and allowing root intrusion that undermined the shoulders.
