Evaluation of geotechnical monitoring results of deep excavation support and back analysis using FEM

ABSTRACT: This paper presents a deep excavation support design, the results of geotechnical monitoring, and back analysis using the finite element method (FEM). Because of its location on a slope, the construction of the residential building required an excavation with a maximum depth of 16 m in the temporary construction stage and a maximum depth of 10 m in the final construction stage. Due to the site topography and ownership requirements, a bored pile wall was proposed. CFA piles with diameters of 80 cm and 100 cm, and lengths of 15.5 to 20.0 m, were applied. In the temporary construction stage (during concrete works), it was supported by steel struts, and in the final construction stage it was a cantilever retaining wall. The design requirements and parameters of the bored pile wall exceeded typical applications. Therefore, geotechnical monitoring was implemented, consisting of geodetic, inclinometer and strain gauge measurements conducted from the time the piles were installed until the present moment. These monitoring results enabled a continuous assessment of the structure's

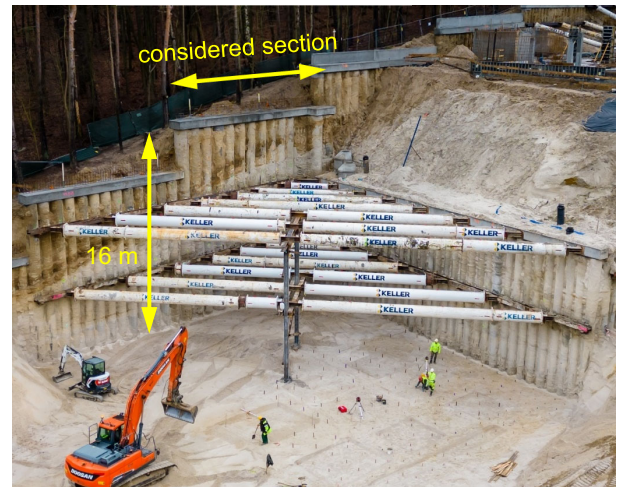
Figure 4. Temporary construction stage.

The excavation support was designed as a bored pile wall using the continuous flight auger (CFA) technique (Figure 2). This paper presents and analyzes a section of the excavation support with the deepest excavation (Figure 4). A 20-meter-long piles with a diameter of 100 cm were spaced at intervals of 115 cm. They were made of C25/30 class concrete and were reinforced with cages of $f_{yk}=500$ MPa steel (Figure 3). A single pile design capacity for simple bending in ULS was $M_{Rd}=1967$ kNm, and for simple shear was $V_{Rd}=285$ kN. In the temporary construction stage, the bored pile wall stability was ensured by a temporary steel structure consisting of CHS508x12 mm pipes (struts) and 2xHEB400 built-up sections (walers) made of S355 steel (Figure 4). In the final construction stage, the bored pile wall was supported by reinforced concrete struts and beams with a cross-section of 50x50 cm, which were connected to the support structure of the designed building (Figure 2, Figure 5, Figure 6). The connections of the struts to the bored pile wall were considered as hinged.

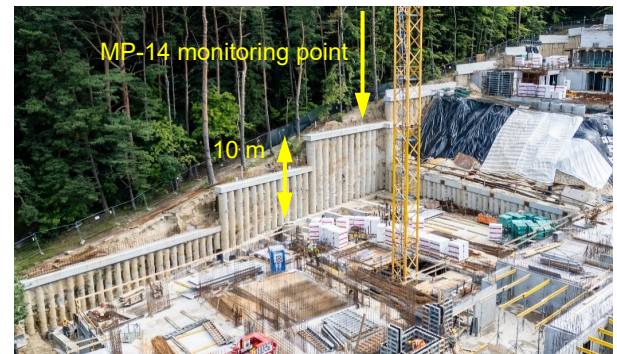
Figure 5. Final construction stage.

This part of the paper will present the basic results of the measurements taken at the MP-14 monitoring point, which experienced the greatest displacement (Figure 5). This monitoring point included strain gauge measurements on Pile No. 467, and geodetic and inclinometer measurements on Pile No. 468 (Figure 7).

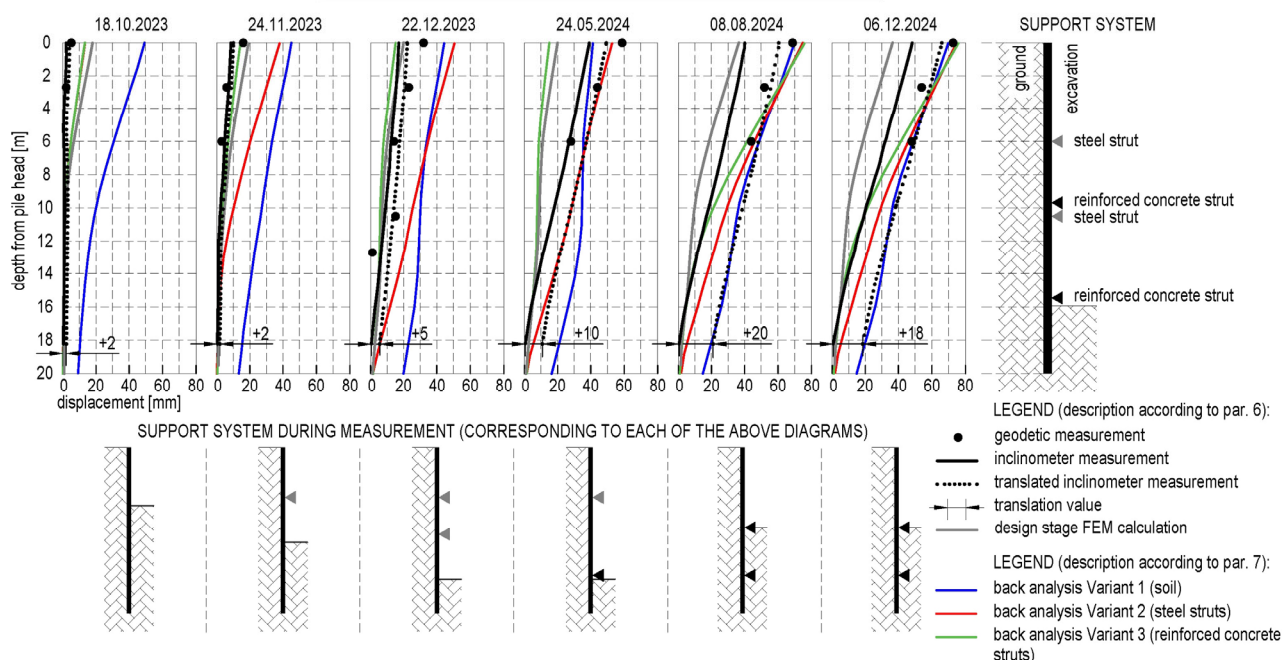
Figure 8. Measured and calculated displacement.

Figure 8 shows the results of geodetic and inclinometer measurements. These graphs allow us to track pile displacement increments over time as the work progressed and the static system of the bored pile wall changed. The deformations indicate pile bending, tilt and horizontal movement. In the final construction stage, the displacement from geodetic measurement at the top of the bored pile wall was 73 mm at the time of the last inclinometer measurements (06.12.2024). This value increased slightly in subsequent measurements, reaching a maximum of 76 mm. It remained unchanged for the following three months of geodetic measurements, indicating stabilization. FEM design calculations estimated the maximum displacement to be 38 mm, assuming the nominal stiffness of the concrete cross-section. However, the more unfavorable value of 0.01H for cantilevers, as reported in the literature (Smolczyk, 2002) - about 100 mm in this case - was used in the design stage to reliably predict maximum displacement.

As shown in Figure 8, the results indicate a probable displacement of the pile base in the direction of the excavation. This is evident from the larger values from geodetic measurements than from inclinometer measurements. The point geodetic and continuous inclinometer measurements were synthesized. The graph obtained from the inclinometer measurement was translated to roughly match the geodetic measurement. The translation distance was determined by minimizing the sum of deviations using the least square method. Thus, the hypothetical shape of the displacement along the entire length of the pile was obtained, including sections inaccessible to geodetic measurements. The interpreted value of the horizontal movement of the pile base increases with the progress of the work and reaches a maximum of 20 mm. In the

The significant increase in displacement after the removal of the lower steel strut (24.05.2024) is noteworthy. The preceding and subsequent phases were associated with much more minor changes in displacement.

Figure 8 and Figure 11 show that there are discrepancies in displacement and stress between the measured and calculated values at the design stage. A qualitative assessment was performed to determine the influence of individual factors on the structure's behavior. However, exact values were not compared. In general, the measured displacement of the excavation support was greater than predicted by FEM calculations at the design stage. Therefore, for further analysis, it was assumed that the cause of the discrepancies was an overestimation of the stiffness of the geotechnical structure's elements.

The displacements and internal forces obtained from the back analysis calculations were compared with the geotechnical monitoring data (Figure 8, Figure 11). Then, conclusions were drawn about how the stiffness of each element affects the system.

Variant 1 displacement (Figure 8, Figure 10) is horizontal movement and tilt. It includes the top and base of the bored pile wall. The calculated values are a good approximation of the geodetic and inclinometer measurement results in the final construction stage. In earlier phases, however, the calculated values are higher than the measured. Given the presence of dense sand in the ground, the obtained value of the reduction in the soil modulus of deformation seems high, unless the CFA technique significantly loosened the sand. Nevertheless, the relationship between the increase in displacement of the bored pile wall base and the soil stiffness reduction identified in this variant suggests that E_{oed} was overestimated in the design stage calculations.

In variant 2, the displacement has tilted shape. It includes the top of the bored pile wall and is negligible at the base (Figure 8). The numerical simulation captures a moderate displacement increase after the upper steel strut is removed. However, there is no convergence of displacement in the initial phases, because the calculated values are larger than the measured ones. Excessive deformation was observed in the elements connecting the steel waling with the piles during the dismantling of the upper level of the steel strut. This was probably the cause of the unexpected and significant increase

in displacement of the bored pile wall after the lower steel strut was removed (24.05.2024 on Figure 8).

In variant 3, the displacement has tilted shape (Figure 8). In the numerical simulation, there is a significant increase in displacement after the removal of the upper steel strut that did not occur. Before the upper steel strut is removed, the calculated displacements are smaller than the measured ones. Reduced stiffness in reinforced concrete struts seems to be less probable than in steel struts and soil. This is because these elements are massive, have simple and rigid connections, and structural robustness.
