## Brief insights: In situ testing of base friction angle in an old concrete dam

Enrique Asanza-Izquierdo, **Carlos Laina-Gómez**, Diego Escudero-Merino, Juan Antonio Díez-Torres  
*Laboratorio de Geotecnia, Centro de Estudios y Experimentación de Obras Públicas (CEDEX), Spain,*  
[carlos.laina@cedex.es](mailto:carlos.laina@cedex.es)

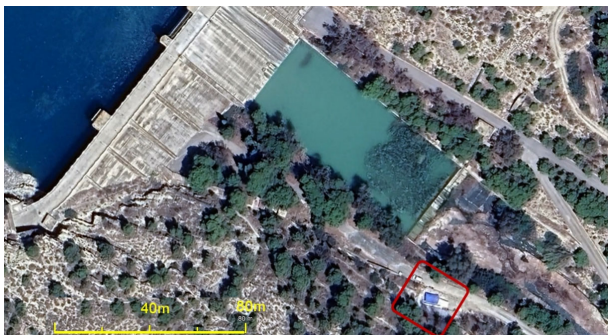
Figure 8. Location of the test, downstream the dam. The blue rectangle is a canopy for shading.

The test area was located downstream the dam (Figure 8), on the right bank where representative massive marly limestone outcrops at the base of the slope (Figure 9). Minor excavation work and ground levelling was needed prior to prepare the test area, where an array of four cast-in-place concrete reinforced blocks 1x1x0,6m in size were programmed to be tested.

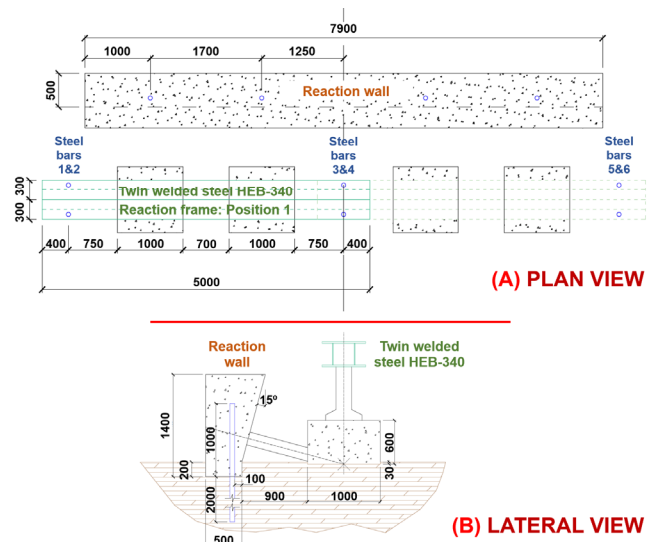
Figure 10. Design drawings of the reaction frame and the concrete wall: (A) Plan view, (B) Lateral View.

- a passive reinforced single-face (workform overhanging 15°) cast-in-place concrete wall, 4 m long and 1,40 m high, densely reinforced; the opposite side was an open rock excavation, previously examined, as all the passive thrust relies on it;
- and a reaction frame: consisted of 2 twin welded steel HEB-340 beams 5 m long, spanning two concrete blocks; the twin beams are pinned at their ends on four threaded steel bars (Ø63,5 mm St670/800) with flat bearing plates and a nut on each side. The twin beams are detachable and movable to cover the span of the other two concrete blocks with another pair of bars. All six bars, which absorb the uplift force of the vertical hydraulic ram, are grouted 8 m into the rock mass. Figure 10 shows the design drawings of the reaction frame and the cast-in-place wall.

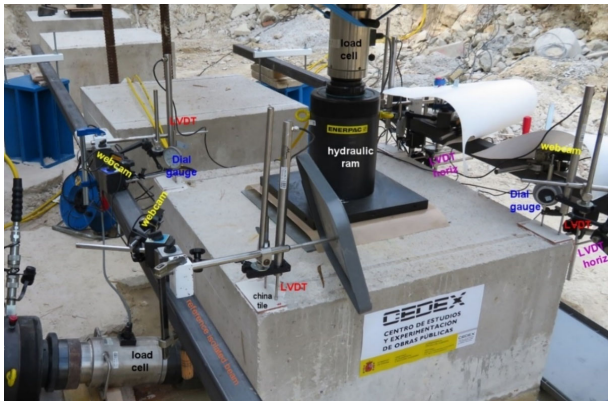
Figure 11. Arrangement of the monitoring system

Although during the test the loads can be obtained by the pressures displayed at both pump gauges, electronic load cells were attached between the ram and the distribution plates and connected to the data acquisition system. With regard to the displacement readings, six regular dial gauges (0,01 mm accuracy; stroke 100 mm) were installed at the tested block: four vertically, at each edge of its top face (dilatancy and tilting); and two horizontally, at the front face near its top corners, to obtain an averaged displacement. All six dial gauges were paired to webcams which, in turn, were connected to a closed-circuit television (CCTV) and recorded (Figure 11). Load values and dial gauges readings were noted down at intervals throughout the test as back-up. All six webcams, displayed altogether on a screen provide useful information to track the test (Figure 12) and spare operators from any hazards, as reading are taken off the testing site. In addition, another set of six LVDT were as well installed next to each sister dial gauges and connected to the data acquisition system with a high reading frequency, so as not to miss out uncontrolled brittle failures. The tip of the LVDTs and dial gauges plungers rest on pieces of china tiles glued to the block on avoidance of surface roughness.

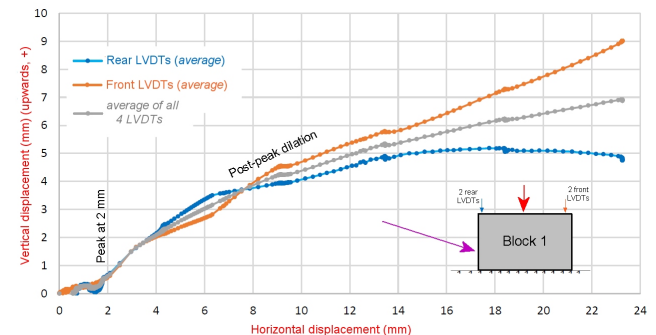
Figure 14. Relationship between vertical and horizontal displacements in the test with Block 1.

As shown in Table 3, shear strains at peak strength ranges from 0,2 to 0,7 %, as previously predicted; thus, further displacements occur with total lack of adhesion/cohesion forces while dilative strength develops (see Figure 2). Test with Block 1, as shown in Figure 14 (vertical vs horizontal displacements), seems to follow such behaviour. In fact, the response of the other 3 blocks do not differ substantially from Figure 14. The dilation angle is obtained from the ratio vertical/horizontal.

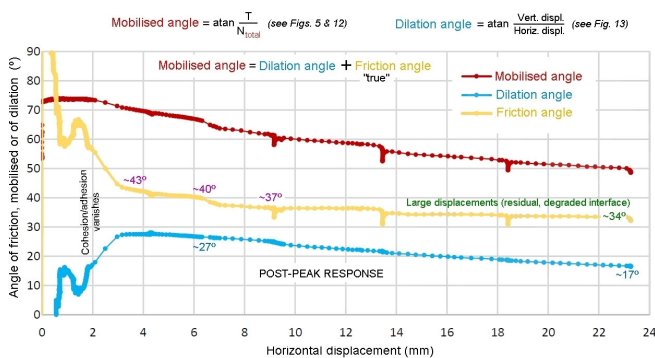
Figure 15. Relationship between angle of friction, mobilised, of dilation and horizontal displacements in the test with Block 1.

Theoretically, the true angle should not vary as the shear continues, whereas the dilation angle should decay due to the grinding effect, unless the rock matrix is hard enough. Figure 15 shows the evolution of the three angles throughout the test with block 1. The mobilised angle and the dilation angle are obtained with the ratios shown in Figure 15 and, therefore, the (true) friction angle is readily inferred as a subtraction. Degraded angles could be roughly derived if large shear displacements have been achieved (>20 mm).
