Preliminary Test Piles in Weak Weathered Lias Group Jurassic Mudstone Rocks

Giorgos Economidis, Maria Dimitriadi, Harry Saroglou
 EKFB, Milton Keynes, UK, giorgos.economidis@ekfb.com

ABSTRACT: This paper presents the findings from preliminary test pile investigations conducted in weak weathered Lias Group Jurassic Mudstone Rocks, as part of the High Speed Two (HS2) Phase One C23 contract. The primary objective of the study was to assess the behaviour of bored piles formed in Charmouth Mudstone under axial loading and to provide valuable insights into the most appropriate design methodology. The campaign included four Preliminary Test Piles, supported by a detailed, site-specific ground investigation that combined in-situ and laboratory testing. The paper discusses the challenges posed by the unique characteristics of the mudstone, compounded by the limited available guidance on this material. It examines the impact the behaviour of the geological unit has on pile capacity as it transitions from a completely weathered state, acting as clay, to a structured weak rock. The paper also critically reviews the applicability of commonly used pile design approaches for weak rock, as found

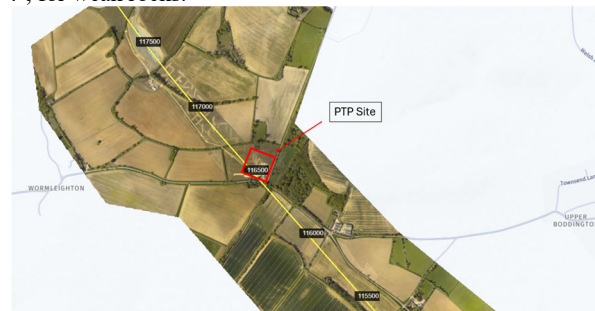
Figure 1. Boddington Preliminary Test Pile site

The preliminary test piles were carried out in 2021 on a test site situated between Upper Boddington and Wormleighton within the HS2 working area, Figure 1. A total of four Preliminary Test Piles (PTP) were carried out.

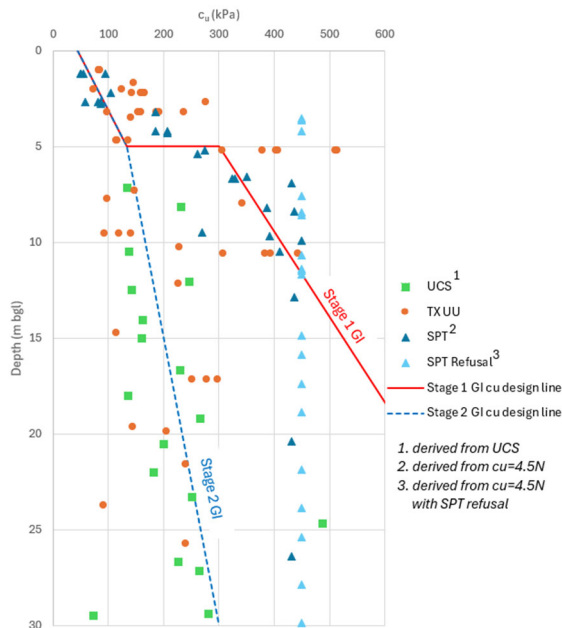
Extensive in-situ and laboratory testing was conducted near the test piles. Figure 2 presents these results as undrained shear strength profiles for Charmouth Clay and Mudstone strata. Noting that only Stage 1 ground investigation (GI) data shown were available when specifying the pile tests.

Figure 2. Undrained shear strength of the top 30m of the test site

At the time the test pile was designed and tested, the shaft resistance of the test pile below the level of +133.4mOD was based on limited Stage 1 GI data. Subsequently, additional detailed design GI was procured and additional UCS tests were undertaken on core samples. These tests show increasing UCS values from 260kPa at the top of the mudstone to 460kPa at the toe of the 20m long pile, or an average UCS value of approximately 350kPa in the section of pile below +133.4mOD. Using the pile design approach for a weak rock (Horvath & Kenney 1979, presented in 4.1), the corresponding shaft friction value would be approximately 115 to 152kPa with a representative value of 130kPa. This is still higher than the measured shaft resistance from the 1500mm test piles. When the UCS values were converted to undrained shear strength, c_u , the c_u values increase from 130 to 230kPa. Using the αc_u design approach, the equivalent shaft friction value increases from 65 to 115kPa with an α value of 0.5. This matches reasonably well with the measured shaft resistance values of the two test piles. However, when the same approach is extended into the mudstone further down, the measured shaft resistance is much higher than the calculated value based on αc_u design approach.

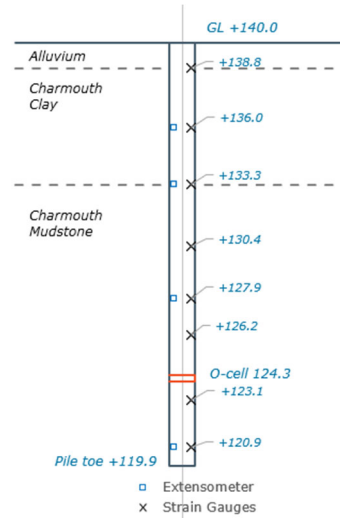
The two 1500mm diameter test piles were constructed with a short 6m temporary casing and bored without support fluid to the toe level before completing the piles via tremie operation due to some water ingress. A single level of O-Cell was installed to introduce bidirectional load to the test piles. Figure 3 shows the schematic sections of the test piles together with strain gauges and extensometers installed to provide load distribution along the piles during the tests.

Figure 3. Instrumentation of test piles and O-Cell arrangement for compression test piles

Sister bar vibrating wire strain gauges were installed at multiple levels along the pile to determine the load distribution throughout the shaft. Arranged in sets of four at 90-degree intervals, these gauges provided redundancy in case of damage or failure. Expansion of the O-Cells was measured using linear vibrating wire displacement transducers, while telltale extensometers recorded compression in the pile sections above and below the O-Cells. To monitor top-of-pile displacements, Linear Voltage Displacement Transducers (LVDTs) were mounted on a steel box beam reference system supported by concrete foundations. Figure 3 and 4 illustrate the placement of the O-Cells and strain gauges for the two typical arrangements.

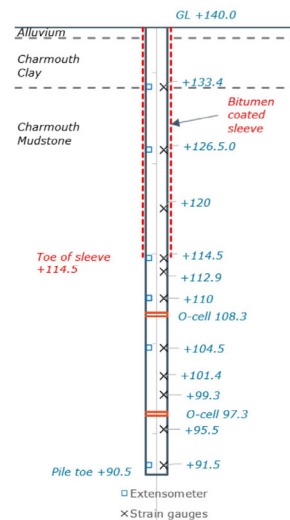
For the two 900mm diameter test piles, a 26.1m long sleeve was grouted into a 1200mm diameter pile bore well before the piles were bored using 900mm diameter tools and concreted under tremie operation. In these test piles, two levels of O-Cells were installed in order to provide an understanding of the distribution of the pile resistance including the

performance of the bitumen coated sleeve of the pile. The test of the bitumen coated sleeve was intended to provide validation of the friction reduction performance of a bitumen coating intended to reduce potential heave force on piles installed in deep cuttings in the Charmouth Mudstone. Figure 4 shows the schematic sections of the test piles together with strain gauges and extensometers installed to provide load distribution along the piles during the tests. Figure 5 shows the application of the bitumen coating on the steel casing which forms the sleeve of the test pile.

Figure 4. Instrumentation of test piles and O-Cell arrangement for heave test piles

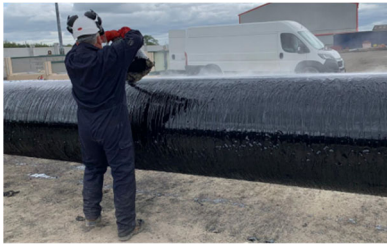
Figure 5. Bitumen coating application on permanent casing

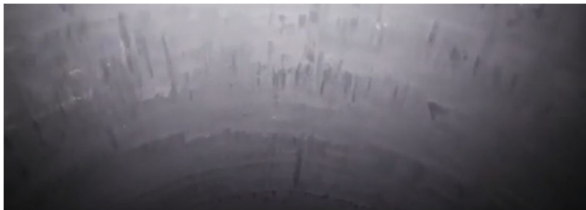
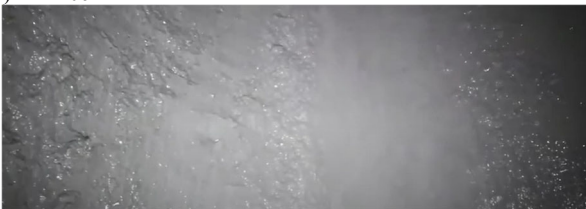
at remeasure of the final depth before concreting the pile observed 600mm of debris at its base. GoPro inspection of the pile bores showed smooth shaft surface of the 1500mm diameter test piles while the deeper 900mm diameter test piles showed rougher surfaces caused by the groundwater ingress and drilling disturbance, see Figure 6 below.

a) PTP06

b) PTP09

Figure 6. GoPro still images for the test piles

0.5 to 0.3. Such low measured shaft resistance from the test pile could be due to the smooth surface observed during installation and a lack of groundwater inflow to roughen the pile shaft. The equivalent pile head load-settlement behaviour of these two test piles extrapolated using the CEMSET program is shown in Figure 8.

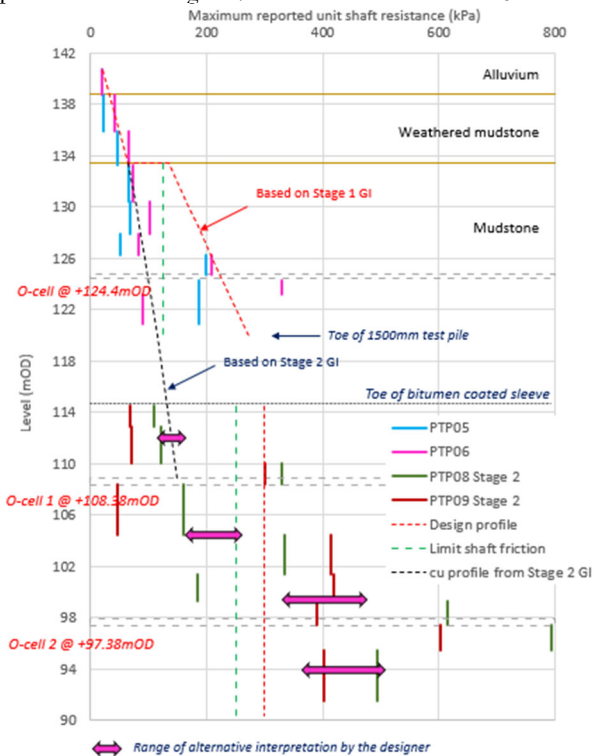
The distribution of the measured shaft resistance of these test piles is shown in Figure 7 and summarized in Table 5.

Figure 7. Distribution of measured shaft resistance of test piles at Boddington test site

For the 1500mm diameter test piles the measured unit shaft resistance in the Mudstone below a level of +133.4mOD was significantly lower than the calculated values representing a reduction of the α value adopted in pile friction calculation from

For the 900mm diameter test piles using multiple O-Cells, the measured unit shaft resistance in the Mudstone above the top O-Cell between +108 and +114mOD was well below the limiting value of 125kPa. However, below the top O-Cell the measured shaft resistance was generally well above the limiting value of 250kPa. For both tests, the mode of displacements did not allow full mobilisation of the shaft resistance of the portion of the pile shaft between the two O-Cells, i.e. when the load was applied to the top O-Cell the observed mode of failure was upward displacement whereas when the lower O-Cell was loaded the observed mode of failure was downward therefore did not allow full mobilisation of the shaft resistance of the middle section of the test pile between the two O-Cells. It is likely that the actual shaft capacity of the pile is higher than the interpreted values if the resistance of the middle shaft is fully mobilised.

When the β design approach is applied to this longer 50m length pile, the vertical effective stress, i.e. σ_v' , at the toe of the test piles is approximately 500kPa therefore the corresponding unit shaft friction value is $\beta \sigma_v' = 400$ kPa. This fits reasonably well with the average value of the longer piles, see Figure 7.

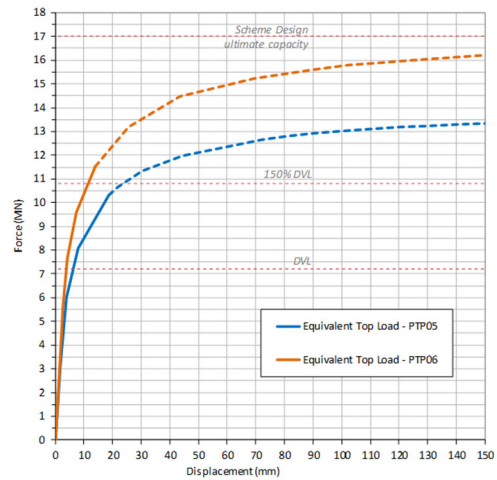
Figure 8. Equivalent pile head load-settlement for PTP05 and PTP06

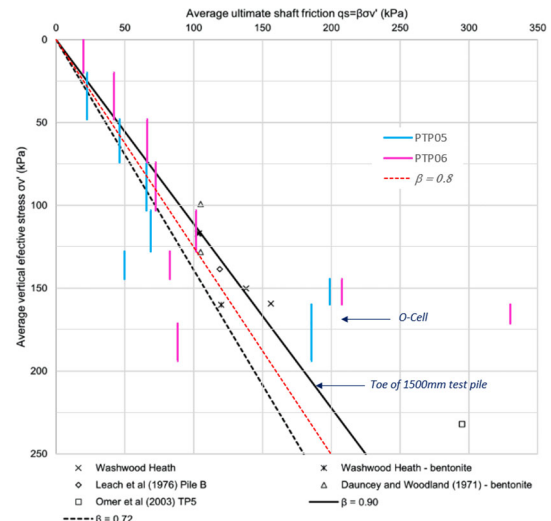
The ultimate shaft resistance of these test piles could be represented using the β design approach (also known as the effective stress approach), i.e. $f_s = \beta \sigma_v'$, where the β value is a constant appropriate for the soil, in this case the Charmouth Mudstone. This approach was adopted by Markyukaj *et al.* (2023) for weak Mercia Mudstone in the HS2 project further north of the Boddington test site. When superimposed onto the Charmouth Mudstone test piles results, a β value of 0.8 seems to fit well with the interpreted shaft resistance value, see Figure 9.

Figure 9. Interpretation of test piles in Charmouth Mudstone using the β design approach, superimposed onto Mercia Mudstone test data (Markyukaj S *et al.* 2023)

that the β design approach with β value of 0.8 shows a better fit to the test data obtained from the HS2 project site studies.
