Challenges & Solutions in Uplift Anchor and Uplift Pile Testing under Complex Geotechnical Conditions: Insights from Water-Filled Excavation Pits

Nejla Yildiz Helvacioğlu, Robert Thurner, Florian Kainz
 Keller Grundläggning AB, Sweden, nejla.helvacioğlu@keller.com

KEYWORDS: Anchor testing, testing in water filled pits.

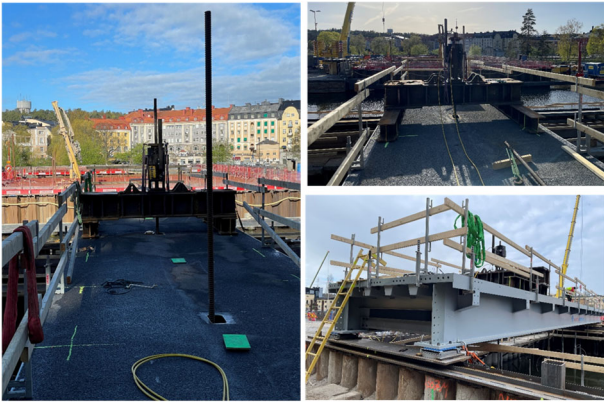
Figure 6. Testing uplift piles against a temporary bridge.

The previously described method was not applicable to all excavation pits. Therefore, a new method was developed for one pit, involving the use of a temporary bridge as a reaction structure (see Figure 6) for testing uplift piles up to a force of 1,382 kN. To use this bridge, back calculations were required to check the bearing capacity of the retaining walls, as well as a structural check of the bridge itself.

In order to carry out the uplift pile tests from the top of the bridge, holes had to be cut in the bridge surface. As the bridge owner initially refused to allow this, Keller prepared a backup solution to test from a suspended construction (see Figure 7).

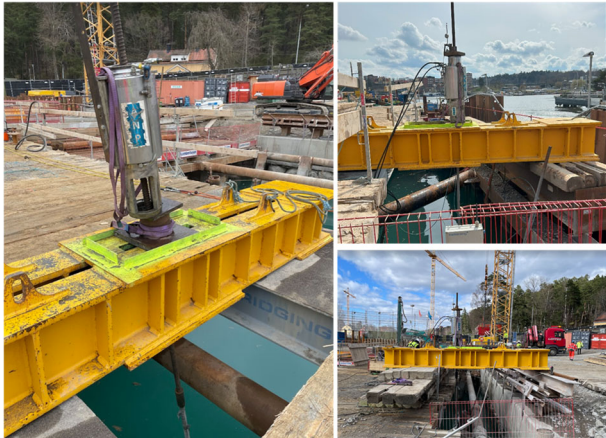
Figure 11. Testing permanent anchors against a temporary bridge.

In addition to the anchors inside the steel piles, permanent anchors have been installed in one of the excavation pits in order to actively pretension an underwater concrete slab. Testing was performed using a temporary bridge construction in combination with a testing beam designed for a test load of

up to 5 MN (see Figure 11). Once testing was complete, divers removed the extension piece of the anchor to allow access for installing a permanent anchor head construction underwater. Once the underwater slab had been cast and cured, the Keller team and the dive team proceeded to tension and lock the anchors. Challenges included poor underwater visibility and the absence of a helmet-mounted camera, meaning the diver had to verbally describe to the test engineer how the domed nut was seated within the concave anchor plate (see Figure 12).
