Deep Excavation Solution at Hill Base Using Tie Rods as Passive Ground Anchors

ABSTRACT: The aim of this article is to describe a retaining wall deep excavation solution with a maximum height of 20 m, to allow the construction of several underground floors of a new building located at a hill base in Leiria, Portugal. Typically, retaining wall solutions in urban areas employ temporary bracing systems that are later replaced by underground building structure. In the present scenario, the retaining wall located at a hill base, required permanent support for earth pressures on the eastern side at the first two levels. Since the building had only three underground levels, the general horizontal bracing was achieved using temporary ground anchors. The horizontal bracing solution at the first two levels on the eastern side uses 50 mm diameter tie rods as passive ground anchors, with lengths up to 28 m, with double corrosion protection provided by enclosing the tie rod in a corrugated sheath and subsequently injecting cement grout inside. The 6 m sealing length, for both tie rods and pre-stressed ground anchors, was accomplished using a multi-valve system and an IRS injection procedure, r

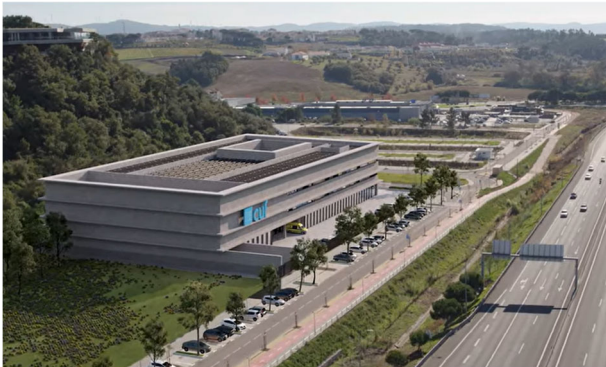
Figure 1. Building graphical representation.

This article aims to describe the excavation and earth retaining solutions implemented for the construction of the underground floors of a hospital building. The building is located at the base of a hill, requiring the excavation of five underground floors on the eastern side, adjacent to the hill and only two underground floors on the opposite western side (see Figure 1).

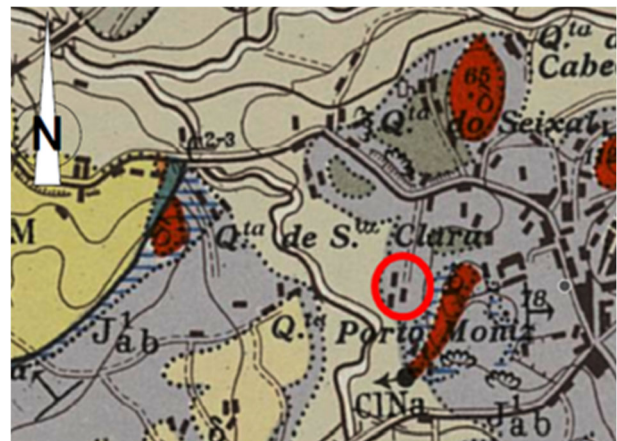
Figure 2. Excerpt from the Portugal Geological Map at 1:50,000 Scale.

Based on the Geological Map of Portugal at a 1:50,000 scale, the study area presents dolomitic limestones and marls of the Dagorda Formation (J1ab), dated from Jurassic period. To the West of the study area, near one of the branches of the Lis River, modern alluvial deposits (a) are found, which are distributed throughout the region along other streams. To the East, the geological map identifies outcrops of dolerites and related rocks (δ). Figure 2 shows the approximate location of the study area on an excerpt from the Portugal Geological Map at a 1:50,000 scale.

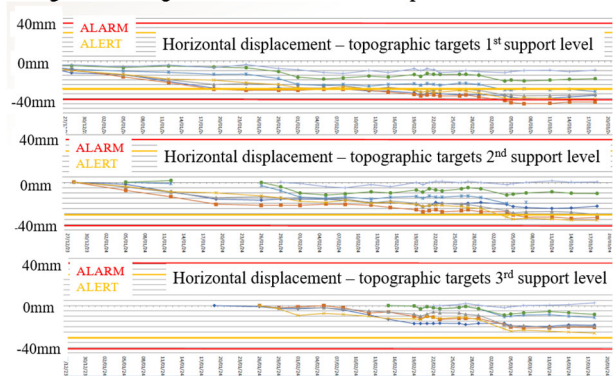
Figure 8. Horizontal movements toward the interior of the excavation measured by topographic targets.

During the excavation works, measurements gradually revealed an increase in monitored values, particularly at the East side retaining structure horizontal displacement with the greatest elevation. These deformations were expected as the upper two levels of ground anchors were passive and therefore require some deformation to mobilize (see Figure 8). However, near the final excavation stage, anomalies were detected in the wedge systems of the pre-stressed ground anchors installed at the lower levels. These anomalies were due to the use of materials with inadequate geometry, leading to load loss in several ground anchors and, consequently, increased deformation of the retaining structure. This poor performance of the temporary pre-stressed ground anchors was offset by the excellent performance of the passive permanent ground anchors.

At that point, since the recorded values had reached the alert thresholds defined in the design phase, as Figure 8 and Figure 9 presents, the associated geotechnical risk was reassessed, and reinforcement measures were implemented along with changes to the construction sequence.

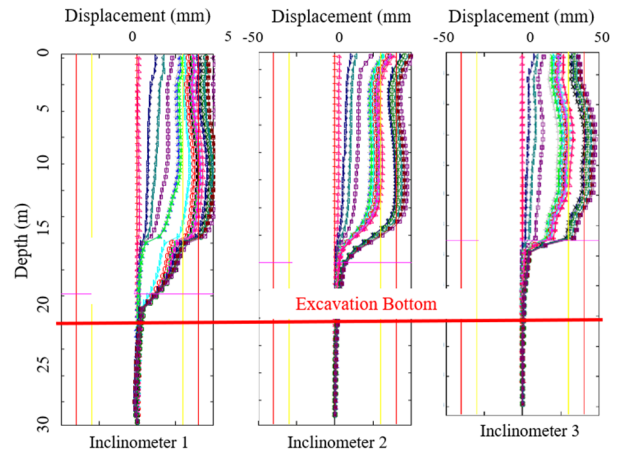
Figure 9. Horizontal displacements toward the interior of the excavation pit, measured by inclinometers.

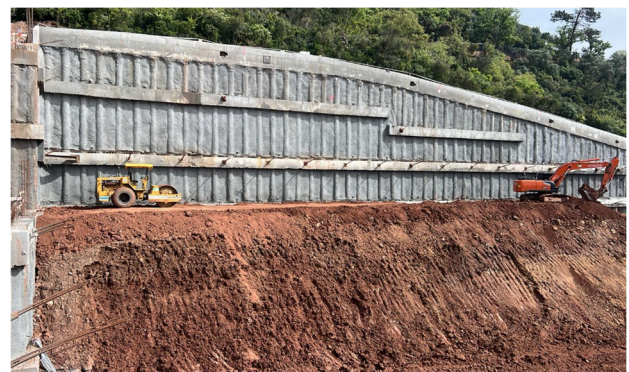
Figure 10. View of the final stage of earth fill execution, implemented as the first reinforcement measure at East side wall.

The first measure, implemented immediately, consisted of earth fill execution at the base of the retaining structure up to Floor 0 level (a fill height equivalent to two floors). This measure aimed to mobilize a higher passive pressure at the base of the retaining structure and to enable the implementation of the second geotechnical risk mitigation measure (see Figure 10).

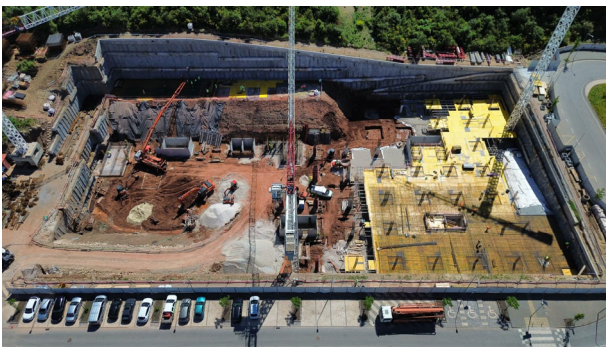
Figure 13. Overall view of the implemented reinforcement measures.
