Stabilization of a gabion wall at an electrical substation in Coimbra: Design solutions and monitoring results

ABSTRACT: This paper presents the analysis, design, and implementation of stabilization measures for a gabion retaining wall located at an electrical substation in Coimbra, Portugal. The wall, approximately 12 m high and founded over sandy fill materials overlying decomposed schist, has exhibited progressive deformation since shortly after construction. Topographic monitoring initiated in 2009 - two years after completion - revealed significant long-term movements. After ten years, average horizontal and vertical displacements reached 30 cm and 22 cm, respectively, while maximum recorded values attained 60 cm (horizontal) and 30 cm (vertical). These displacements led to structural damage to substation buildings, pavements, cable ducts, and other critical infrastructure, motivating the need for a comprehensive geotechnical reassessment and stabilization intervention. The scope of this work includes (i) diagnosis of the failure mechanisms governing wall deformation, (ii) numerical and analytical evaluation of reinforcement alternatives under geotechnical, structural, and op

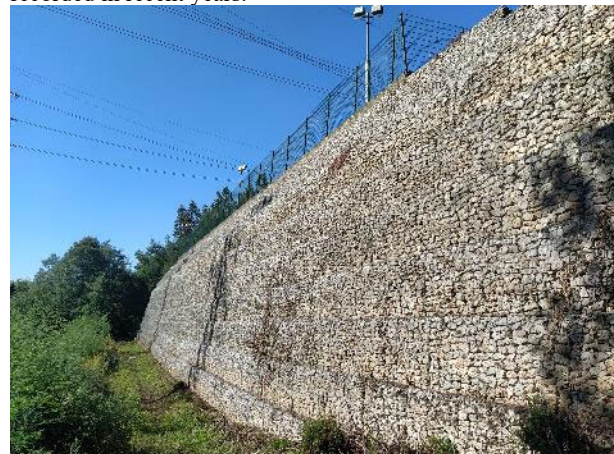
Figure 1. Existing gabion wall.

The Bemposta substation, located in Coimbra, Portugal, is supported by a gabion wall with approximately 12 m high (Figure 1), founded over sandy fill materials overlying decomposed schist. Since its construction in 2007, the wall has exhibited progressive deformations, resulting in damage to the

Topographic monitoring initiated in 2009 revealed horizontal displacements of up to 60 cm and settlements bigger than 30 cm in some areas, with increasing deformation rates recorded in recent years.

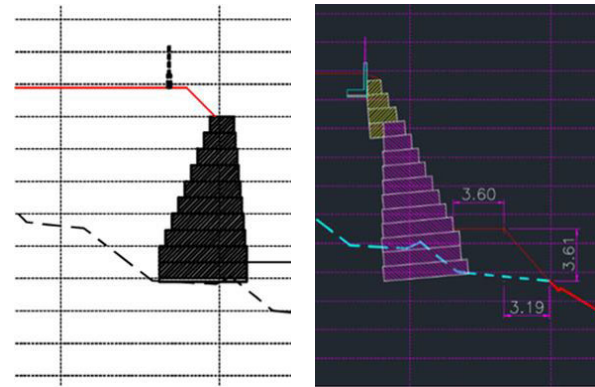
Figure 3. Gabion wall from the original design (left) and gabion wall as executed (expected) (right).

According to information provided by the client, the gabion wall was built in 2007. Interpretation of the design drawings, compared with the as-built structure, indicated that the wall cross-section underwent modifications during construction (see Figure 3).

The original wall has an approximate length of 70 m and is topped by a reinforced concrete retaining wall, which was not part of the original design. The height difference between the substation platform and the access path at the wall's toe is about 12 m, with the upper platform at the elevation of 95.00 m and the bottom path at elevation 83.00 m. Boreholes performed to assess the wall's foundation revealed that the gabion structure extends an additional 2–3 m below the existing path platform.

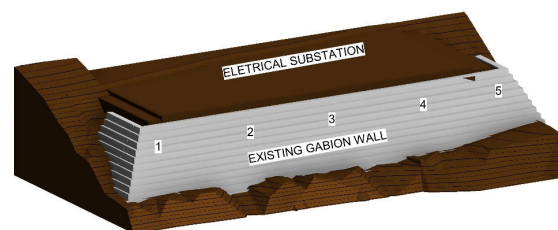
Figure 4. Location of the targets place after the construction of the gabion wall.

Topographic monitoring of the wall began in 2009, two years after its construction, through the installation of survey targets. Three monitoring campaigns were carried out on April 2009, September 2012, and February 2019. Of the 10 installed targets, only 4 had complete data from all three campaigns (Table 1 and Figure 4). The analysis of the recorded movements showed:

- Horizontal displacement: Targets located at elevation 90.5 m (approximately 60% of the wall height) experienced the largest displacements, about twice that of the other targets, with an average of 60 cm;
- Settlement: Targets at elevation 94.7 m recorded the largest settlements, averaging 30 cm, compared to an average of 22 cm for the remaining targets;
- Plan view distribution: Displacements were greater at central targets (54 cm) than at those near the wall ends (10cm);
- Deformation rate: With some reservations due to incomplete data, the average rate of horizontal displacement and settlement was higher between 2012 and 2019 (1.05 cm/year and 0.16 cm/year, respectively) than between 2009 and 2012 (1.35 cm/year and 0.67 cm/year, respectively). This suggests that observed deformations are mainly associated with long-term consolidation effects.

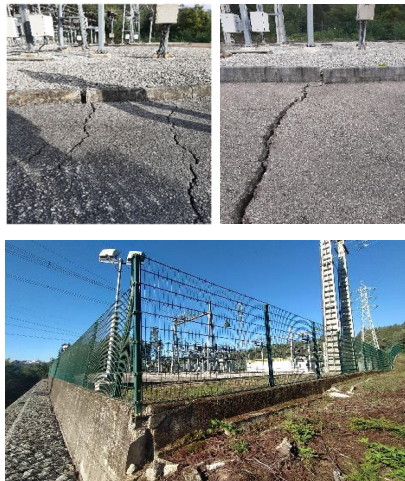
Figure 5. Existing pathologies at the substation.

These findings are consistent with visual inspection of the wall, which revealed several pathologies such as cracking, misalignment, and local instability at the wall crest (see Figure 5).

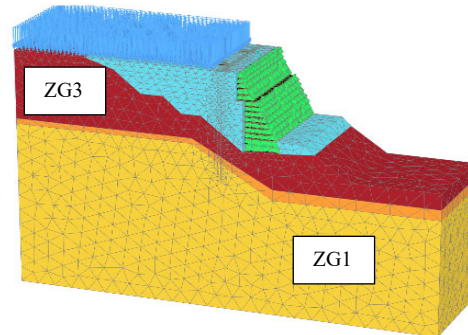
Figure 8. Plaxis 3D model used to evaluate the design solution.

To analyze the structural and geotechnical behavior of the retaining and reinforcement system in terms of internal forces and deformations, a finite element analysis was carried out using PLAXIS 3D (see figure 8).

The soil behavior was modelled using Linear Elastic, Mohr–Coulomb, and Hardening Soil constitutive models, with deformability and shear strength parameters adopted from the geotechnical investigation. The piles and capping beam were modelled as beam elements. For the bored pile wall, the modelling approach consisted of a cluster assigned with concrete properties, within which dummy pile elements with very low stiffness were inserted to evaluate the forces and deformations on these elements.

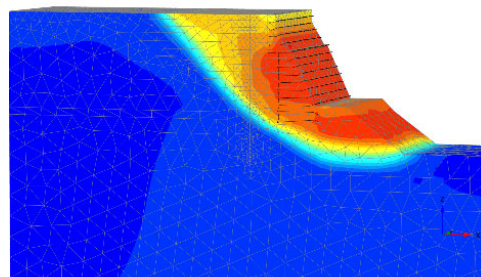
Figure 9. Critical surfaces for the gabion wall solution without reinforcement: safety factor of 1.16.

Limit state checks confirmed that the existing gabion wall alone had a factor of safety of 1.16 (Figure 9), while the reinforced solution achieved 1.48 (Figure 10).

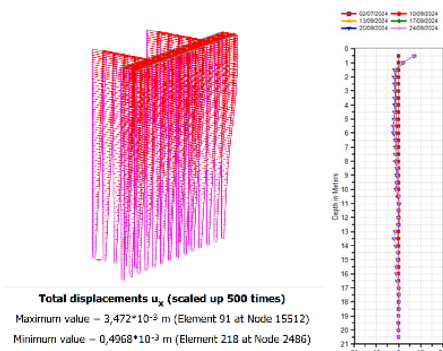
Figure 13. Maximum horizontal displacement estimated for the adopted solution (right) and monitoring results of the inclinometer (right).

As of the current date, no significant deviations from the project estimates have been recorded based on the available readings. The maximum horizontal movements on the targets and inclinometers are approximately 5 mm, below the horizontal displacement estimated at the design phase (see Figure 13).

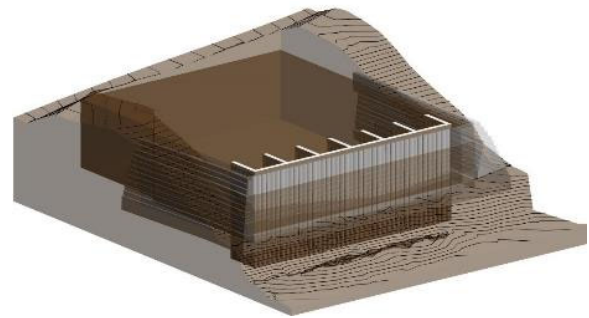
Figure 14. Overall view of the stabilization solution

Considering the positive outcomes of the established monitoring and survey plan, this case study demonstrates the reinforcement solution, combining a bored pile curtain with secant pile buttresses (see Figure 14), was tailored to the geotechnical conditions and operational constraints of the Bemposta electrical substation
