Application of the observational method for the optimization of supports: examples of the extension of the Knuedler car park and the Hosingen bypass in Luxembourg

Steve Gruslin, Tiffany Hennebaut

Department of Geotechnics & Engineering Geology, GEOCONSEILS, Luxembourg, steve.gruslin@geoconseils.lu

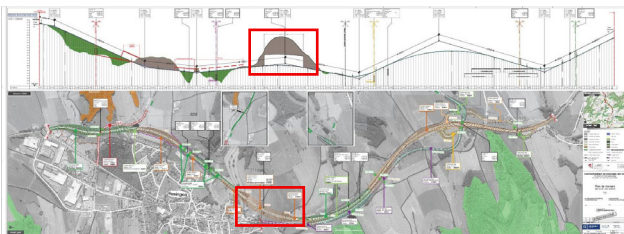
Figure 2. By-pass location in red on the global project.

One of the main road of the north of Luxembourg called "N7" is a national road that go through the village of Hosingen. The aim of the bypass Hosingen is to divert the traffic currently passing through the village by creating a traffic lane better suited to the flow of traffic.

For this project, the project owner has decided to build part of the section using a cut-and-cover tunnel. To realize this cut-and-over tunnel, some massive rock excavation had to be made.

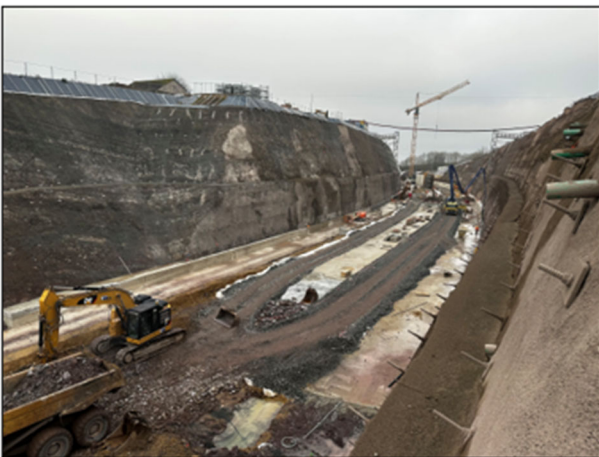
Figure 3. General view of the project

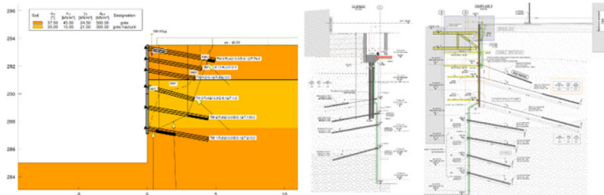
Figure 6. Example of calculations and typical support cases

After securing the foot of the walls, a series of standard cases was calculated in advance to cover a wide combination of rock that was more or less weathered at certain pre-established levels, in order to reduce intervention times during the worksite.

critical phase. The load under the foundation of the most heavily loaded column was quantified at 4,538kN at the serviceability limit state (SLS). A series of preliminary measures were recommended by the design office to reduce the load during construction of the reinforced concrete base: the foundation was connected to the existing structure by a reinforced concrete beam, and temporary steel supports fitted with a hydraulic jack were installed on the three floors of the existing car park. This reduced the load to 2,538kN at SLS. We carried out a series of calculations to verify the underpinning phases of the column. Based on our on-site observations, we assumed that the fracture surfaces would be inclined between 0 and 15° from the vertical (joints). Given the good condition of the rock observed in situ as the excavation phases progressed, no additional stabilization was required to complete the work.

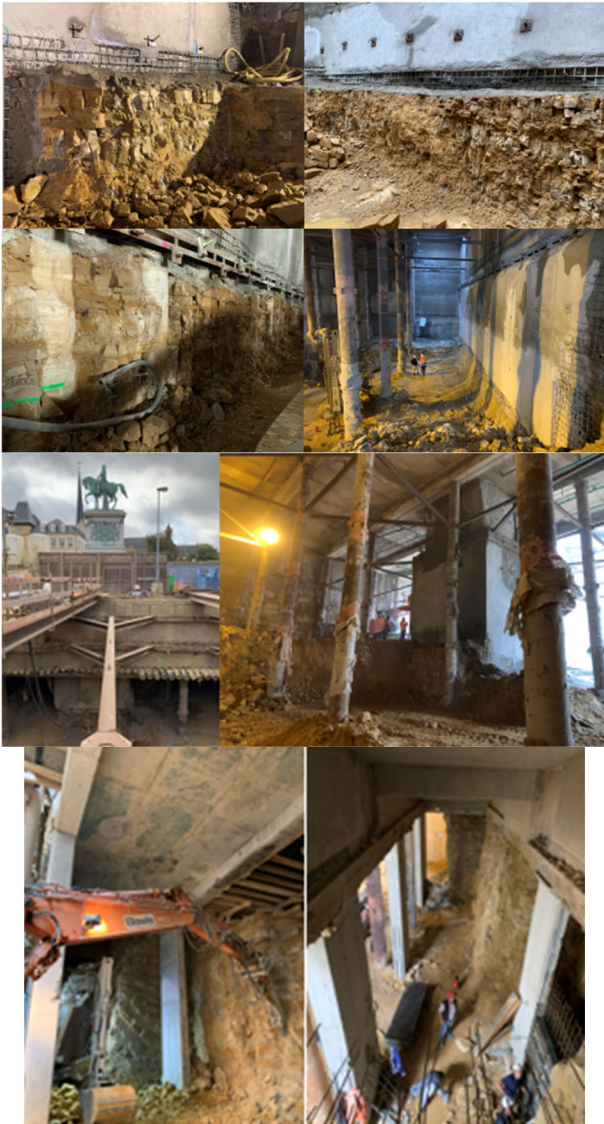
Figure 8. Some specific cases encountered during the excavation

For the large-scale earthworks, the following decisions were taken on the basis of the findings: earthwork embankments in phases, lay the embankments down, shotcrete them or leave the rock as it was. For the 3 side walls, minimal gunning was still planned to enable the waterproofing to be applied, but with simple pinning used solely to hold the trellises in place, as the gunning had no static role in this case. Depending on the findings, it was decided either to maintain the simple pinning, or to add nails according to a mesh and length predefined by the calculations explained in Chapter 5.

Figure 7 shows some specific cases encountered during the project.

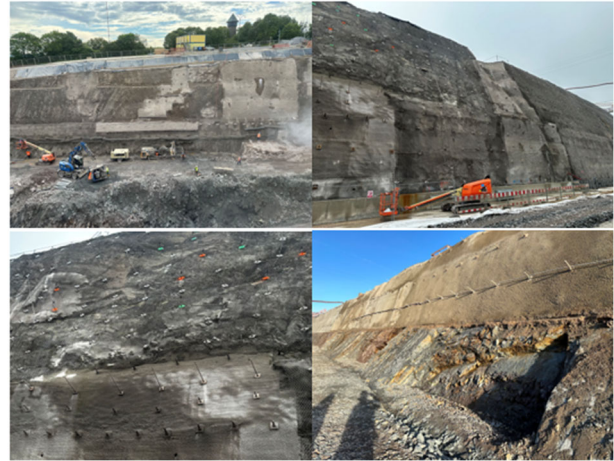
Figure 9. Specific situation requiring an adaptation of the securing

In addition, the earthworks also created instability, often characterized by overhangs. Due to the height of the earthworks, these overhangs had to be secured using concrete

reinforcement and steel tie beams, or with cables system working in shear to hold the block in place.
