# Landslide Risk Management in the City of João Pessoa, Paraíba, Brazil: Scenario Analysis and Strategy Development

**ABSTRACT:** This study proposes an integrated approach to landslide risk management in the city of João Pessoa, Paraíba, with a focus on the Roger neighbourhood, an area characterised by high socio-environmental vulnerability. The methodology comprised risk area mapping, geotechnical characterisation of a critical slope, back analysis based on the Morgenstern–Price method, and laboratory testing under two moisture conditions. The safety factors obtained were below the minimum required by the Brazilian standard, indicating seasonal instability exacerbated by soil saturation and vehicle traffic at the crest of the slope. As part of the prevention and mitigation actions, environmental education initiatives were carried out with the local community. The results highlight the importance of multidisciplinary strategies that combine technical analysis, geotechnical monitoring, and social mobilisation to promote risk reduction and protect lives in vulnerable urban areas.

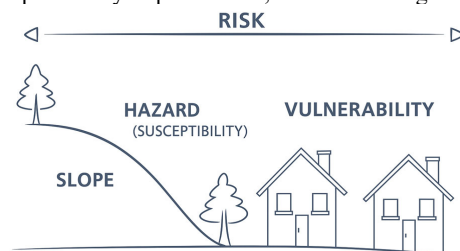
Figure 1. Risk: Hazard (susceptibility) and Vulnerability.

According to Casarim (2021) *apud* Simões (2023), risk is defined as the combination of hazard — represented by the susceptibility to mass movements on slopes or hillsides — and vulnerability, which relates to the presence of buildings located near the potentially impacted area, as shown in Figure 1.

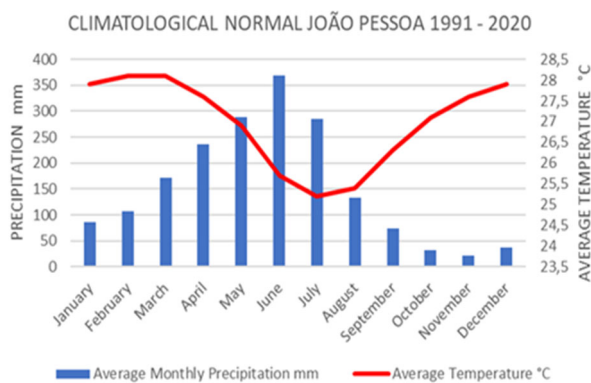
Figure 4. Climatological Normal João Pessoa 1991 - 2020.

The climate of the municipality of João Pessoa, Paraíba, Brazil, is characterised by its location at low latitudes and close proximity to the Atlantic Ocean. Figure 4 presents the most recent climatological normal, covering the period from 1991 to 2020.

As shown in Figure 5, the average annual temperature is approximately 26.9°C, exhibiting little variation throughout the year. The hottest month is March, with an average of 28.3°C, while July is the coldest, with an average of 25.4°C. The average annual precipitation is 1,837 mm, with the wettest period occurring between April and July. November is the driest month, with a monthly average of 25 mm of precipitation, whereas June experiences the highest rainfall, averaging 370 mm.

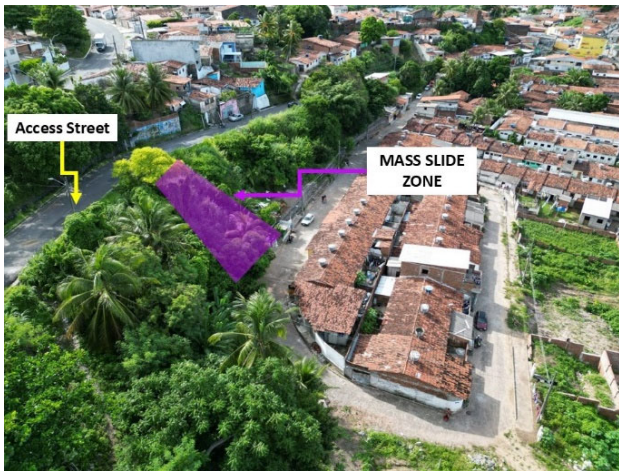
Figure 7. Drone survey of the main access road to Baixo Roger, Paraiba, Brazil.

The purple zone (Z3), classified as very high risk, extends up to the crest of the main access road to Baixo Roger, Rua Monsenhor José Coutinho, Figure 7. This road experiences heavy traffic of both light and heavy vehicles, generating additional load at the top of the slope, Figure 7. Previously, a sign prohibiting the circulation of large vehicles was in place, but it was vandalised, allowing trucks and other cargo vehicles to pass. In 2023, new signage was installed; however, the practice of disregarding traffic restrictions still persists at the site.

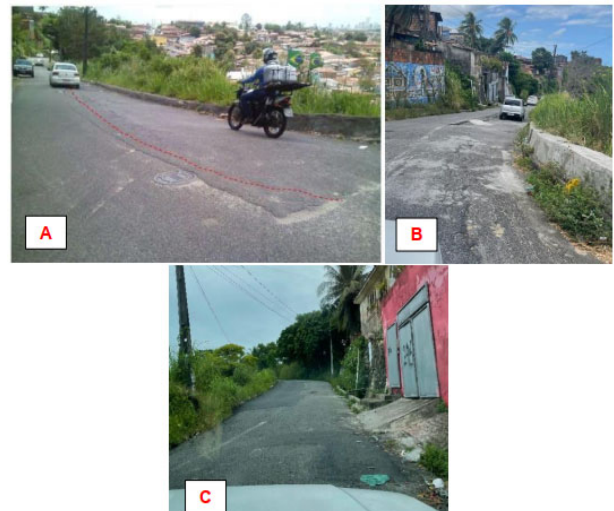
Figure 9. History of the Crack in the Study Slope.

Since 2021, the behaviour of the crack at the crest of the slope has been monitored. Using images from Google VIEW, it was observed that the fissure began in 2017 and has exhibited, to date, a seasonal pattern of widening during rainy periods. Thus, Figure 9A depicts the first visit to the neighbourhood in 2021, Figure 9B shows the progression of the crack in 2023, and Figure 9C illustrates in 2024 the application of an asphalt layer over the crack to facilitate traffic in the area, although without stabilising the slope, creating a false sense of security for local residents.

Monitoring the high and very high landslide risk areas is an important tool to prevent tragedies, given the presence of dwellings in these zones. One measure adopted is the annual visual monitoring of the settlement of the crack at the crest of the slope.

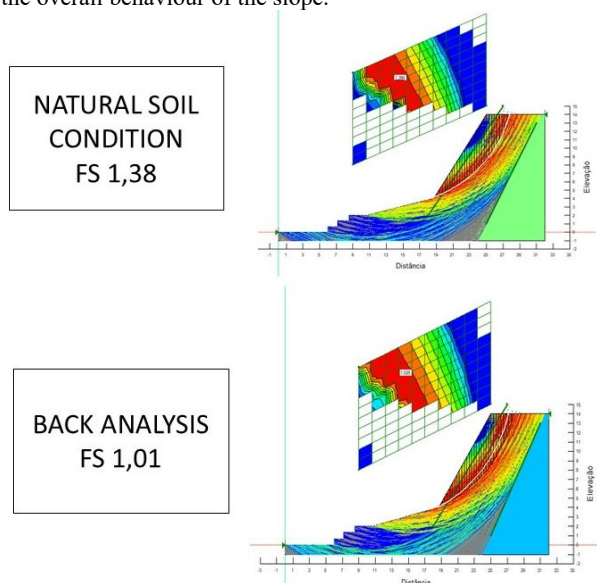
Figure 11. Minimum Factor of Safety Results from the Analyses.

The stability analysis of the hillside was conducted using GeoStudio 2023.1 (student license), employing the SLOPE/W module. Two distinct scenarios were considered:

- Scenario 1: soil under back-analysed condition (unsaturated);
- Scenario 2: soil in its natural moisture condition (unsaturated).

For both cases, the Factors of Safety (FS) were estimated, the investigation employed the Mohr–Coulomb stability criterion, and the analysis was carried out using the Morgenstern–Price limit equilibrium method, Figure 11. This approach allowed for a comparison of the variation in the Factor of Safety caused by changes in the soil's apparent cohesion due to climatic seasonality, highlighting the influence of suction on the overall behaviour of the slope.

The Factors of Safety (FS) obtained for the back analysis and for the natural soil condition were 1.01 and 1.38, respectively. It is observed that, for the natural soil condition, the values are close to the minimum limit of 1.3 established by NBR 11682 (ABNT, 2009). This low FS explains the gradual movement of the slope recorded since 2017, characterising a seasonal instability process that intensifies during periods of higher precipitation and accumulated rainfall. With seasonality and the increase in infiltrated water volume over the seasons, the FS exhibits significant variations, reflecting the direct influence of climatic conditions. In these situations, the soil tends to become saturated, increasing its apparent weight, while soil suction decreases, resulting in a reduction of apparent cohesion.
