Physical modeling of failure accompanied by near-surface collapse characterizing cyclic soil structure interaction in integral bridges

ABSTRACT: Although absence of deck expansion joints in integral bridges brings multiple benefits, such as increased redundancy and resilience, lower construction costs, and improved vehicular ride quality, the evolving soil structure interaction behind the abutments results in detrimental distress of bridge approach slab that starts very early in the life cycle of the bridge, thus posing a threat to traffic safety and requiring maintenance. This study investigated the complexities of the cyclic soil structure interaction by adopting an experimental approach, in which a downscaled model of the abutment, piles, and backfill was subjected to load cycles simulating the effects of thermally induced expansions and contractions of the bridge superstructure. In addition to contact measurements of load and displacement, a high-resolution digital camera and digital imaging correlation software were used to obtain the strain field in the backfill behind the abutment. The selected magnitude of the abutment top displacement induced three concurrent deformation

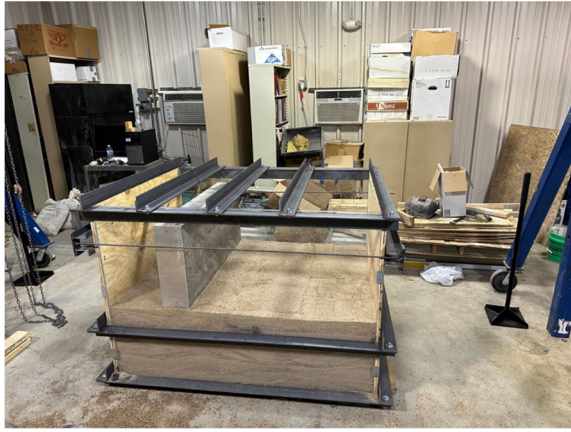
Figure 1. Soil enclosure with soil and abutment

The physical model was constructed by downscaling a section of the abutment and two piles of the “Bemis Road Bridge: F-4-20” over the Nashua River in Fitchburg, Massachusetts (Perić et al., 2016), five times. The floor of the soil enclosure, constructed from two pieces of plywood, each 1.27 cm thick, measured 1.09 m x 1.50 m. The front wall,

through which the abutment is visible in Figure 1, and the back wall were made of 2.54 cm-thick plexiglass, measuring 1.12 m in height and 1.5 m in width. The right and left side walls, measuring 1.12 m in height and 1.14 m in width, were composed of two pieces of plywood, each 1.25 cm thick. The abutment, which was made of an aluminum block measuring 0.483 m in height, 1.09 m in length, and 0.152 m in width, was supported by two hollow aluminum piles with a center-to-center spacing of 0.55 m (Figure 2). Each pile had a diameter of 3.81 cm, a wall thickness of 0.508 cm, and a length of 50.8 cm. Figure 2 shows the abutment along with the attached piles, load cell, and a part of a screw jack. The distance between the center of each pile and the edge of the abutment that is in contact with the plexiglass wall, which is 0.27 m, is considered sufficient for preventing any undesired boundary effects. The load cell and screw jack assembly is attached to the abutment 8 cm below its top. Loading was applied by controlling the rate of horizontal displacement at this elevation. As seen in Figure 1, four steel angles were connected to form a rectangle, thereby providing bracings at the bottom, top, and 0.356 m from the bottom of the container. The additional steel angles connecting two long walls were placed at the top of the container. To produce the desired movement, a screw jack was connected to the reaction frame, which comprised two steel channels extending along the wooden vertical walls (Figure 1). The channels were connected with two long threaded rods extending along the plexiglass walls. In accordance with Meymand (1998), the flexural rigidity of the model piles was scaled at $1/\lambda^5$ with respect to the prototype piles, where λ is a length scale factor, equal to five in this case.

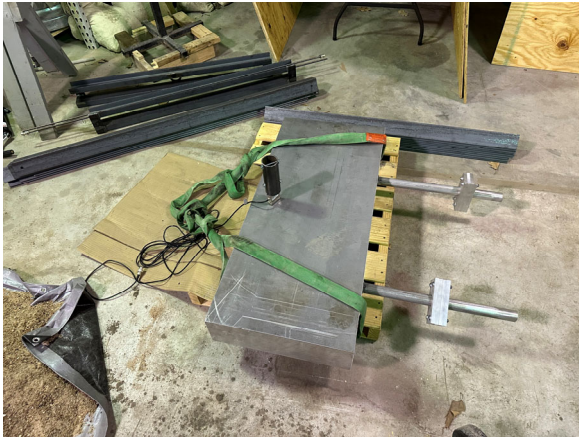
Figure 2. Abutment, piles, and load cell

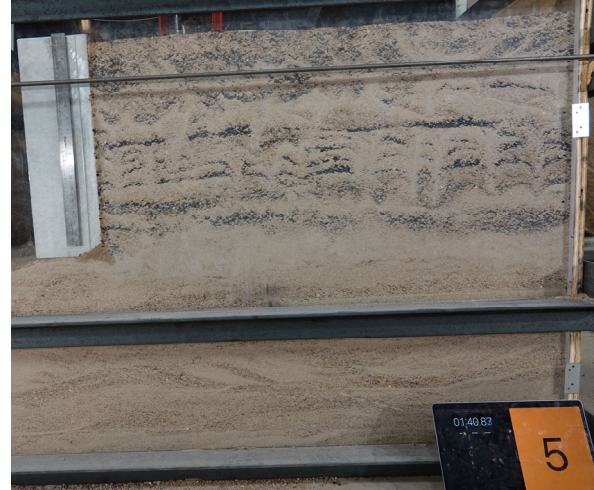
Figure 3. Beginning of the fifth cycle

This paper focuses on the first five loading cycles because the approach slab distress begins very early after the bridge construction is completed. 3 shows the photograph of the deformed configuration at the beginning of the fifth cycle, after the abutment was moved 3 mm away from the backfill. The data acquisition system was capable only of logarithmic time sampling, resulting in the most complete data for each tenth cycle.

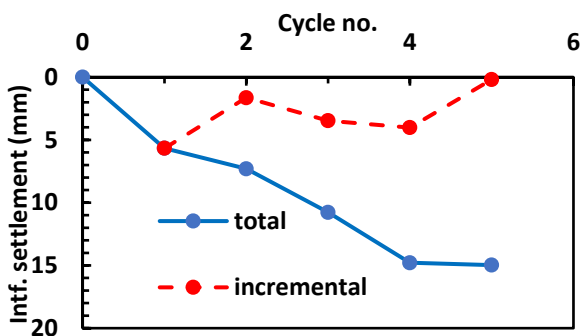
Figure 5. Backfill settlement at interface vs. cycle number.

Figure 5 shows the evolution of total and incremental settlement at the interface of the abutment and backfill during the first five cycles. The final total settlement was 15 mm, while the largest incremental settlement in the amount of 5.7 mm occurred at the end of the first cycle.

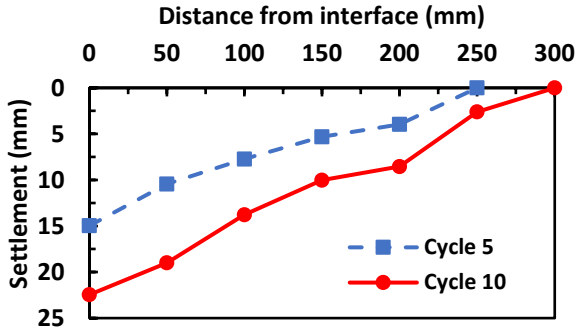
Figure 6. Lateral extent of backfill settlement.

Figure 6 depicts the settlement profile at the end of the fifth and 10th cycles. At the end of the first cycle, the settlement extended horizontally up to a maximum distance of 250 mm from the interface, corresponding to 51.7% of the abutment’s height. The settlement profile after 10 cycles is provided for comparison, showing that the lateral extent of settlement at this time has increased to 300 mm, or 62.1% of the abutment height. This indicates that the void behind the abutment increases in size with the increasing number of load cycles. The void is located below the approach slab in IBs, but the approach slab is not included in the physical model employed herein. The lateral extent of settlement represents the unsupported length of the approach slab that becomes significant even after only five loading cycles, likely leading to the early development of approach slab distress. The larger the void created by settlement, the more extensive and time-consuming the mitigation efforts required.
