Guidelines for resilient infrastructures in the Amazon Region, Brazil

Gisleine Campos, Felipe Santos, Claudio Gomes

Institute for Technological Research of Sao Paulo State, SA, Sao Paulo, Brazil, gisleine@ipt.br

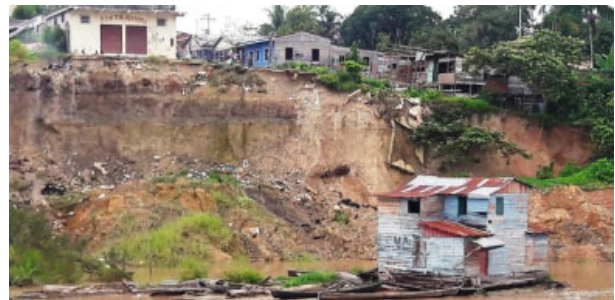
Figure 1. Collapse in Solimoes riverside, Amazon Region in Brazil (Ribeiro, 2018, *apud* Rodrigues, 2024).

Figure 1 to Figure 5 depict recent incidents that have significantly compromised the functionality of vital infrastructure, including ports and bridges. These events have resulted in the destruction of communities situated along riverbanks and have tragically led to the loss of several human lives.

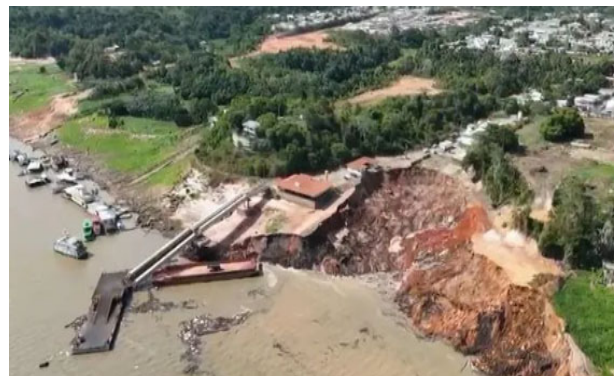
Figure 2. Collapse of a port enterprise in Manacapuru city, Amazon Region, Brazil (CNN, 2024).

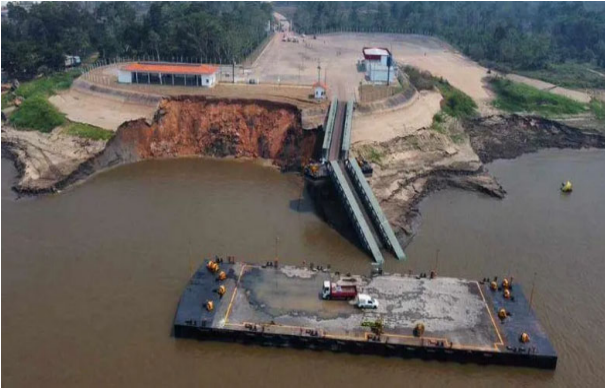
Figure 3. Collapse of a port enterprise in Itacoatiara city, Amazon Region, Brazil (Globo, 2023).

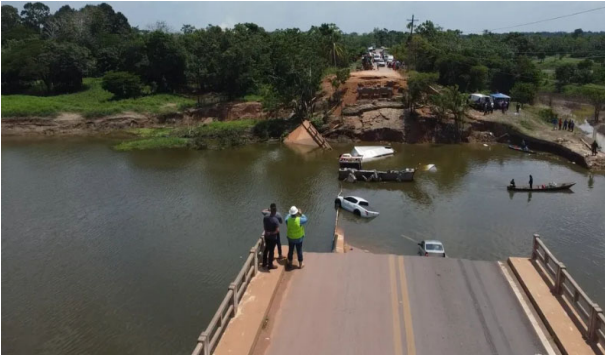
Figure 4. Total collapse of a bridge in BR 319 road, near Manaus city, Brazil (Globo, 2022).

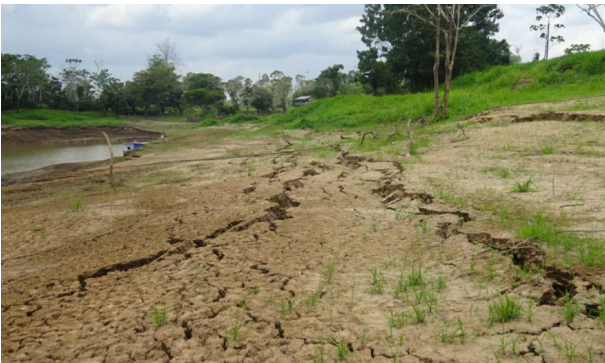
Figure 5. Fallen Lands phenomenon induces stepped terraces on the Amazon Rivers, Brazil.

As previously mentioned, “Fallen Lands” predominantly occur in recent alluvial deposits composed of unconsolidated sand and clay layers, in conjunction with fluvial erosion processes during the dry season. Mass movement phenomena such as soil creep, rotational, and translational slides typically occur during the dry season, triggered by the rapid lowering of river water levels. In general, the initial stage of riverbank destabilization is characterized by a series of small subsidence steps, accompanied by a significant number of minor surface cracks.

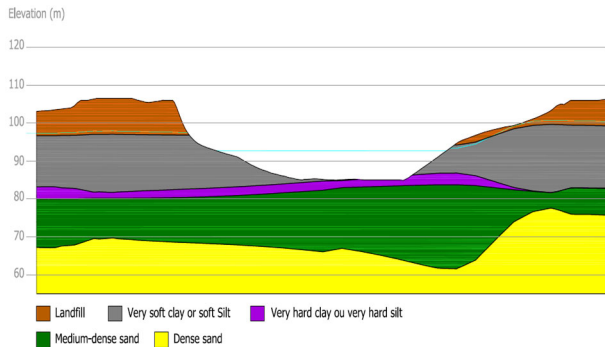
Figure 7. Typical cross-section of a tributary of the Amazon River, with a channel depth of approximately 20 m.

The Figure 6 and the Figure 7 provide graphical interpretations of the typical profile along the banks of Amazonian rivers. Figure 6 illustrates a scenario on the left bank of the Amazon River, where the channel depth can exceed 80 m; Figure 7 presents a typical cross-section of an Amazon River tributary, with a channel depth of approximately 20 m.

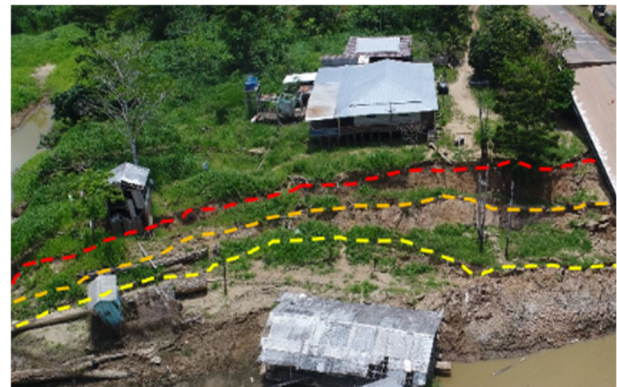
Figure 8. Subsidence steps (dashed lines) next to a partially collapsed bridge.

One approach that can aid in understanding the process and in parameterizing the involved soils is the application of back-analysis techniques, as proposed by Gomes (2003). An example of this methodology is the collapse of a bridge in the Amazon region (Figure 8), associated with the occurrence of the Fallen Lands phenomenon. In this figure, the subsidence steps (dotted lines) formed during the riverbank destabilization process can be observed.

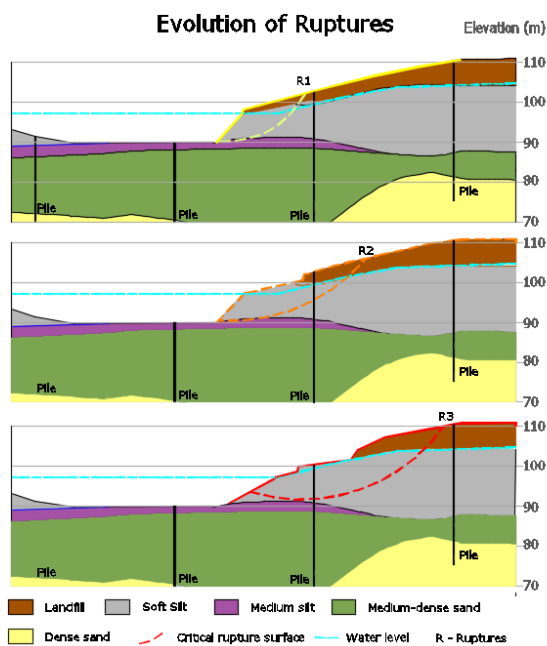
Figure 9. Geological model of the unstable area, slope geometry, and critical failure surfaces obtained through back-analysis, illustrating the retrogressive progression of the the Fallen Lands phenomenon.

Figure 9 illustrates the geological model of the destabilized area, the slope geometry, and the critical failure surfaces obtained through back-analysis, characterizing the retrogressive progression of the destabilization mechanism typical of the Fallen Lands phenomenon. It is evident that the failure surfaces R1, R2, and R3 accurately intersect the three main subsidence steps identified in the field, confirming the correlation between the analytical results and the field observations.

It is observed that the geometric variations of the slope between the stages represented by the yellow and orange colorations are minimal. This behavior may indicate a shortened time interval between failures R1 and R2, which is characteristic of the evolutionary dynamics of the Fallen Lands phenomenon.

In contrast, between failures R2 and R3, significant changes are noticeable in the toe region of the riverbank slope, suggesting a longer time interval between events. This longer interval would have allowed for more intense fluvial activity, promoting erosion of the previously failed soil mass. The results of the back-analyses performed are consistent with values reported in the technical literature. As an example, Table 1 presents also data from studies conducted in a region near the city of Manaus, Amazonas, in which undrained shear strength values were obtained through piezocone testing.

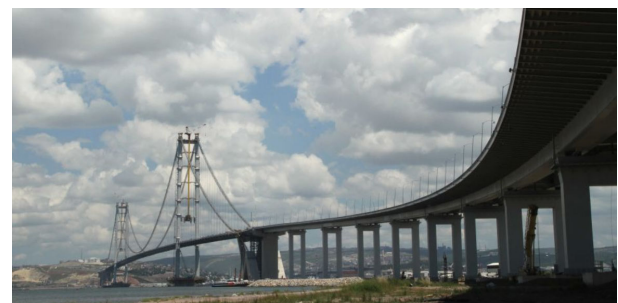
Figure 10. Bridge in Turkey, with continuous monitoring (Cimento Itambé, 2025).

An outstanding illustration of resilient infrastructure is the Oman Gazi Suspension Bridge, located in Turkey, and inaugurated in 2016 (Figure 10).

This impressive structure measures nearly 2,700 meters in length and is constructed from concrete and steel. Its innovative design features steel components interconnected in a manner akin to game pieces (Figure 11), enabling the structure to effectively withstand seismic activity. To ensure ongoing safety and structural integrity, the bridge is subject to continuous monitoring via sensors to detect vibrations.

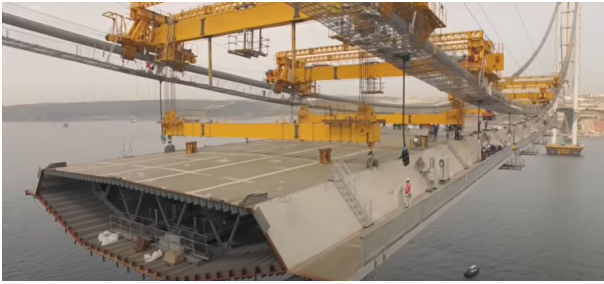
Figure 11. Turkey bridge steel deck (Engenharia,2019).

The bridge is equipped with advanced sensors that monitor humidity levels and evaluate the risk of corrosion in its steel components. Each deck features climate stabilizers that ensure internal humidity does not exceed 40%. The design of both the steel and concrete pillars, which rest on concrete bases, has been strategically developed to withstand seismic activity. This is achieved by utilizing gravel beds beneath the pillars, which serve as shock absorbers during earthquakes, effectively transferring seismic energy to the bridge structure (Cimento Itambé, 2025). The construction of the bridge has resulted in a reduction of approximately 140 kilometers in the distance between Istanbul and Izmir.
