Multiple landslides in a natural touristic area (Mullerthal, Luxembourg): causes and safety works

ABSTRACT: The touristic region of Mullerthal (Luxembourg) is an area at particular risk of landslides. In recent years, the combination of complex geology, steep topography, and heavy rainfall, led to numerous landslides, causing extensive damage, and blocking roads. The area is also a nature protection area which limits the options for securing the sites and means that innovative solutions had to be found. The article presents the causes of some landslides, and the solutions implemented to remedy them. The area is characterized by complex geological formations: sandstones, marls, limestones, and clays whose presence strongly influences the risk of landslides by acting as a soap layer. For the first landslide, the water masses resulting from the heavy rains crossed the backfills and mobilized the sliding surface constituted by the clays. About 10,000m³ of materials had slipped. The slope damaged was replaced by a reinforced earth wall constructed with in situ soil. The second landslide, also secured by reinforced earth, was caused by the water seeping into the embankment. At the third

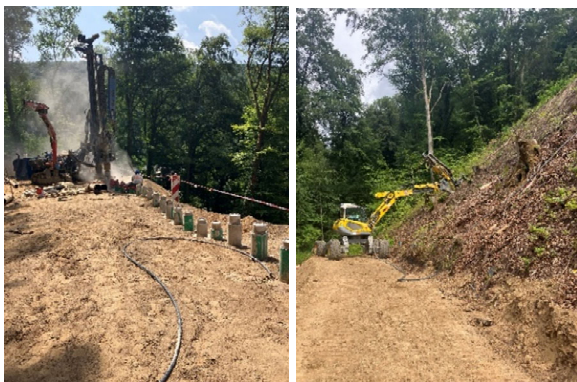
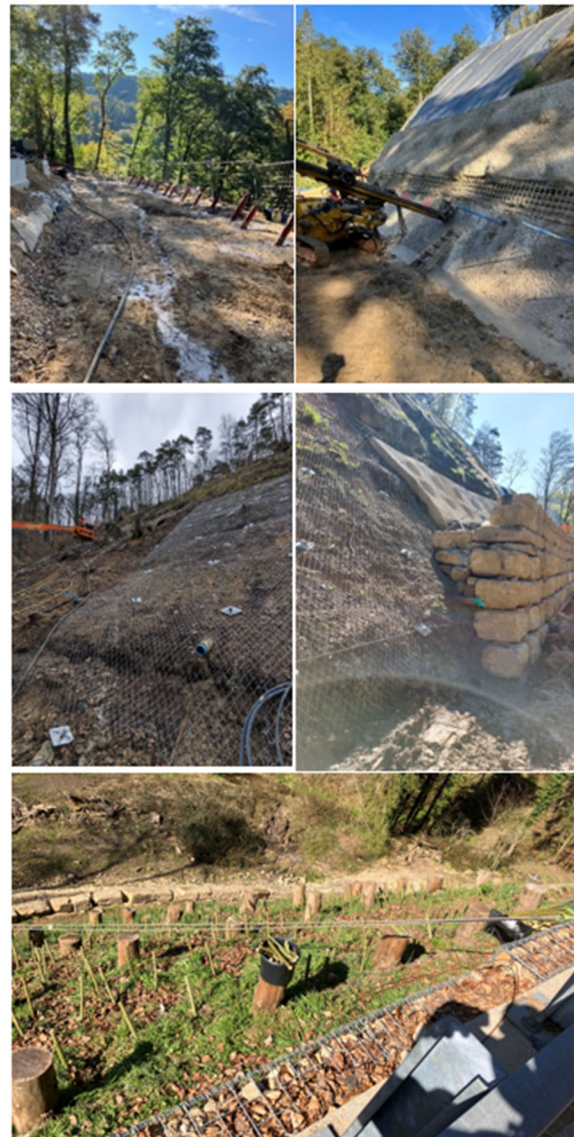
Figure 7. CR356 safety works in progress

The landslide took place on the downstream side slope of road CR356, between the villages of Mullerthal and Waldbillig. The area is characterized by slope scree of up to 50° mainly overlying Luxembourg sandstone and, in the lower part of the project, the Li1 marl formation. The visual observation of a strike-slip fault and several normal faults clarifies the varying level at which the rock top has been encountered here, as well as the presence of the marl at heights where the overlying sandstone remains in other areas. The entire zone is designated as a protected zone on account of its water sources.

During these supervision times with also provide advice on the reuse of excavated sandstone. A transversale fault had been also found during the supervision, which allows us to give additional clues about the global slide, and the presence of marl found higher than expected.

Multiple stabilizations were used in this project. The safety factor of the downstream slopes was calculated using the limit equilibrium method. A series of micropiles were installed at alternating batter angles, along with a reinforced concrete cap wall, to stabilize the CR356. Additionally, a shotcrete wall with self-drilling anchors was implemented to stabilize the bottom of the slope. A substantial amount of 1000 m³ was utilized to stabilize the slope during shotcreting, in accordance with a predetermined work phase. Additionally, sub-horizontal drains were designed to improve slope drainage. To comply with the standards for natural slopes and the existing masonry wall along the road, a steel mesh and soil nail were designed to increase the safety factor. Furthermore, some naturalistic engineering measures (wooden mesh, palisades combined with the planting of local pioneer species) were provided to stabilize the first meter of the steep slopes by improving soil cohesion. Figure 7 shows the different phases of the safety work in progress.

In order to follow the diverse steps of the works, we carried regularly the site supervision, especially for micro-pile works, the realization of access ramps made of crushed aggregate, and the securing of the slope with the steel mesh for example.
