Impacts and adaptation measures of state roads in Spain to climate change

ACT: The resilience of transport infrastructure, particularly road networks, is a critical aspect of ensuring their functionality in the face of external impacts, especially those driven by climatic factors. Cantabria, a region in northern Spain, serves as a notable example of proactive measures in this domain. With frequent climate-induced disruptions to its road network, the region has leveraged its extensive experience to implement and refine methodologies for assessing and mitigating climate-related risks. The methodology, as highlighted by Alonso et al. (2022), emphasizes evaluating risks across key dimensions: sensitivity, probability, severity, and criticality. These evaluations guide the development and application of adaptation measures to strengthen the network against anticipated impacts. The ongoing initiatives in Cantabria not only enhance the resilience of its road infrastructure but also contribute to a broader body of knowledge. This knowledge facilitates the identification of effective practices and the quantification of measures' efficacy, helping to mitigate current and future impacts of c

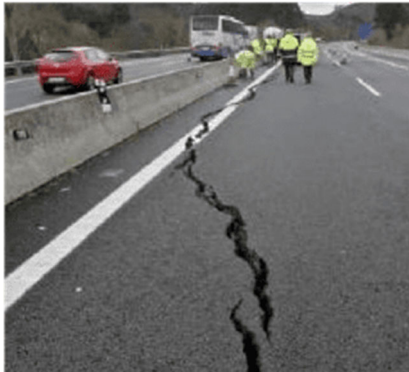
Another impact was caused by a large landslide of the right-hand carriageway (Figure 3), in this case the slope of the A-8 motorway at KP 167, in Liendo, on 8 February 2013, with strong horizontal and vertical displacement of the right-hand carriageway, of the order of 30 and 100 cm respectively. This led to the closure of traffic on the carriageway and the urgent installation of metal lanes in the median to prevent the landslide from affecting the left-hand carriageway, which is where the two directions of traffic circulated

Figure 3. Cracking the carriageway with a 100 cm drop on the A-8 motorway, Liendo.

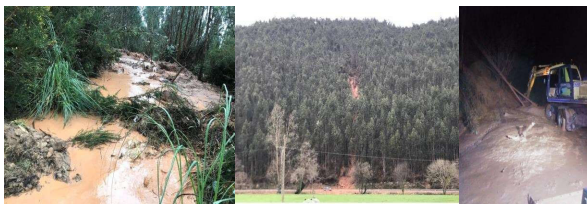
The first line of authors is followed by the affiliation of those authors. Use the “Affiliation” style and the structure: [Department], [Affiliation], [City], [Country], [Corresponding author’s email address]. As soon as it rains in the area of the N-634, mud and stones are washed onto the road, creating a risky situation for users of the N-634 road, despite the speed with which the conservation services act. The origin of this problem is due to the lack of channeled drainage of the runoff water which runs along the various tracks on the slope, to which the lack of support for the slope is added, which is significantly high, a factor which adds to the risk in extreme rainy situations. Thus, for example, on 4 January 2021, a landslide occurred, which partially invaded the carriageway of the N-634 road and caused the partial closure of traffic (Figure 4). A possible solution to this problem is detailed in section 3.2.4.

Figure 4. N-634, between KP 247+100 and 248+10, Cabezón de la Sal.

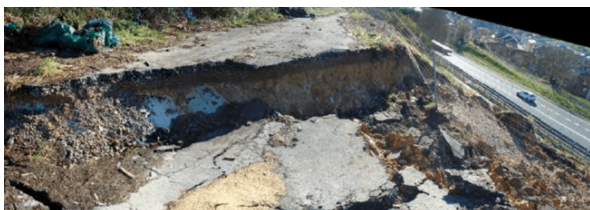
On 28 December 2020, a rotational landslide occurred on the right-hand side of the N-629 road at the Ampuero junction (Figure 5). In section 3.2.5 a possible solution is proposed based on the driving in of rails and breakwater walls.

Figure 5. N-629. Slope landslide. Initial situation. Road platform at the head of the slope.

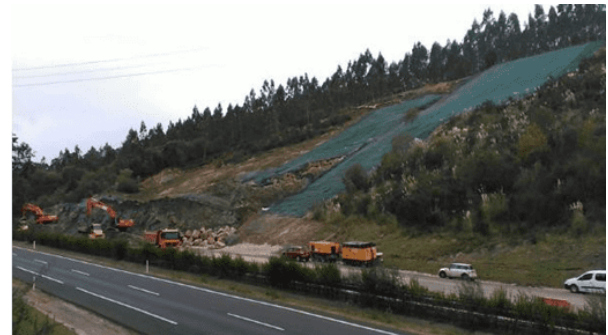
Figure 7. . Slope detachment. Removal of material to provide traffic on the left lane.

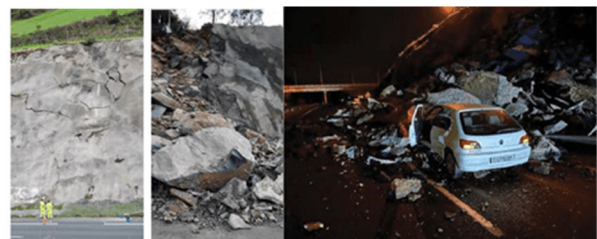
Recently, in the early hours of 23 April 2022, on the section of the A-8 dual carriageway (which runs through the north of Spain from east to west), between Castro Urdiales and the border with the province of Vizcaya, there was a landslide of the slope, with a large volume of material and stones of significant size, causing an accident and the complete cutting of the road in the direction of Santander (towards the west). This is an area of slope approximately 180 m long and 23 m high, covered with a layer of gunite without any drainage system for the back of the slope. This lack of drainage caused cracks and buckling of the gunite (Figure 8), which eventually led to the cuttings breaking off. The solutions are also described in section 3.2.6.

Figure 8. Slope detachment. Initial situation. Removal of material to provide traffic.

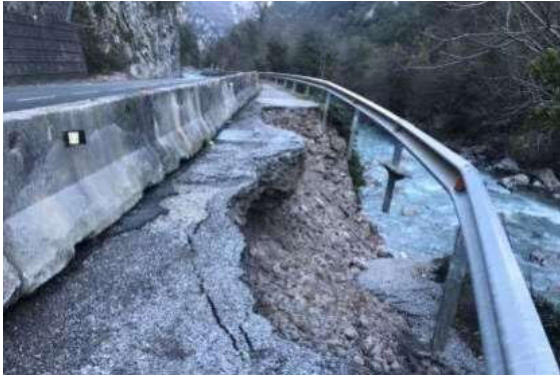
Another impact that has been recorded in the area is the overturning of retaining walls due to heavy rainfall, as shown in Figure 9. In this case, it is necessary to consider the difficulty of building breakwater walls, as well as reinforcement of existing masonry in the area. Section 3.2.7 contains solutions for dealing with the impacts related to the overturning of retaining walls.

Figure 9. Collapse of wall N-621 pk 161.950

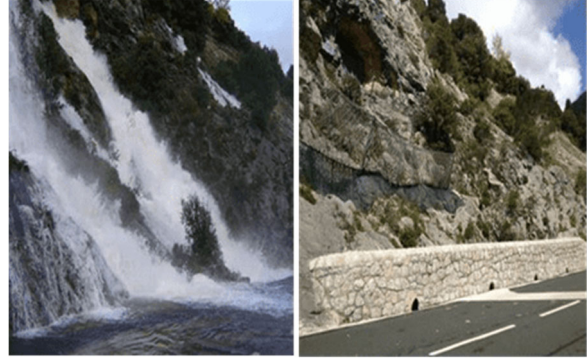
It is associated with a rocky outcrop which descends to the edge of the road, with a height varying between 50 m and 75 m and a 17° slope. The speed and energy of the force of the water flowing from two karst cavities has been reduced and channelled to the river Deva, through 5 consecutive levels. The receiving basin has been improved by cutting into the rock and a masonry wall has been built, with mechnales and blending in with the natural environment, which allows it to be integrated into the landscape (Figure 11).

Figure 11. Situation of PK 158.140 MI caused by heavy rains.

The water curtain is channelled towards the river Deva by means of a dense metal net and the creation of ditches and culverts (ODT) which cross under the road.

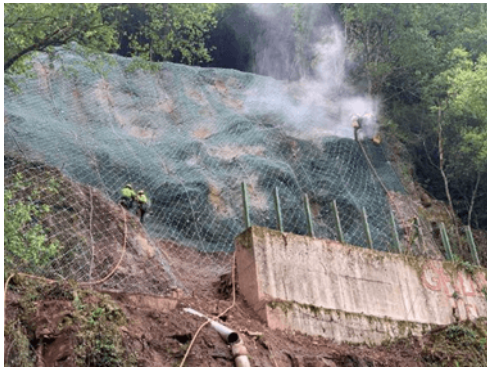
Subsequently, a 10 KN/m² slope support treatment was installed, consisting of cable netting on triple twist mesh reinforced with diagonal reinforcement cable and 25 mm diameter bolts (Figure 14).

Figure 14. N-611 PK 167+000 Laying of cable netting, triple twist mesh and bolting.

In the area around KP 167+000 of the N-611, due to water runoff on the slope on the left bank, mud and stones fell and affected the roadway. To resolve this situation, a reinforced

geogrid was installed, after clearing and cleaning up the affected slope.

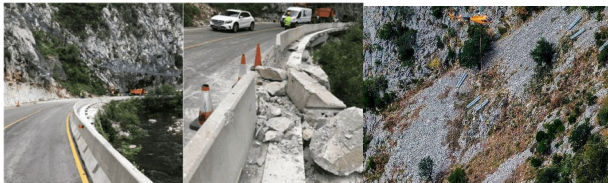
In relation to falling stones, only the action of placing dynamic screens in the different locations due to the adverse meteorological phenomena that have taken place during the months of March and April 2020, has meant a budget of 950,000 euros (Figure 14b).

Figure 14b. This is the conference logo. Situation at KP 160.700 MD caused by heavy rains after cleaning the remains of stones from the roadway and placement of material by helicopter.

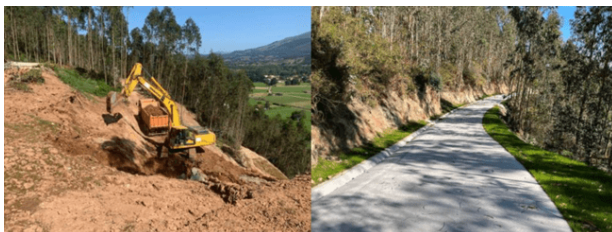
Another adaptation measure to minimize the risk derived from landslides has consisted of the widening of two existing forest tracks. One of them with layers of blast rockfill and a subsequent layer of natural gravel in the area of the landslide. And the other forest track, in addition to the previous layers, with a steel mesh reinforcement (Figure 16). For the channeling of the water that reaches the forest tracks, ditches have been built, factory works have been cleaned with pressurized water, ditch guards and concrete walls.

Figure 15. This is the conference logo. Situation of the N-634, PK 247+100 and 248+100. Excavation and cleaning up, and action completed.

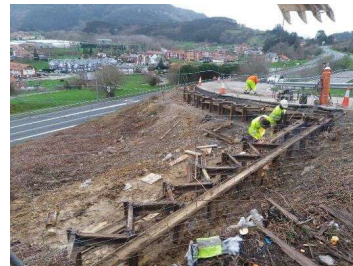
To contain the platform of the CA-502 road above and on the slope of the N-629 road (Figure 16), a pile of rails has been driven in, arranged in staggered staggered rows, the heads of

which have been braced with welded rails. The upper area of the rails has been embedded in concrete, forming a beam parallel to the road (Figure 19) and the service road. The latter was also affected by the landslide, so a breakwater wall has been built with a concrete breakwater footing and provided with longitudinal drainage, solving the water problem with ditches, drainpipes, gullies and transversal drainage pipes.

Figure 16. Welding the rails of the rail jacking to contain the CA-502 platform.

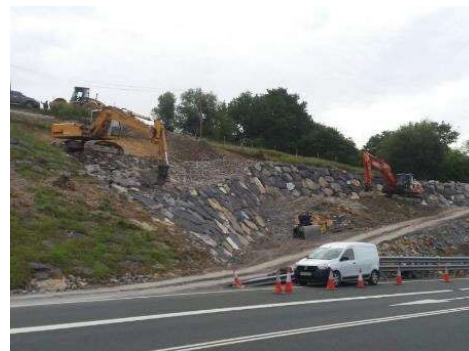
A breakwater wall was built to contain the slope of the N-629. First of all, the volume of loose material was removed to subsequently build a concrete breakwater footing, directly supported on the rocky substrate, and then the body of the breakwater wall was built (Figure 17).

Figure 17. N-629 PK 81+800 MD. Slope detachment. Construction of a breakwater wall

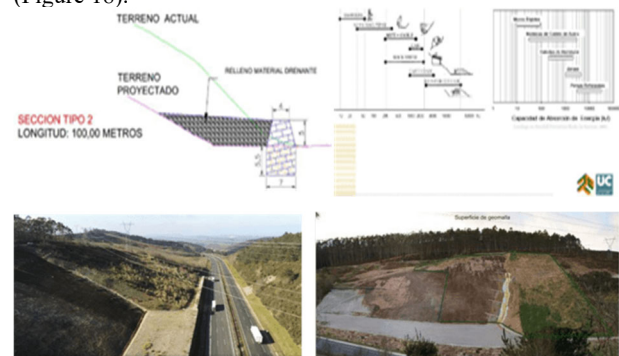
At KP 254 (Caviedes) of the A-8 Cantabrian motorway, in the municipality of Valdáliga, a retaining wall was designed to support the thrust of the slope which is currently moving. The breakwater has to support the thrust of the earth, but it is also necessary to remove the material from the slope, which is likely to detach, thereby reducing the weight of the thrust of the earth (Figure 18).

Figure 18. N-629 PK 81+800 MD. Slope detachment. Construction of a breakwater wall

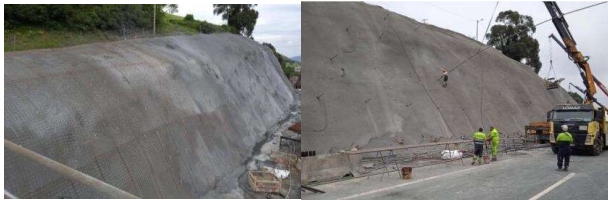
In the case of Castro de Urdiales, at KP 139+300 MD, the cracked gunite that has not collapsed is demolished, followed by scarification of the layer of loams and micritic limestone altered by the effect of the water retention of the cuttings on the undrained gunite layer (absence of mechnales). To adapt the slope, a triple torsion mesh and a layer of gunite are placed. After the slope has been prepared, a layer of electrowelded mesh is placed and a first layer of concrete 10 cm thick is projected. After this first layer, a layer of electrowelded mesh is placed (Figure 19).

Figure 19. Stabilisation of the slope of the A-8 motorway (E-70). Placement of electrowelded mesh and anchors.

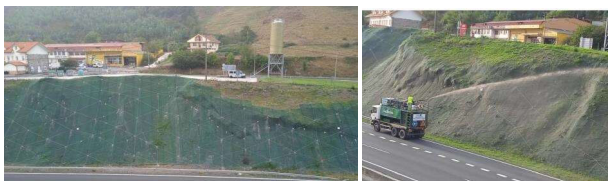
The second layer of gunite is then sprayed. The stabilisation of the massif is designed using a mesh of permanent active bolts of 40 mm in diameter, with a yield load of 1,1190 KN (119 ton) tensioned to 35.4 tonnes, with an anchorage zone of 5 m (80 mm diameter perforation) arranged at 20° to the horizontal, in a mesh of 3.25x3.25 m staggered mesh, forming a total of 7 rows depending on the geometry of the slope, with a length of 18 m for the two upper rows, 15 m for the two subsequent rows and 11 m for the three lower rows. Californian drains of 15m in length are laid out in 10x10m mesh, with an upward slope of 5° and the upper path is reinstated. On the left bank, geogrid and triple twist mesh is placed with its supporting cables (Figure 20).

Figure 20. Placement of anchor cables and hydroseeding.

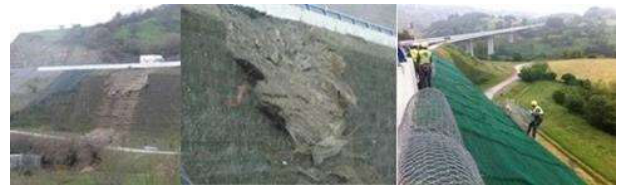
To solve the problem of overturning retaining walls on the A-67, the head of the slope of a green wall was secured with a reinforcement system consisting of a volumetric three-

dimensional geogrid, triple torsion mesh and 16 mm diameter steel cable, forming 8x3 m triangulations, all anchored to the ground by means of self-drilling bolts and cable nets. As this is a green wall with a pedraplén type fill, it was necessary to use self-drilling bolts with a greater amount of mortar in the anchoring bulb to ensure the strength required by the system (Figure 22).

Figure 22. Green wall with self-drilling bolts on the A-67 motorway.

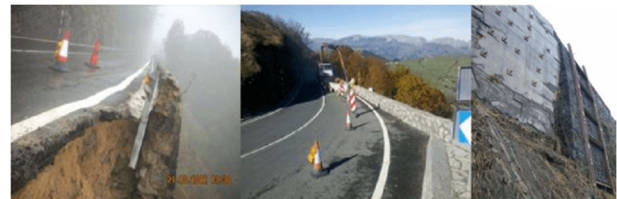
On the N-629 road (Figure 23), at KP 50+100, at the height of Puerto de Los Tornos, a landslide occurred in 2012. It is a very old road, more than 100 years old, with a meagre road surface. Among the solutions adopted was the installation of a metal structure composed of UPN-160 and HEB-160 type beams, braced and bolted to the ground using 30 mm self-drilling bolts, similar to the one done in 2016 on the N-623a road (Figure 24), where a breakwater was also built and a masonry wall was rebuilt.

Figure 23. Sinking of the N-629 roadbed caused by heavy rains, provisional signalling and reinforcement of the masonry wall.

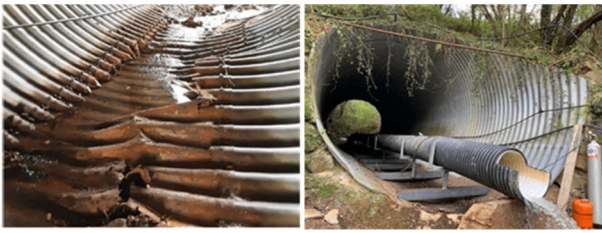
On the N-623 at PK 103+800 an ARMCO type group collapsed (Figure 25). To solve the problem, the pipe was cleaned and the accesses were conditioned. Subsequently, a series of HEB-160 profile metal beams were placed in the lower part of the pipe, in a transversal direction, as reinforcement. A black corrugated polyethylene pipe Ø 630 mm was then installed, attached to the bottom of the ARMCO pipe by welding a metal profile in the shape of a "Y", to channel the water from the stream during the works (Figure 26). A mass concrete slab was laid, and the reinforced concrete structure was mounted on it, consisting of a horizontal slab, curved gables and a vault (Figure 26).

Figure 25. N-623 KP 103+800. ARMCO pipe collapse. Initial situation and river diversion

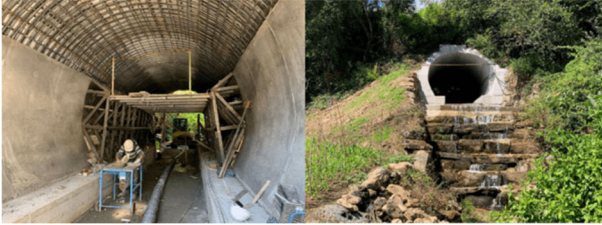
Figure 26. N-623 PK 103+800. ARMCO pipe collapse. Formwork and exit with natural projections.

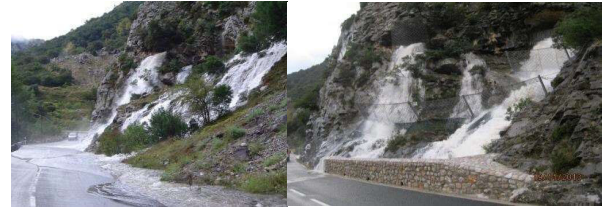
The good results obtained with the use of chain curtains in the Hermida gorge (Figure 30) are noteworthy, substantially improving road safety conditions in times of heavy rain.

Figure 30. Safety problems due to falling stones and hydroplaning on the N-621 road after heavy rain. Situation PK 158.140 MI produced by the heavy rains on the rocky slope where the work was carried out.
