Long-term monitoring of a seasonally active landslide in the semi-arid Thompson Plateau, British Columbia, Canada

ABSTRACT: A landslide-prone stretch of railway weaves through the Thompson River Valley between Ashcroft and Lytton in British Columbia, Canada. The rail corridor forms an ideal route through the Rocky Mountains to the Port of Vancouver. As a result, it has been shared by both of Canada's primary rail operators since 1915. The shared corridor is a high consequence section of infrastructure that is critical to the Canadian economy. Bypassing the valley corridor between Ashcroft and Lytton would require > 1000 km detour via Prince George or Cranbrook. Approximately 6 km southwest of Ashcroft, a reactivated portion (< 1 Mm³) of the larger historic "North Slide" (15 Mm³ landslide that occurred in 1880) intersects the rail right-of-way and seasonally requires track maintenance. A detailed site investigation and desktop study was conducted in collaboration with the Geological Survey of Canada (GSC) to identify the landslide movement triggers. Clifton has collected drone imagery since 2022 at this site, including high resolution photogrammetry, light detection and ranging (Li

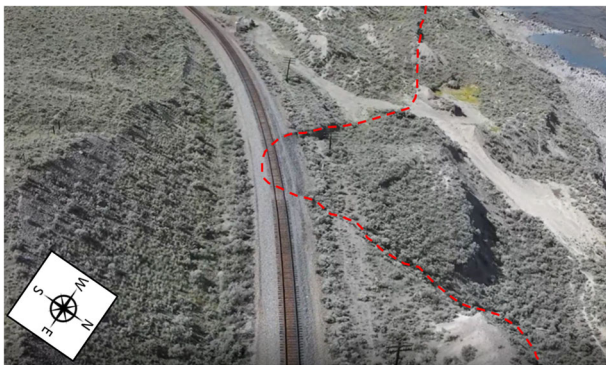
Figure 2. Active landslide slump block impacting 30 m of track.

However, because the shoreline has been eroded sufficiently to over-steepen the till slope which the track is constructed on, a tension crack already extends beneath the rail ballast for a distance of approximately 30 m. Furthermore, historical studies in the area have noted that significant erosion can occur during extreme flooding events. For example, the Thompson River experienced high levels of flow in 1997 that were significant enough to damage erosion protection berms at the nearby South Slide and cause deep scour holes adjacent to that landslide. The North Slide is particularly susceptible to flood events because the landslide toe is exposed in the Thompson River and occurs along the outer meander of the river. As a result, increased flow velocity has the potential to remove material from the toe and further accelerate displacement rates when the river levels subside. A combination of shoreline protection and avoidance of the existing, active, tension cracks may provide a long-term solution that minimizes future maintenance.

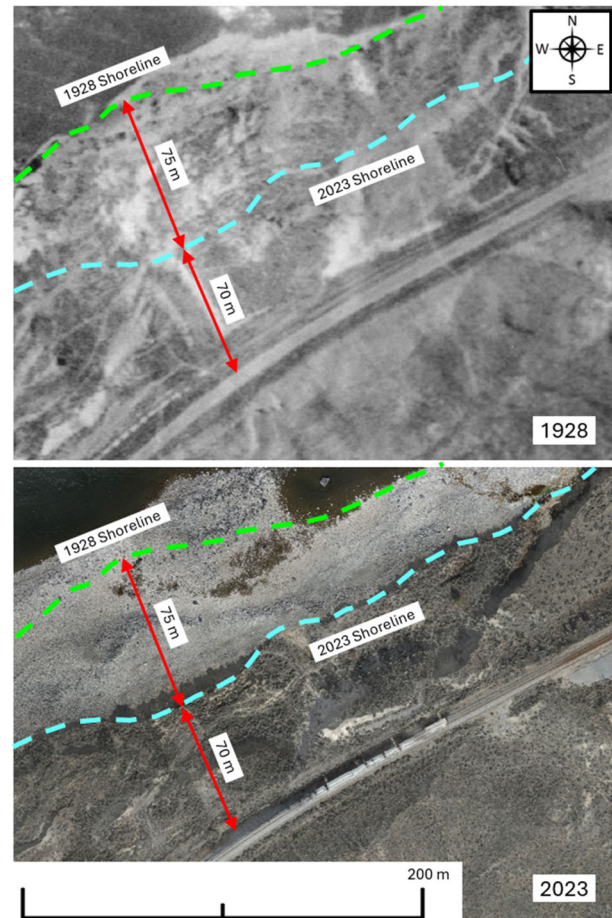
Figure 3. Progressive shoreline erosion between 1928 (top) and 2023 (bottom).

One of the challenges at the North Slide is that the river pathway through the valley was modified recently, in geological terms. In October 1880, one square kilometer of riverbank failed into the Thompson River at North Slide, damming the river's flow for 44 hours (Daily British Colonist, 1880). A recent example was displayed by the Chilcotin Landslide in 2024 (Huntley et al. 2026). Similar to the Chilcotin Landslide, the Thompson River had to re-route itself around the landslide debris to re-establish flow. As a result, there is a noticeable "kink" in the Thompson River at the North Slide. In the years since 1880, the river has been trying to straighten itself out to re-establish the path of least resistance. At the north edge of the North Slide, the south flowing river cuts sharply to the west to avoid the 1880 landslide debris. A previous study by Porter et al. (2002) indicated that the current rate of riverbank erosion is 0.7 m/year based on air-photo comparisons between 1928 and 2002. An updated review of aerial imagery at the toe of North Slide indicates that erosion rates are now shown to average 0.8 m/year since 1928 (Figure 3). In the past 5 years, localized

shoreline erosion has increased to a rate of 2.0 m/year near the landslide toe bulge.

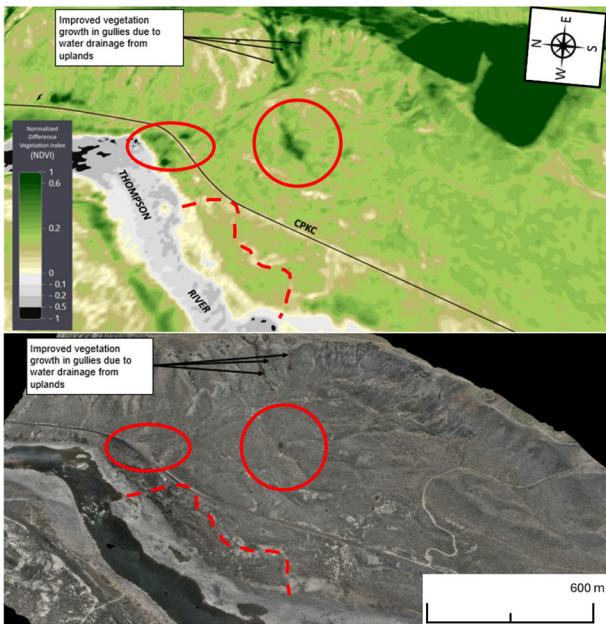
Figure 6. Vegetation health index map from 13 August 2023 (top). Corresponding photogrammetric imagery from 13 April 2023 (bottom).

The NDVI analysis shown in Figure 6 demonstrates the impact of irrigation on the uplands in August 2023. The densely vegetated croplands show excellent vegetative health, which extends into the upper reaches of the North Slide through various erosion gullies. The red circled areas in Figure 6 show areas that may be impacted by the excess irrigation runoff. One of the consequences of the runoff is the potential to raise the water table upslope of the track. Historical drainage infrastructure used to channel the upslope runoff is currently in a state of disrepair. As a result, poor upslope drainage to the river has begun to manifest itself in the form of ponding water and marshy areas in an otherwise dry desert landscape.

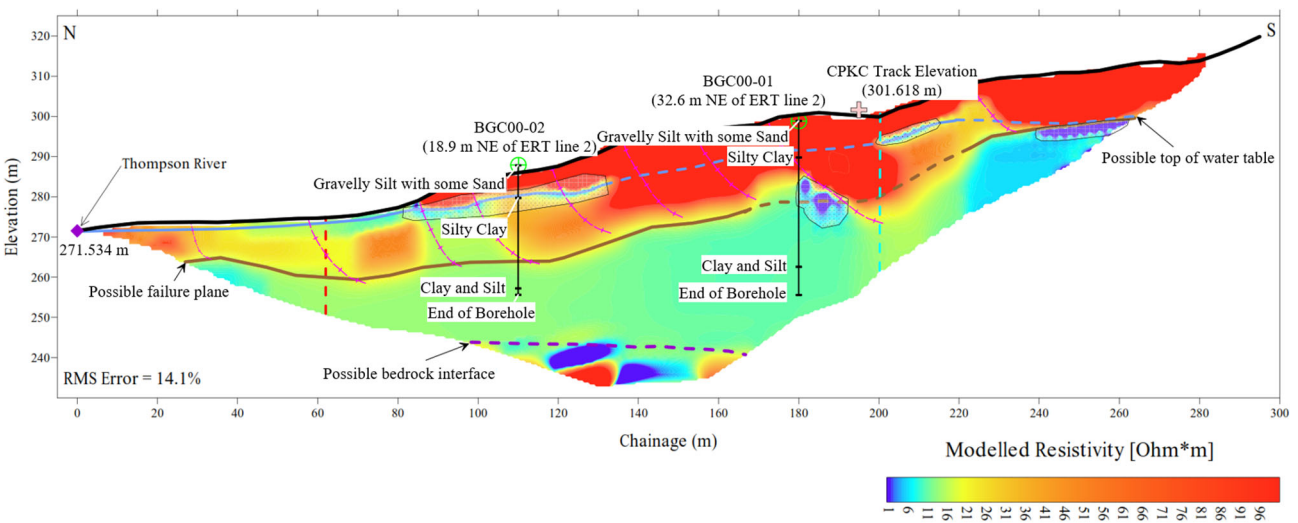
Figure 7. Electrical resistivity tomography cross section through the active landslide area.

The ERT plot shown in Figure 7 noted pore pressure build-up (circled dark blue areas) that intersect the annual high river level mark on the slope (approximately 278 m). During

subsequent site inspections, Clifton noticed that there was evidence of historical internal erosion from groundwater seepage (piping) on the slope face that coincided with the high-water mark and pore pressure accumulation from the ERT plot. The survey was conducted in the winter to ensure that the shoreline was captured during the low river level. During the survey, relatively high groundwater seepage was observed to the north of the survey line. Pore pressure accumulation was also noted well below the tension cracks that undercut the tracks and near surface upslope of the tracks. A thick layer of high resistivity (dry/coarse) material was located underneath the track. Previous investigation identified a thick (> 1.5 m) layer of ballast, possibly a remnant following years of track lifting and ballast addition. The material appears to trap water while surrounding clay till restricts the flow of water and causes a build-up of pore pressures, as indicated in Figure 7.

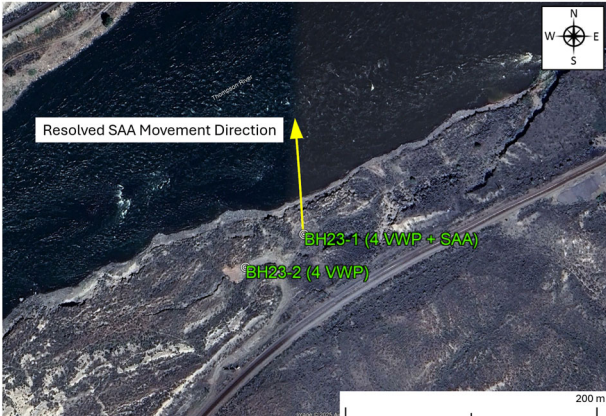
Figure 8. Clifton borehole investigation layout in 2023.

In 2023, Clifton completed two 60 m deep boreholes through the active landslide mass downslope of the rail right of way (Figure 8). The geotechnical investigation at North Slide expanded upon the original geophysics investigation and early borehole logs completed over two decades ago. Clifton's investigation probed deeper into the subsurface stratigraphy, re-established displacement and porewater pressure monitoring, and collected strength and stiffness parameters via pressuremeter, which was a first in the Thompson River valley. Geotechnical instrumentation was installed in each borehole, consisting of vibrating wire piezometers (VWP) and a ShapeAccelArray (SAA) in BH23-1. The instrumentation installed in these boreholes was used to monitor porewater pressures and subsurface displacements. These findings improved our understanding of the landslide mechanism, local geology, and groundwater.

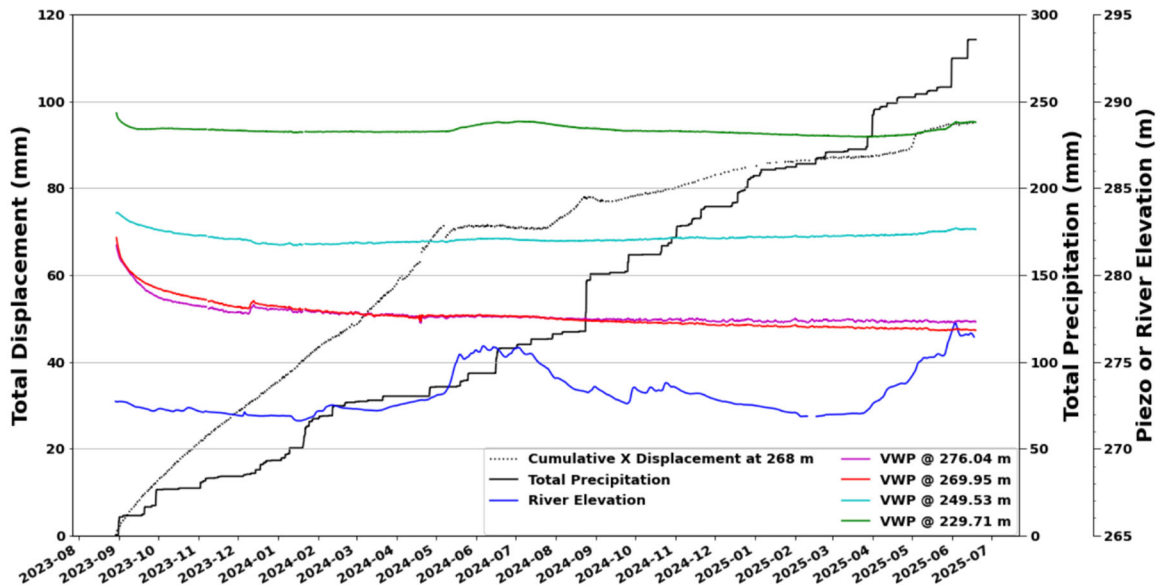
Figure 9. Record of displacement, precipitation, piezometric head, and river elevation since the 2023 site investigation.

Piezometric measurements collected since installation have identified the presence of strong upward hydraulic gradients (on the order of 10 m) in the vicinity of the actively sliding region (Figure 9). Changes to the river level have an increasing effect on piezometers with increasing depth. The deepest piezometer seasonally rises by about 1 m during spring freshet. However, a strong upward hydraulic gradient is maintained throughout the year. These gradients also indicate strong uplift pressures on the landslide toe. Upward hydraulic gradients can contribute to destabilization of a landslide, particularly when these forces exist near the toe of an active landslide. Uplift forces help drive landslide rotation, causing

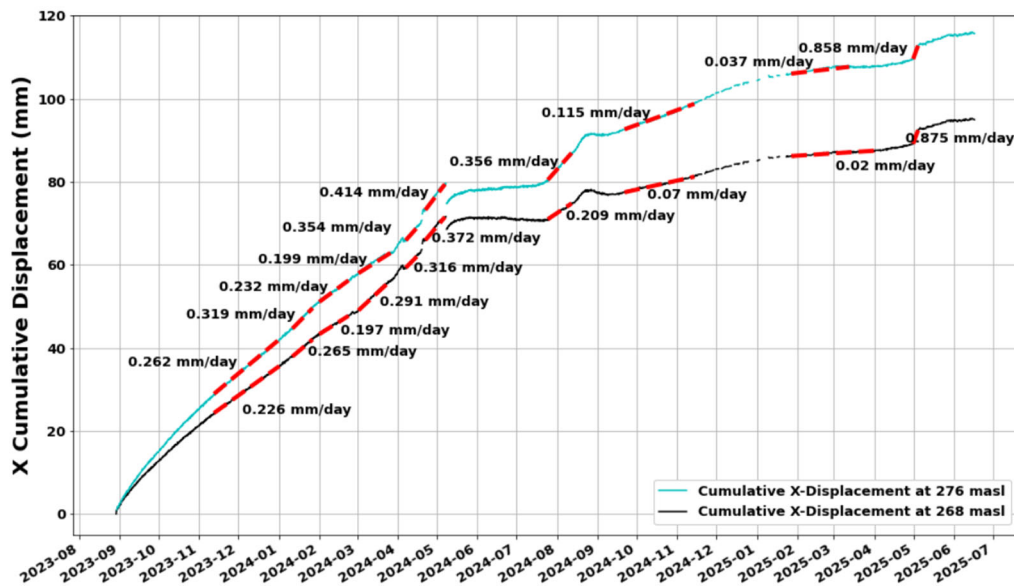
Figure 10. Rate of displacement on the upper and lower shear planes since 2023.

ShapeAccelArray displacement monitoring indicated that there are two distinct shear planes in BH23-1. The upper shear plane occurs around 275.9 m with a displacement rate of up to 0.86 mm/day (Figure 10). The lower shear plane, located at approximately 267.5 m, is currently moving with a higher displacement rate of up to 0.88 mm/day (Figure 10). The displacement rates since installation in August 2023 are shown in Figure 10. The measurements indicate seasonality to the movement that is not always repeated from one year to the next. Another apparent pattern is that rapid movement follows periods of little to no movement. Finally, the plots show that movement on the upper shear plane is highly dependent on movement of the lower shear plane. As a result, it may be possible to simplify the analysis and focus on the lower shear plane displacement. The resolved direction of movement for the lower shear plane is depicted in Figure 8. Ongoing monitoring continues to provide an uninterrupted record of porewater pressures and landslide displacement, which is critical to understanding this complex landslide.
