Investigating the risk of brittle behaviour in collapsible soils beneath a tailings storage facility: A case study

Massyn Harmse, Nico Vermeulen, Rudi Aschenborn
 Geotechnical Engineering, Jones & Wagener, South Africa, harmse@jaws.co.za

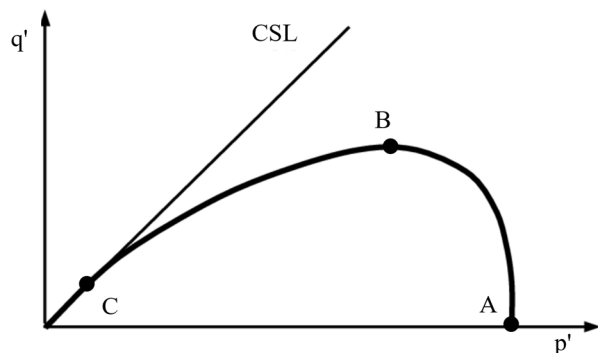
Figure 2 presents an undrained stress path ABC for a soil that exhibits strain softening behaviour. The specimen achieved peak q' at B whereafter strain softening took place. Unlike the undrained stress path in Figure 1, failure now takes place at C at a lower q' than the peak q' achieved at B.

Figure 2. Strain softening stress path in $p':q'$ space.

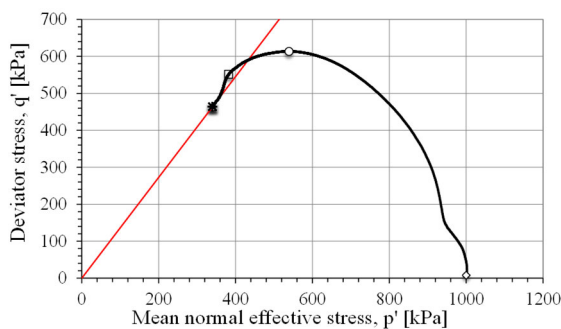
A CU triaxial test was performed on this specimen. The specimen was isotropically consolidated to a mean effective stress (p') of 1 MPa before undrained shearing. Figure 3 presents the stress path in $p':q'$ space.

Figure 3. Stress path in $p':q'$ space.

Based on the stress path in Figure 3, it can be seen that some strength loss took place close to or at the CSL. Upon closer inspection of the post-test condition of the specimen, it was noted that the top cap tilted severely. Hence, the post peak results are questionable as the loss of strength could be attributed to loss of integrity of the external measurements due to tilting of the top cap.

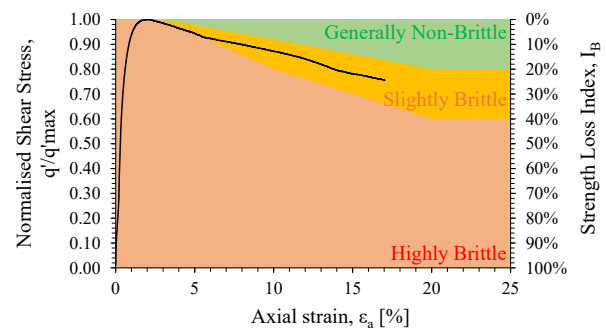
Using the triaxial data, brittleness (I_B) was assessed by plotting the normalised shear stress (q'/q'_{max}) against axial strain, refer Figure 4. The following ranges and descriptions are recommended as per ICOLD Bulletin 194 (2022):

- $I_B < 0.2$ Generally Non-Brittle
- $0.2 < I_B < 0.4$ Slightly Brittle
- $I_B > 0.4$ Highly Brittle

Figure 4. Brittleness during undrained loading.

According to Figure 4 the hillwash would classify as slightly brittle. However, there were doubts as to whether the brittleness was due to actually strength loss or an artefact of the test data.

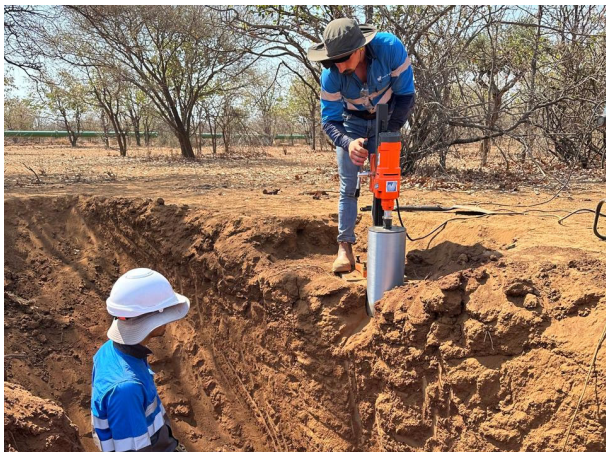
Figure 5 shows the coring process in progress. The cuttings evacuation channel can be seen to the left of the barrel. Figure 6 shows a core sample after it was extracted from the core barrel. Although this method of sampling worked well, some imperfections are visible on the surface of the sample. This varied between the various samples retrieved.

Figure 5. Sample coring on site.

Coring commenced from the top of the cleared area. It was observed early in the process that cuttings were becoming lodged in the barrel, leading to sample disturbance and damage. To resolve this issue, a trench was excavated through the centre of the cleared area, adjacent to the sampling position. An opening was then created from the trench sidewall to the cutting edge of the advancing barrel, allowing cuttings to evacuate freely and reduce sample disturbance.

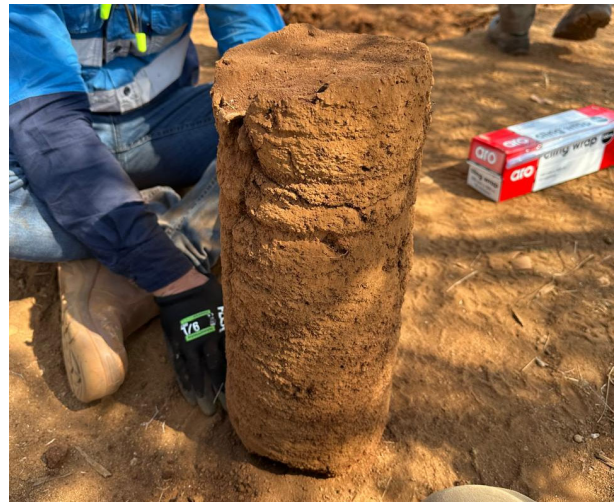
Figure 6. Extracted core sample prior to packaging.

A total of eight samples were cored. The samples were wrapped in clingfilm and tinfoil prior to being placed into a PVC split mould. The split mould was slightly larger than the sample, hence the annulus was filled with expanding foam. All eight samples were transported in a specially designed, foam lined crate to the laboratory.

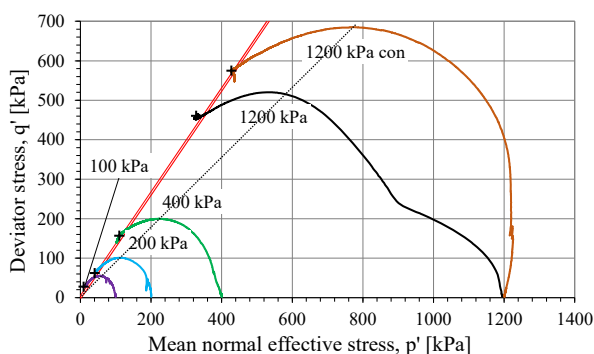
Figure 7 presents a comparison of the four (dry consolidated) plus one (wet consolidated in blue) stress paths for the various specimens in $p':q'$ space.

Figure 7. Stress paths in $p':q'$ space.

The hillwash specimens yielded contractive behaviour, regardless of the applied consolidation stress.

All specimens yielded strain softening behaviour as peak q' was achieved prior to strain softening taking place, resulting in failure at the CSL at a lower q' . Interestingly, when a line is drawn through the peak q' for all specimens, the Instability Locus (IL) can be defined (black dashed line). A specimen sheared in undrained conditions may become unstable once the stress path crosses the IL. In the case of the hillwash specimens, the specimens reached the IL and underwent softening, failing at the CSL after strength loss.

The stress paths suggest that the strength loss (difference between peak q' and q' at failure) reduces with increasing confinement stress (p'), thereby reducing the brittleness of the material.

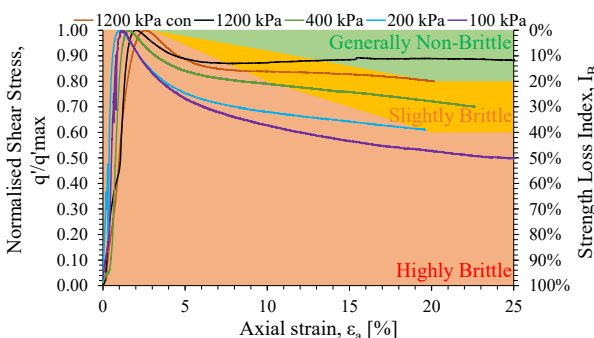
Figure 8 presents the normalized shear stress vs axial strain plot for the various specimens.

Figure 8. Brittleness index comparison.

The 100 kPa specimen is classified as highly brittle ($I_B > 40\%$). The 200 kPa and 400 kPa specimens exhibit slight brittleness ($20\% < I_B < 40\%$). Both 1200 kPa specimens fall within the generally non-brittle range ($I_B < 20\%$), although the dry-consolidated specimen (black) is considered borderline between non-brittle and slightly brittle.

From Figure 8, it can be concluded that the I_B reduces with an increase in p' , hence an increase in overburden stress tends to reduce the propensity to brittle strength loss.

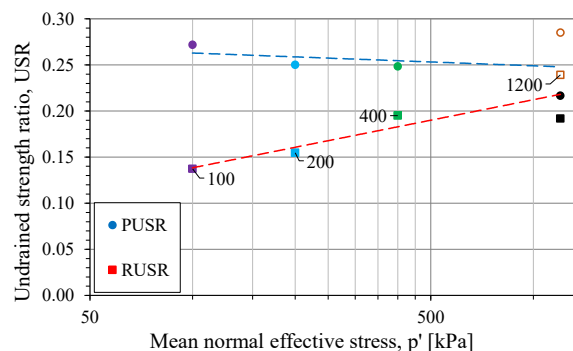
Figure 9 presents the Undrained Shear Strength Ratio (USR) vs p' plot for the various specimens. Both the peak USR (PUSR) and residual USR (RUSR) were determined for all specimens based on the CU triaxial results. Note that the open symbols depict the results for the conventionally flushed and saturated CU triaxial consolidated to 1200 kPa (in black).

Figure 9. Peak and residual undrained strength comparison.

The PUSR slightly reduces from 0.27 at 100 kPa to 0.22 at 1200 kPa for the dry consolidated specimens. The conventionally flushed and saturated specimen yielded a PUSR of 0.29 at 1200 kPa.

The RUSR increases from 0.14 at 100 kPa to about 0.20 at 400 kPa and 1200 kPa, respectively. Again, the conventional CU triaxial yielded a higher RUSR of 0.24.

In general, the PUSR and RUSR tend to converge at higher p' (> 1200 kPa). Hence, the brittleness (difference between PUSR and RUSR) decreases and will likely ultimately converge to a single PUSR at a high enough overburden stress.
