# Back-analysis of Eemdijk full-scale failure test on sheet pile reinforced dike

**Arny (H.J.) Lengkeek**

Witteveen+Bos, Deventer, The Netherlands, [arny.lengkeek@witteveenbos.com](mailto:arny.lengkeek@witteveenbos.com)

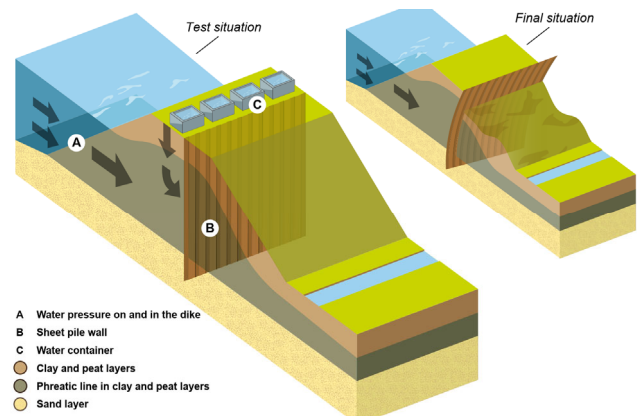
Figure 1. Schematic loading conditions of a sheet pile reinforced dike [Figure courtesy Bredeveld et al. (2019)].

The Eemdijk full-scale failure test enables to investigate failure conditions in a controlled manner, which are representative for a sheet pile reinforced dike as schematically shown in Figure 1. The primary loading and reduction of strength follow from the increased water pressures (A). The secondary loading follows from surcharge (C). The sheet pile wall (B) is unanchored and embedded in the deeper sand layers. The corresponding failure mechanism as shown on the right side is a combination of active/passive wedges and a slip circle. In practice also shorter sheet piles supported by inclined anchors can be used to reinforce dikes.

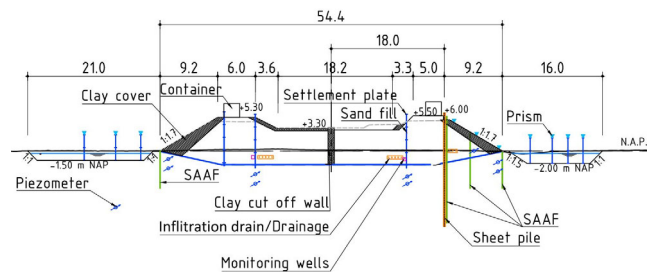
Figure 2. Cross section of ground dike (left) and sheet pile dike (right) with monitoring instrumentation.

The GD-test and SPD-test are performed on a newly constructed embankment. The embankment consists of two parallel sections of 60 m length with a maximum height of 5.5 m, see Figure 2. The core material consists of sand and the cover layer consists of firm clay with a slope of 1V:1.7H. The center area between the two dikes is about 2 m lower and contains a clay cut-off wall to create two compartments with controllable water levels.

The sheet pile wall configuration consists of a staggered wall with alternating panels of 18 m and 9 m length. The panels consist of triple U-profiles. A staggered wall is selected because a continuous wall was expected to be too strong to fail. All panels are connected by the sheet piles interlocks. The structural properties of the sheet piles are presented in Lengkeek (2022). The monitoring instrumentation on the sheet pile wall comprises of glasfibers (GFSG), inclinometers (SAAF) and Prisms.

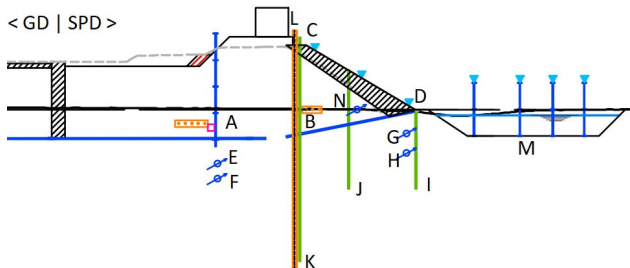
Figure 3. Cross section of the SPD with locations of monitoring instrumentation.

This section presents the results of the back-analysis of the SPD. The performance of the four FEM back-calculations is compared with the monitoring results and with each other. The back-analysis is compared to the measurements at specific monitoring instrumentation locations, see Figure 3. The locations are identified by [A, ..., M].

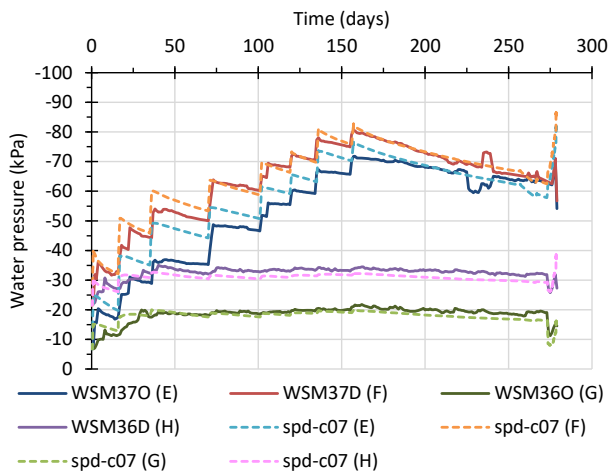
Figure 4. Measurements (WS..) and back analysis (spd-c07) of pore pressure, at 1.5 m depth in the clay and 3.0 m depth in the peat, at the toe and crest.

Figure 4 presents the pore pressures during construction phase and failure test phase. The comparison of the construction phase is only shown for FEM back-calculation c07, as the construction phases are the same for all FEM back-calculations. The solid lines are the measurements and the dashed lines the back-analysis results. Based on these figures it is concluded that

the excess pore pressures are correctly modelled. The initial response deviates as is often seen with embankment on organic soils. For the back-analysis it is more to get the correct excess pore pressures at the start of the full-scale failure test.

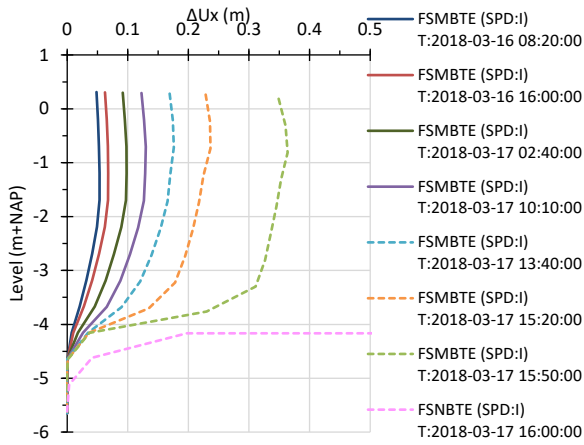
Figure 5. Inclinometer measurements at the toe (SAAF location I). The final eight measurements are presented starting 1 day prior to failure. The last measurement is as after failure and not reliable due to excessive deformations.

Based on the evaluation of the SPD measurements it is concluded that failure of the slope (see Figure 5) occurs prior to the buckling failure of the sheet pile. The latter is considered the point where the integrated system of the sheet pile reinforced dike fails.

The rate of deformation increased rapidly after 10 cm displacement, up to a horizontal displacement at the crest of about 60 cm and at the toe of about 35 cm. At this deformation the sheet pile failed which caused a collapse of the SPD and ultimately a flooding. The total duration of the collapse was about 7 minutes. The deformations stopped after the top of the sheet pile was deflected to almost 45 degrees.

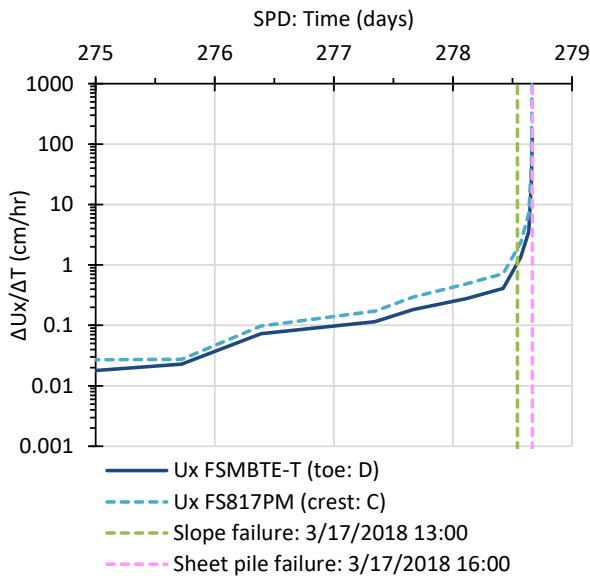
Figure 6. Horizontal displacement rate of the SPD during the last days of failure test. The displacement rate at the crest and toe are derived from the top of the inclinometer measurements.

To determine the deformations prior to slope failure, the ‘moment of failure’ needs to be defined. This is defined as the moment in time when progressive failure under constant loading is permanent (irreversible). This moment is based on the evaluation of the measurements presented in Figure 6. From this evaluation, the moment of failure is set to a horizontal displacement rate of 1 cm per hour at the toe of the dike. This moment coincides with a sharp increase in displacement rate, and with the occurrence of visual cracks in the slope. The same rates and moment of failure is found for the ground dike test (GD).

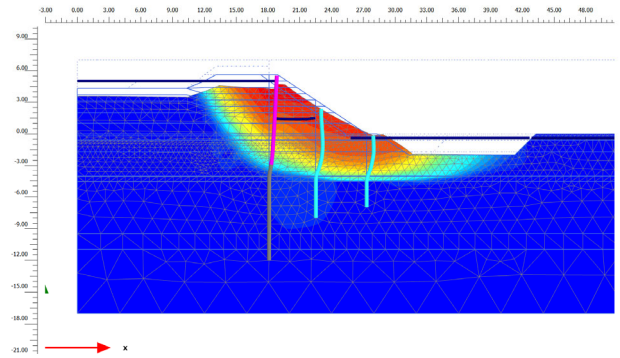
Figure 7. FEM calculation results with shaded plot of phase displacements prior to failure (red is large, blue is small). The magenta line is the continuous sheet pile and the grey line is the staggered part. The turquoise lines are the modelled inclinometers.

Figure 7 presents the phase displacements of FEM back-calculation c07. The deformation mode complies well with the reconstructed failure mode as presented in Figure 8. The reconstructed failure mode is based on all the measurements and post failure 3D radar scans and excavations, as illustrated in the photos of Figure 9 and 10. Figure 8 shows that on the passive side the exit point of the slip circle is pushed up more than 2 m. At the toe, the failure surface is at the boundary between the peat layer and sand layer. Towards the sheet pile there seems to be no single failure surface, but a failure zone indicated between the two dashed lines. The maximum inclination of the sheet pile is 42 degrees. The failure point of the sheet pile is approximately at -3.5 m NAP. On the active side an area of active wedges developed.

The deformation mode is similar for all four FEM back-calculations. The failure of the sheet pile (exceedance of the maximum bending moment capacity followed by a plastic hinge) occurred in all FEM back-calculations at the same level followed by a global failure of the dike.

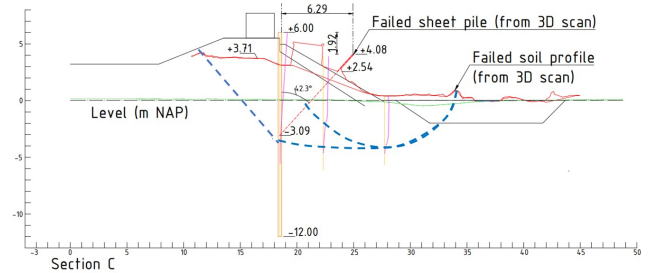
Figure 8. Reconstructed failure surfaces from 3D scans and surveys.

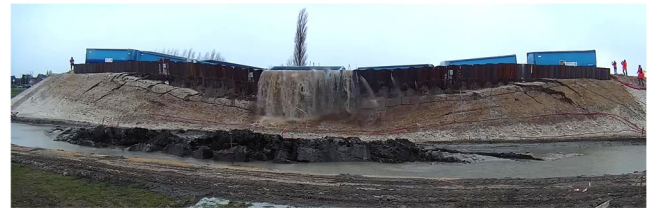
Figure 9. Photo at the moment of failure (16:00 hr.), showing the pushed-up slip circle, the sheet pile deflection and overtopping.

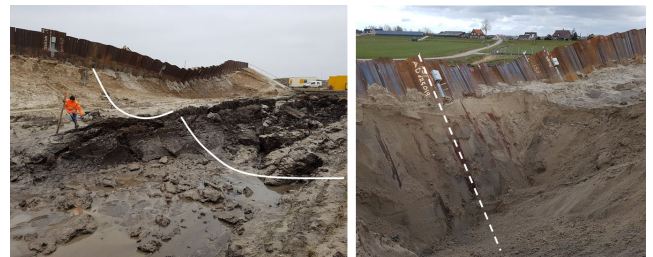
Figure 10. Left Side view of the SPD failure mode after draining the ditch, with clear indication of the exit point of the slip circle. Right Top/back view of the sheet piles after failure and local excavation, the dashed line indicates the inclination of the sheet pile. All interlocks of sheet piles are still intact.

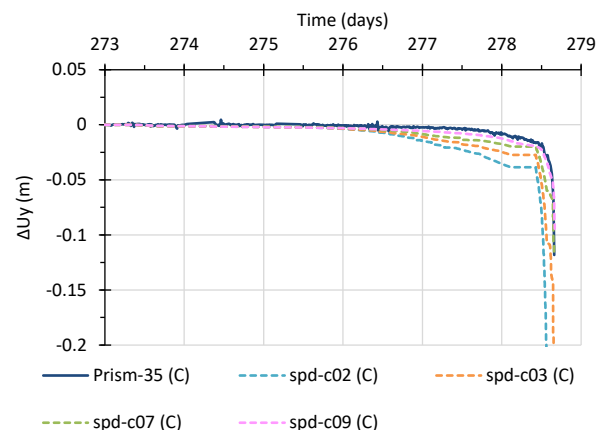
Figure 11. Measurements (Prism..) and back analysis (spd..) of vertical displacements at the crest (location C).

Figure 11 to Figure 13 present the four back-calculations in comparison to the measurements. In Figure 11 the vertical displacements of the top of the sheet pile are presented. In Figure 12 the horizontal displacements at the toe are presented. In Figure 13 the horizontal displacements of the sheet pile are presented. Figure 13 shows that the location of the plastic hinge in the sheet pile at about -3.5 m NAP is well captured by the FEM back-calculations. The indication T=278.5 in the legend refers to day 278+12 hrs.

It is concluded that the back-analysis c02 overestimates the displacements at any moment in time, with a premature instability. The actual global stability is underestimated with the current approach and 2D modelling.

With the increased strength properties of FEM back-calculation c07, failure occurs in the correct stage with the correct loading and with a slight overestimation of the displacements. The increase of 15% is still less than the upper bound undrained shear strength parameters which are 20 to 25% higher, mainly caused by not applying the geometrical barreling correction.

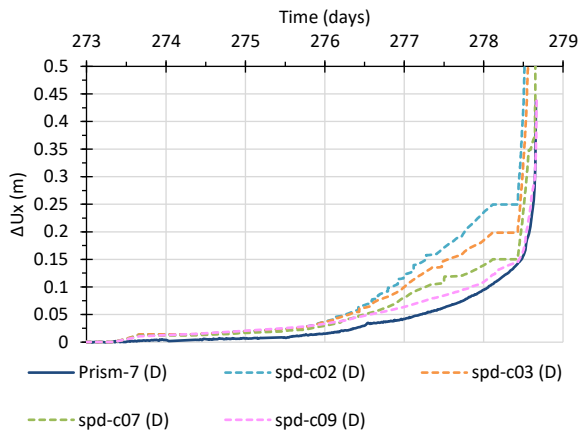
Figure 12. Sheet pile dike, measurements (Prism-7) and back analysis (spd..) of horizontal displacements, at the toe (location D).

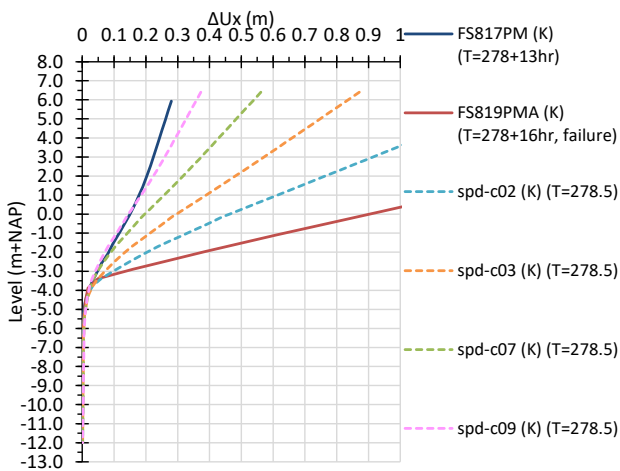
Figure 13. Measurements (FS..) and back analysis (spd..) of horizontal displacements of the sheet pile (SAAF location K) in last loading stage prior to failure with water level +5.0 m NAP.
