Fibre Optic Movement Sensing for detecting and monitoring railway track support condition

Agnes van Uiter, Paul Kootwijk, Joost van 't Schip
ProRail BV, Utrecht The Netherlands, agnes.vanuitert@prorail.nl

Ben Cooper, Kit Chambers, Toby Fisher, Ed Austin
Focus Sensors Ltd., United Kingdom, edaustin@focus-sensors.com

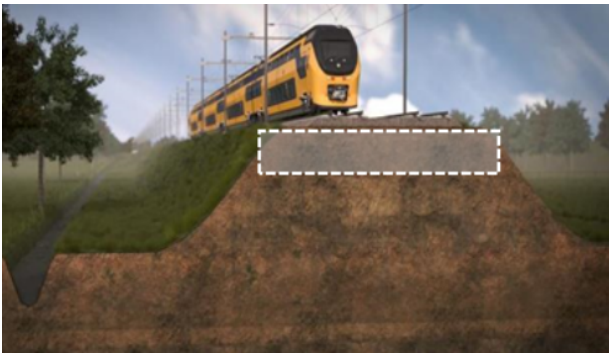
Figure 1. Location of reduced bearing capacity under the track

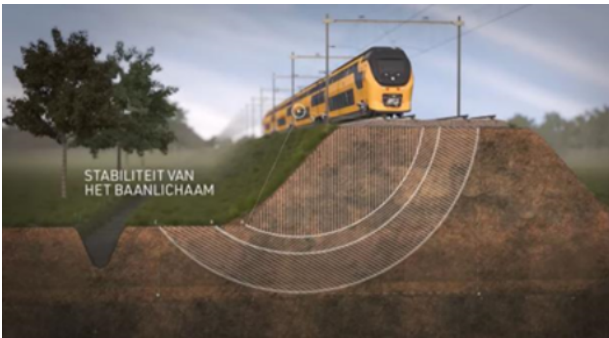
Figure 2. Example of sliding plain in the track embankment

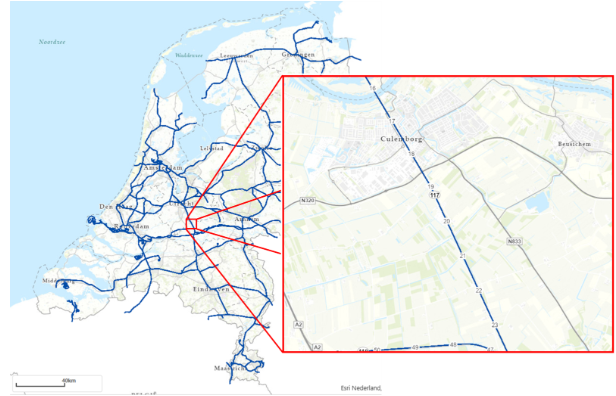
Figure 3. Location of test site in the Netherlands

The research site is located in the middle of the Netherlands, alongside the railway track between Culemborg and Geldermalsen, see Figure 3. The fibre optic cable, which is a

spare within an existing cable normally used for communication purposes, is buried in the top of the embankment on which the railway is situated.

A single-mode (SM), non-dispersion-shifted (NDS) fibre that conforms to ITU-T G.652.D was available for the measurements along the west side of the track between Culemborg and Geldermalsen. This fibre is approximately 8 km long and has been patched twice. The fibre is installed in a HDPE tube with a diameter of either 32 mm or 40 mm.

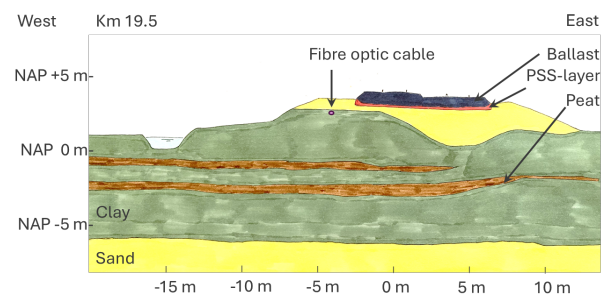
Figure 4. Cross section of the rail topology

A track renewal was carried out in the summer of 2023 due to the high number of deformations in the track when trains passed at speeds of approximately 140 km/h. A PSS layer (a highly compacted, almost waterproof sand layer, 30 cm thick) was installed under the tracks to enable speeds of up to 140 km/h. However, this layer did not solve the problem sufficiently. Therefore, a temporary speed restriction for trains and monitoring of the track via FOMS was introduced. Figure 4 shows the cross section of the rail environment.

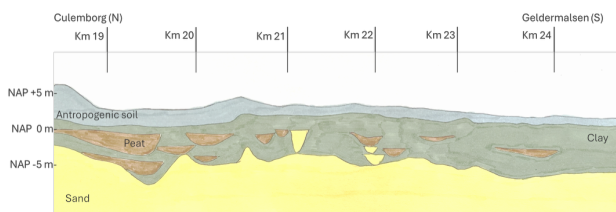
Figure 5. Culemborg to Geldermalsen geotechnical profile.

During the warmer Holocene period that followed, the groundwater level rose and the rivers Lek, Waal (which together form the Rhine) and Maas flowed again, depositing sediment (the Echteld Formation) on the research site. The town of Culemborg and the village of Geldermalsen are located on former levees, and the area between them consists of bowl grounds. These bowl grounds consist mainly of weak clay (mostly humus-rich) interspersed with sandier stream belts. See figure 5, geotechnical profile.

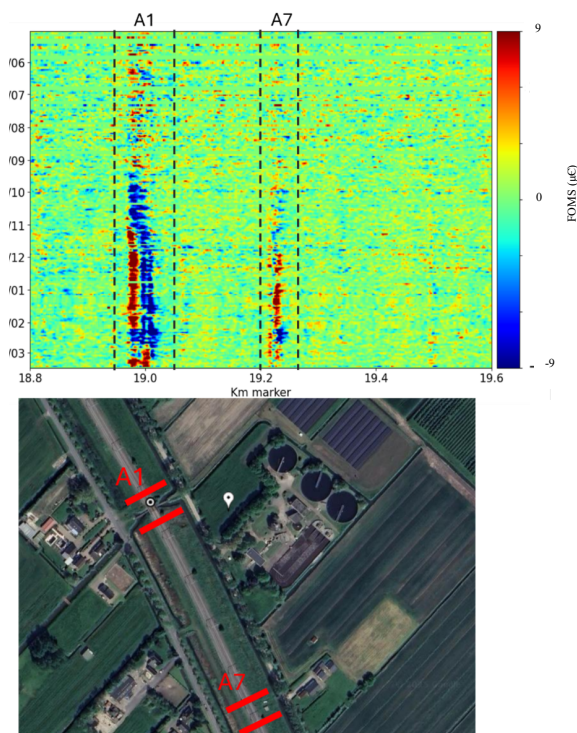
Figure 6. (a) Example of FOMS history showing signals from areas of interest (AOIs) A1 and A7, (b) The locations of the areas of interest A1 and A7 on aerial photograph.

Raw FOMS data is often displayed as a Geopanel, a heat map displaying FOMS history related to several hundred metres of track. Stable areas will experience the effects of passing trains but will typically return to the same state as before the train arrived, giving a low strain change and low FOMS value. A Geopanel can quickly highlight stability changes over time. Focus systems automatically identify areas where track stability varies compared with the rest of the track, called Areas of Interest (AOIs). If the FOMS system detects a rapid or unexpected change in an AOI, then an alarm is raised, alerting the customer. An example Geopanel is shown in Figure 6, where eleven months of FOMS data is displayed for an 800m section between Culemborg and Geldermalsen. Two areas of interest (AOIs) are shown in this area (A1 and A7) indicating worsening track stability four months into the deployment.

In this section we describe FOMS measurements from area of interest A1. Area A1 was identified shortly after installation in April 2024. Elevated FOMS values were detected compared with nearby track as shown in Figure 6 a). AOI A1 FOMS metric is shown in Figure 8. The metric shows a period of elevated but stable FOMS up to October 2024. In October 2024, the metric rose to 100 units (12.9 microstrain per train), leading to an automatic alarm. At that time, the track was inspected but no visible issue was found. Later in December 2024 the metric had risen further to 200 units (about 24.7 microstrain per train). Over the next period we saw significant changes in the FOMS, leading to a further alarm in March 2025. Further track inspection revealed subsidence and significant track shear. Emergency lifting and realignment of the track was required.

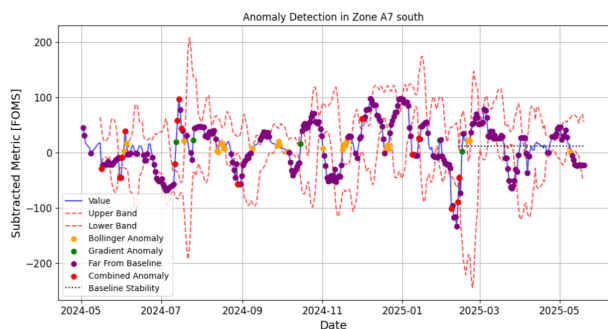
Figure 7. FOMS metric (AU) for AOI A7, showing degradation around November 2024, this change corresponded with rough ride reports in this area.

FOMS data related to areas of interest are processed to produce a summary metric, a unitless derived quantity which describes the evolving status of each AOI. Sometimes a ‘subtracted metric’, emphasizing performance at the AOI relative to nearby stable track is used. Over time, the system learns ‘normal’ behaviour for each AOI, such that alarms can be sent via email whenever abnormal changes occur indicating significant degeneration. An example metric timeseries is shown in Figure 7 for AOI A7. The system checks for extreme gradients and divergence away from a rolling standard deviation (Bollinger bands) which provide the conditions for an alarm trigger. Here a combined anomaly (all three conditions) is represented by a red point. The system currently checks for combined anomalies daily and creates an alert email in the case of triggers.

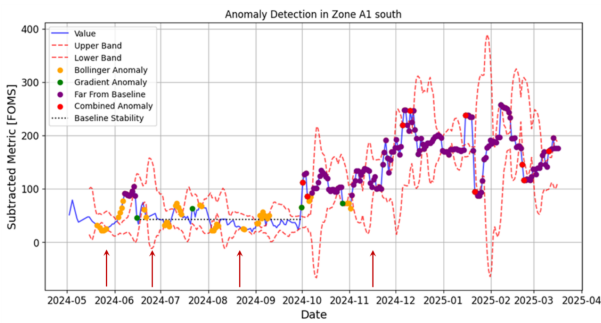
Figure 8. Calculated FOMS metric (AU) AOI A1. A1 was identified in April 2024 as an area of elevated FOMS. Greater instability was observed starting around October 2024. The dates of measurement train visits to the area are shown as red vertical arrows.

Visits from the measurement train to area A1 are shown as red vertical arrows in Figure 8. We see the first two visits from the measurement train in June and July 2024 corresponded with periods of relative stability, so the track instability detected by FOMS was not reflected in measurement train data. The data collected by the measurement train in August 2024 and November 2024, was requested by ProRail from the BWMS (Branche Wide Monitoring System). When the combined track parameter (which is a ProRail proprietary measure used to indicate issues with the displacement of the track) and the vehicle effect are compared from the August measurement run and the one from November, an increase (dark green parts) in both parameters is seen, which means a degradation in track geometry, as detected by FOMS. See figure 10.

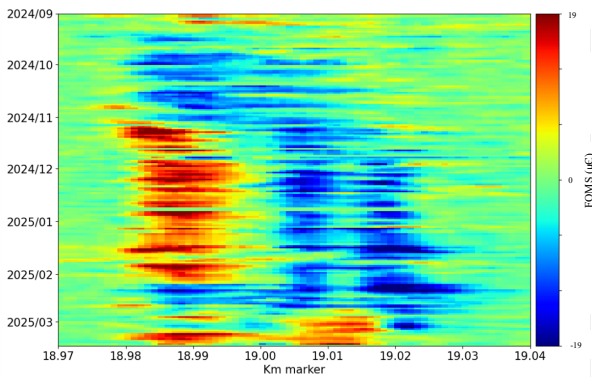
Figure 9. AOI A1 geopanel zoomed, showing evidence of subsidence.

Figure 9 shows a FOMS Geopanel zoomed around A1. The figure shows several changes in the sign of the FOMS signal. At km 18.99 FOMS goes from positive (red, ground expanding with each train) to negative (blue, ground contracting with each train) then back to positive again. Whereas a few hundred meters away we see negative (blue) signals switch to positive (red). The ground is contracting in the area near the bridge (km 18.99) and expanding out after the bridge (km 19.0 +). This movement is indicative of subsidence because it shows ground has moved away from km18.98 leading to blue contraction areas and associated expansion (red expansion zones).

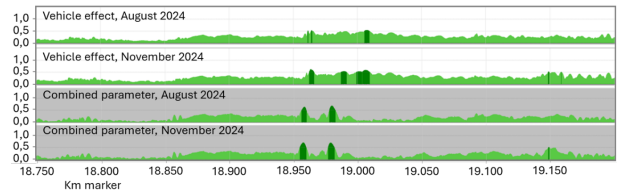
Figure 10. Measurement train data at AOI A1

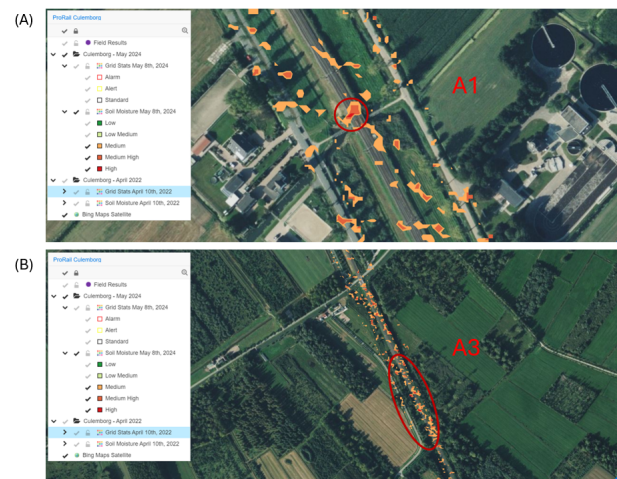
Figure 11. Asterra satellite data: (A), AOI A1 where subsidence near a bridge was discovered. (B) AOI A3, a 30m section with regular displacement.

However, during wet periods when a lot of rainwater has to run off the embankment to the parallel ditches. Some of this rainfall will inevitably infiltrate the track bed and have an influence on the bearing capacity of the sand at the top of the embankment. To gain an initial understanding of the moisture content of the soil in the investigated embankment, Asterra satellite data was used. As can be seen in figure 11 at location A3 the moisture content at the AOI is clearly higher (more orange and red) than in the surrounding embankment.

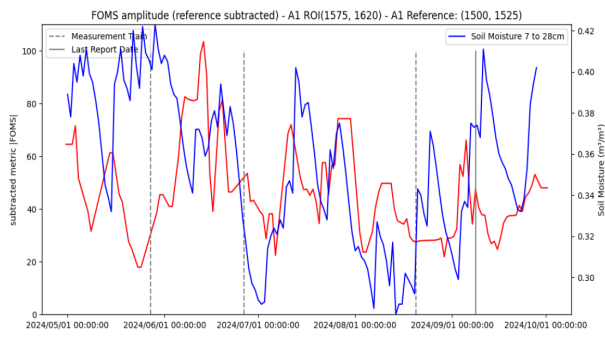
Figure 12. Soil moisture content correlated with FOMS (AU)

In addition to the Asterra data, the regional moisture content data from the open Meteo API was used to compare the FOMS results and the moisture content. It can be seen that there is a correlation between moisture content (25 cm under surface level) and FOMS as some of the peaks align well. However, the correlation is not very strong highlighting the presence of other influences, see figure 12.

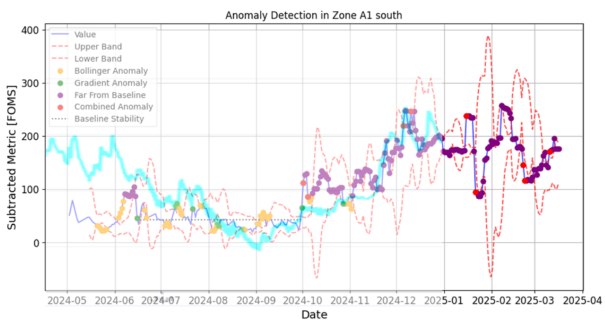
Figure 13. FOMS (AU) metric with ground water overlay

To supplement the moisture content analyses, further data was gathered. The groundwater head was measured around, and in the surrounding area of the track. As can be seen on the left-hand side of figure 13, when the groundwater head (light blue) decreases in spring and summer (let us assume that the embankment begins to dry out from the top) the FOMS signal remains fairly stable. Later at the end of September a period of rain begins and the temperature drops by a few degrees, the embankment soil becomes wet and it is around this time that we see displacements.
