Frozen retaining structure (Berlin shoring with ice-infill) for inner city construction pit, Sturegalleria/Stockholm

Christoph Haidenthaller

Züblin Scandinavia AB, Stockholm, Sweden, christoph.haidenthaller@zueblin.se

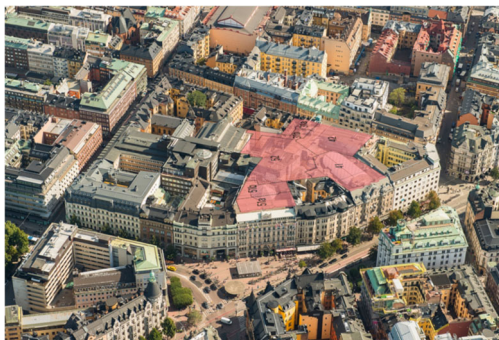
Figure 1. Overview of the renovation area marked in red (buildings 51a and b, 52, 31a and b, 41, 42).

The major new construction and renovation project, called Mainworks, began with the southern stage, which started in 2023 and is scheduled for completion in 2026. The project was awarded to Peab Sverige AB and is being designed by Sweco Sverige AB with Züblin Scandinavia AB as a subcontractor for all ground and foundation work, see Figure 1 for location.

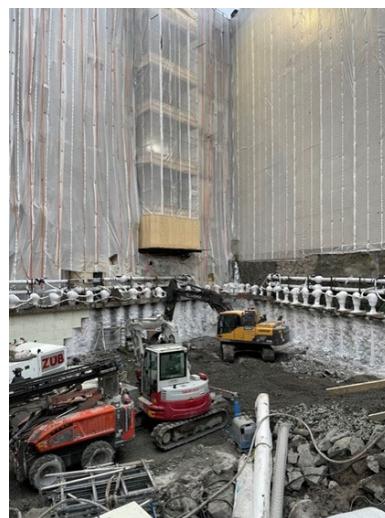
Figure 4. The image shows excavation work in progress, milling of frozen soil inside sheet piling and insulation in Area 1. Above the Berlin shoring, the feed lines and connection to the freezing pipes are visible.

- Removing the frozen soil from the inside of the excavation pit was sometimes very time-consuming as the soil was very hard. This was especially true if it took longer than planned from the start of freezing.

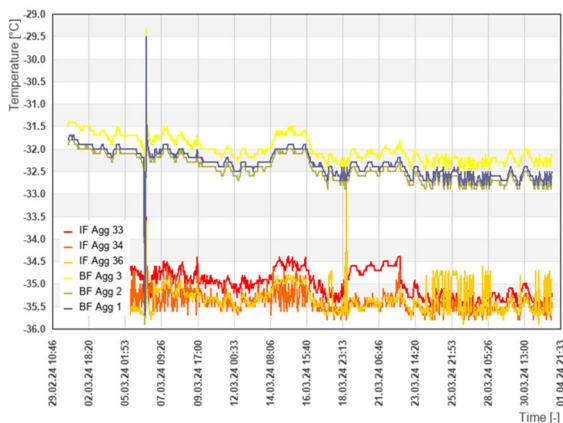
Figure 9. Brine temperature. 'IF' inflow brine from cooling unit. 'BF' backflow brine to cooling unit after a complete cycle in the pipe system.
