Pile tests in nuclear area: case of Chernobyl

Dr. Daniel Durot

Rincent BTP services recherche expertise (retired), Champlan, France, daniel.durot@durot-consulting.com

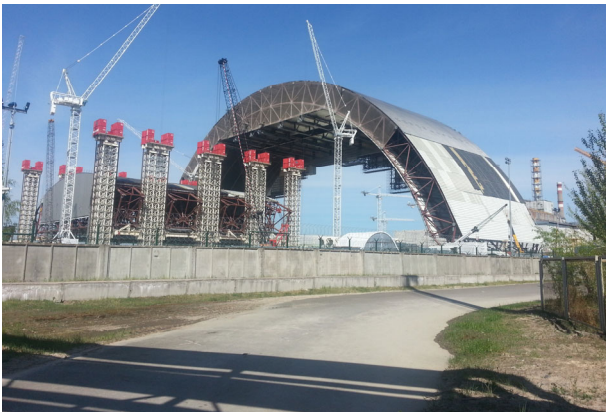
Figure 3. First section of the vault placed in the transfer zone and the second one's beginning

- Supply and assembly of the prefabricated metal parts of the first section of the vault in the erection zone, with various lifting phases.
- Movement of this first section of the vault by sliding it on the ground beams to the transfer zone (Figure 3)

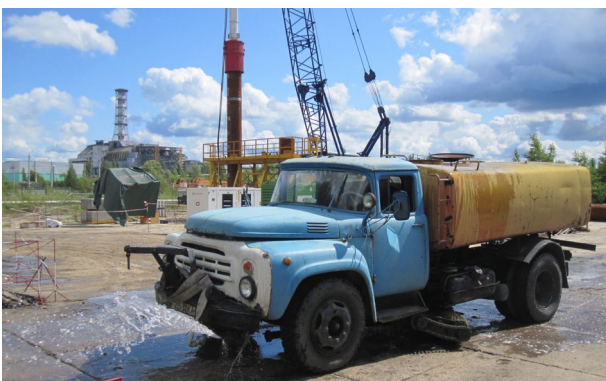
Figure 4. Watering device for soil decontamination in remote areas

However, this required the systematic decontamination of the concrete slabs protecting the ground. This was done using a truck equipped with a watering system (Figure 4.)

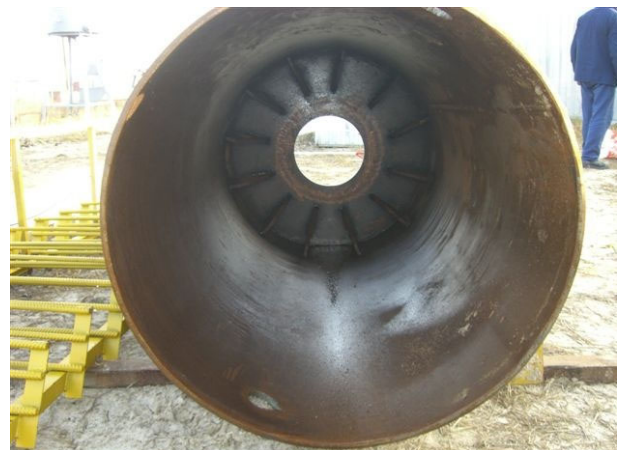
Figure 5. diaphragm

This was achieved by installing a diaphragm whose height was determined based on the soil's capacity to mobilize an optimal void ratio. This diaphragm had an annular shape that reduces the impact of water pore pressure (Figure 5)

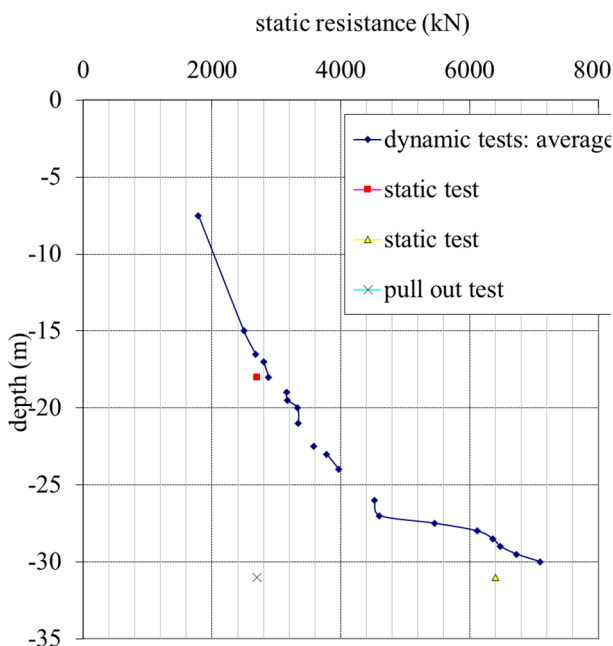
Figure 7. Summary of data from vertical loading tests

These static and dynamic data were then compared to assess the evolution of the static resistance of the piles in compression as a function of depth. This is expressed in the summary graph shown in Figure 7.

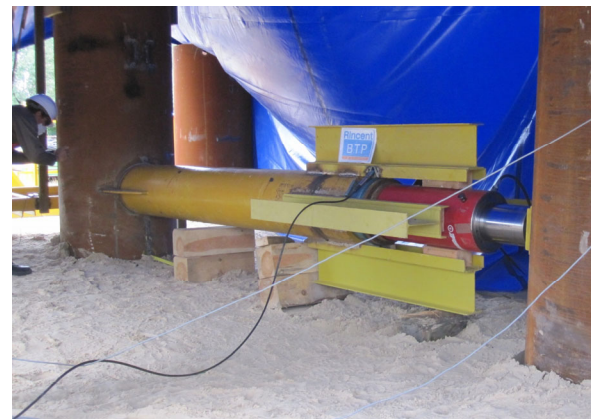
Figure 9. Lateral test using 2 piles, one acting as reaction

These lateral tests were conducted by steps, with force/displacement measurements recorded via a data acquisition unit designed specifically for these tests. A specific driven pile was used for reaction (Figure 9). Of course, the measurements concerned both the test pile and the reaction pile.

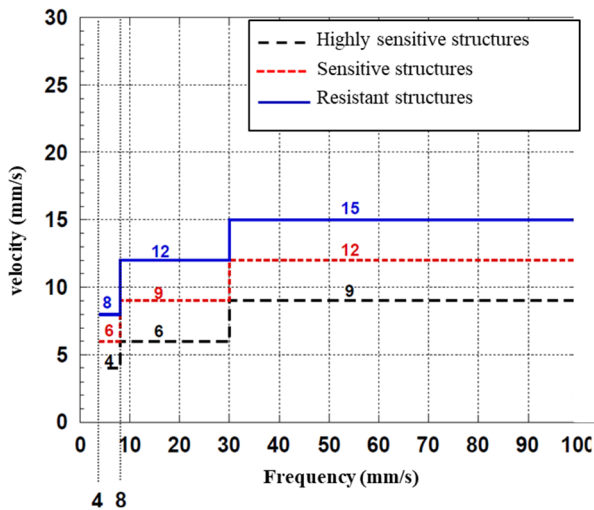
Figure 10. French recommendations

1. And 2. refer to French 1986 recommendation that sets out velocity limit values as a function of frequency and the sensitivity of nearby structure. These recommendations consider two cases: sustained vibrations and impulse vibrations. One of the graphs resulting from these recommendations is shown in Figure 10: the velocity measured in each of the three directions of space and according to their frequency must be below the indicated criteria.

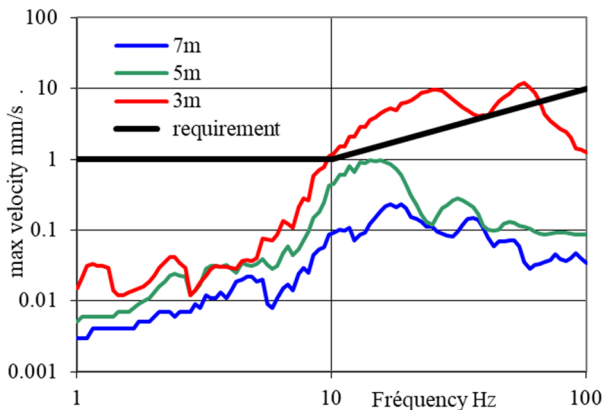
Figure 11. Example of vibration analysis according to Ukrainian standards

3. refers to the Ukrainian standard. An example is given in Figure 11 showing the vibration measurement results during driving at 3; 5 and 7m from pile side, according to vertical axis, when pile toe is located at 5m deep from the surface.

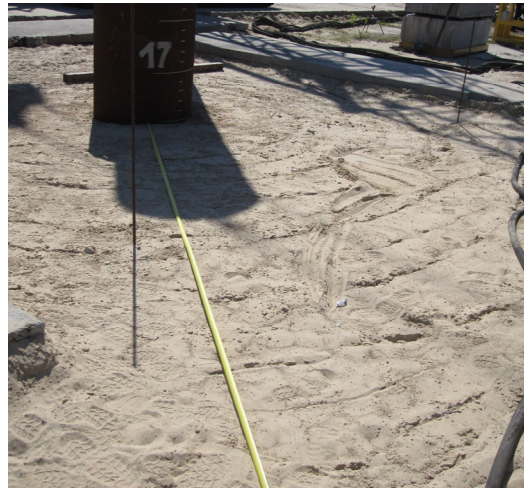
Figure 12. Measurement of distance between surface waves

These measurements were supplemented with visual observations, among which it was relevant to measure the

visible spacing between surface waves appearing during driving and the settlement after pile driving (Figure 12.).

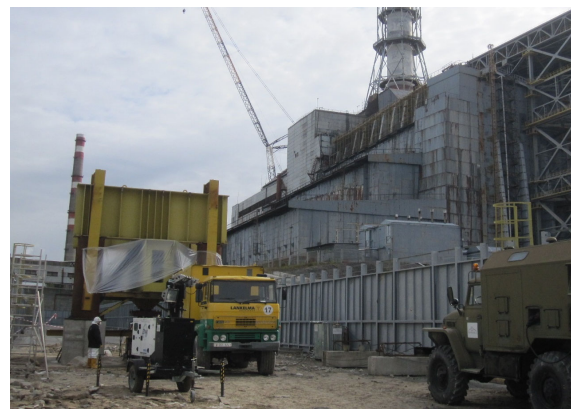
Figure 13. Static test on specific test pile

Static load tests on specific CFA test piles required the installation of 4 reaction piles supporting the reaction beam. A general view is given in Figure 13.

These piles were equipped with vibrating wire lines embedded at various depths in order to determine the lateral friction for each of the soil layers identified during the preliminary geotechnical investigations.

They were therefore not placed at equal distances from each other, but at varying depths. They were connected to a data acquisition system that also collected data from sensors placed at the pile head (displacement sensors, load cells).

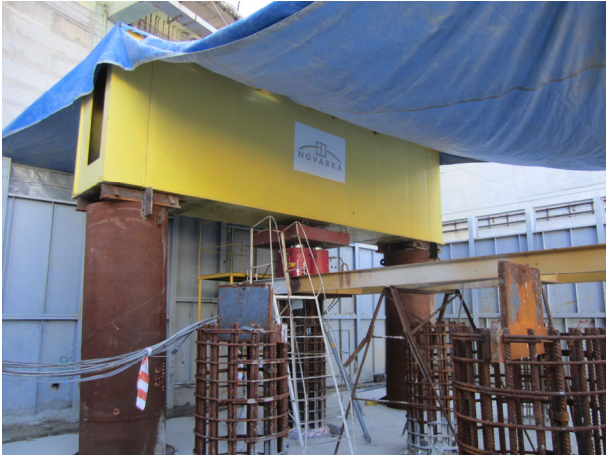
Figure 14. Device specific to the production pile loading test

For the production piles, vertical static loading tests were also carried out; nevertheless, vibrating wires were not included as the forces applied at the head were significantly lower. To ensure the reaction, only two piles were needed to absorb the traction forces. A casing connected to their reinforcement cage allowed the connection with the reaction steel structure, as shown in Figure 14.

This vertical arrangement enabled the transfer of forces via the jacks to the previously concreted test pile head without the need of cutting the reinforcement cages.

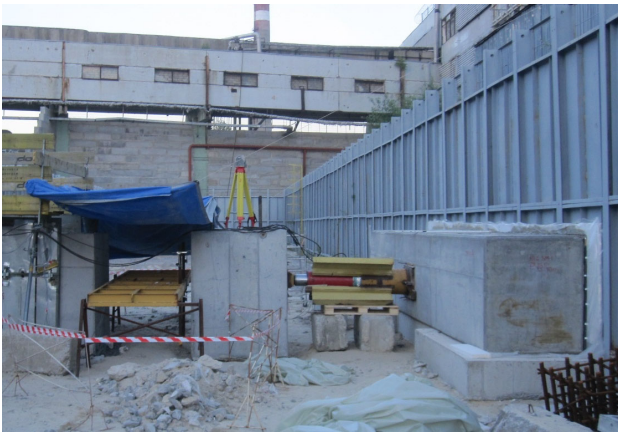
Figure 15. Reaction device for lateral test on CFA pile

Conventional static lateral tests were performed using a reinforced concrete beam placed on the retaining wall supporting the trench in which the ground beam was to be constructed. It acts as reaction (see figure 15). The measurement principle employed was consistent with that utilised for steel piles.

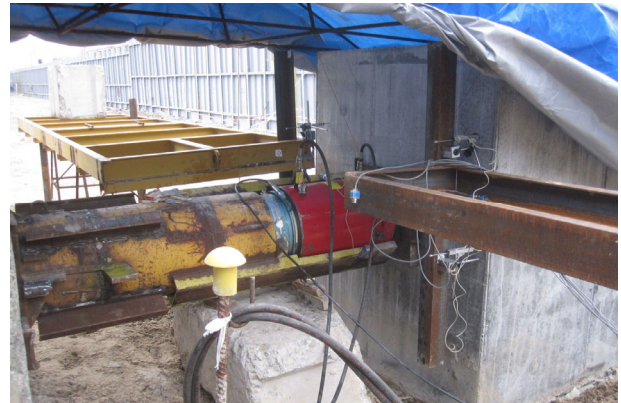
Figure 18. Setting up the device

Each sensor was of course based on independent reference beams and therefore the supports were located far from the zone of influence (Figure 18).

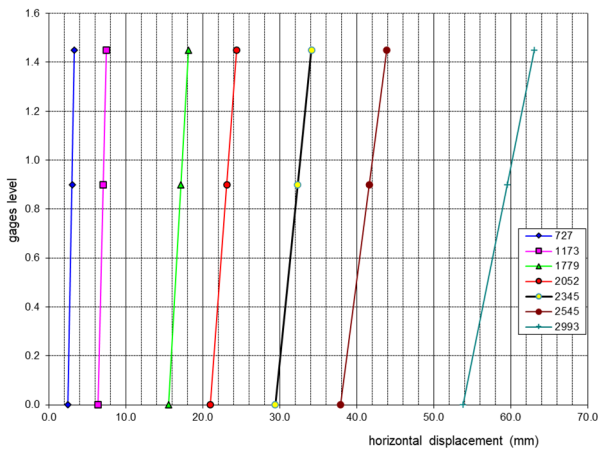
Figure 19. Inclination of pile cap at end of each step

The loading tests were conducted in accordance with a step loading procedure that adhered to both European and Ukrainian standards. The acquired data (force/displacement) were processed to obtain data relating to the inclination of the top of the pile cap. An illustration of this phenomenon is provided in Figure 19, which provides supplementary information regarding the observed translations.

This kind of data was used in the modelling process to evaluate the abutment and the horizontal stiffness that could be considered. Indeed, the lack of direct information regarding the rotation along the entire pile length did not prevent defining the boundary condition at the pile head by knowing its displacement and rotation.

Thus, by considering pile's inertia and the couple: restraint at the foundation base/displacement + rotation at the head for each load step, the only remaining unknown was the horizontal stiffness. This parameter was crucial for accounting the horizontal force applied by the vault.

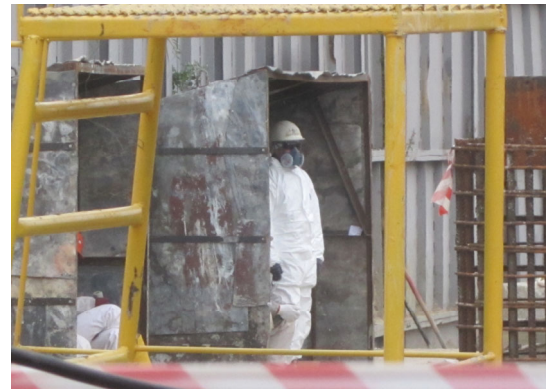
Figure 21. Protection against radiations and contamination

Consequently, a range of measures were implemented, including the provision of lead shelters to ensure the protection of personnel (Figure 21).

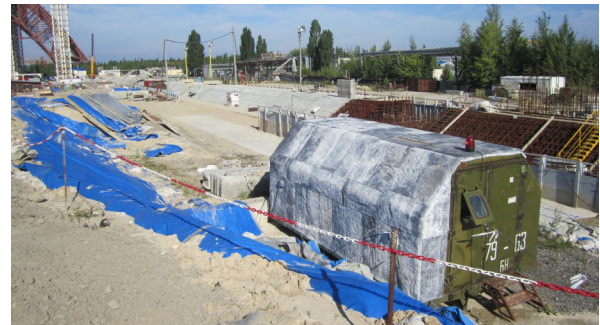
Figure 22. Shelter protection against radiations and contamination

This category of lead protection also encompassed the shelters of the personnel responsible for conducting static loading tests (figure 22).
