Landslide risk in Polish lignite opencast mines and implementation of remote monitoring methods

Zbigniew Bednarczyk

"Poltegor-Institute" Institute of Opencast Mining, Wrocław, Poland, zbigniew.bednarczyk@igo.wroc.pl

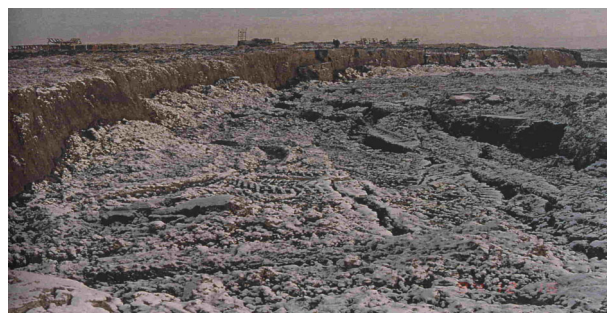
Figure 3. Turow Mine external spoil dump landslide, Dec. 1994.

1990. After stabilizing the risk zone, the mine implemented a special geotechnical and hydrogeological monitoring system. In 2010, this allowed lignite to be exploited at a depth of 100-200 m below the natural terrain level. This was also possible due to the reduction of slope angle to 10-12 degrees (Milkowski 2009). Landslides on the external spoil dump of this mine have been recorded since the beginning of its existence in the 1960s. They were particularly noticeable in the 1990s due to the huge volume of the spoil dumpsite, amounting to 1.7 billion m³. Its height of 245 m caused numerous problems with the stability of the slopes. The Swiniec landslide, which occurred in December 1994, had a volume of 6 million m³. The landslide was over 1300 m long, 750 m wide, and covered an area of 68 ha (Fig. 3).

At that time, the eastern part of the spoil heap was located about 150-300 m from the border with the Czech Republic. The landslide was caused by the storage of large masses of overburden in difficult geotechnical conditions. Soil dump masses covered the former river spring area and had an inefficient drainage system built at the beginning of the 1960s. The bedrock substrate layers represent low strength loess and clayey soils. The direct cause of the displacement activation was a significant increase in the height of the spoil heap from 370 to 415 m a.s.l. in the southeastern part of the spoil dump. Very high and steep slopes, reaching in some cases up to 70 m, were formed there at that time. An additional factor was low strength parameters of clayey soils transported by belt conveyors over a distance of more than 15 kilometers, which resulted in its strength parameters deterioration and partial liquefaction. One of the additional failure triggers was caused by the failure of one of the dumping machines. This resulted in the loading of the endangered area by another dumping machine, temporarily directing double the overburden masses that were originally planned to that area. After that, the first displacements of 0.5 m were observed on December 7, 1994 at a level of +415 m a.s.l. On the following days, the displacements increased to 25 m per day. The total displacements reached 170 m in the upper part of the landslide and 92 m on its head. The observed movements ranged from 5 to 22 m per day until December 13, 1994. The landslide tongue moved towards the border with the Czech Republic at a distance of 70 m between December 10 and December 12, 1994. The reclamation included drainage and rescue stabilization works. However, due to the size of the landslide masses, the possibilities of stabilization were limited. The retaining wall, which was 343 m long and built of Larssen steel elements, was driven into the ground to a depth of 5.5-14 m. Three boreholes were drilled to allow for the drainage of groundwater from the contact layers of the landslide bed. The pumps operated 24 hours a day. The newly built retaining wall was partially destroyed on December 22, 1994. Ten special load-bearing structures made of reinforced concrete were built to strengthen it. This work was successful, and on January 2, 1995 the movements disappeared. Stabilization work included

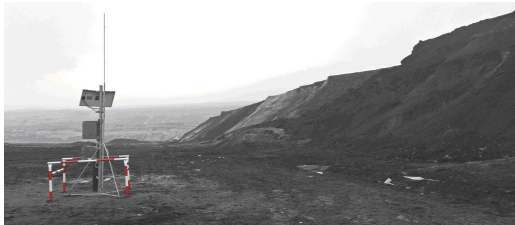
Figure 7. The on-line monitoring station in Belchatow mine.
