Construction of a Cross Passage between Two MRT Tunnels

Fang Y.S., Lin C.T., Liu C.

ABSTRACT: This paper reports the ground improvement and excavation of a cross passage between two shield tunnels for the construction of Tu-chen Line of Taipei Rapid Transit Systems. Jet grouting was conducted for soils around the cross passage before the tunneling with the shield machine. Water-leak tests were conducted to detect any possible crack in the JSG soilcrete, and chemical grouting was conducted from the shield tunnel to fill any possible crack. It is concluded that the subsurface conditions encountered at great depths might be quite complicated. The geotechnical engineer should never overestimate the watertight characteristics of the soilcrete formed around the cross passage by jet grouting and chemical grouting. Under the threat of high water pressure, the contractor is suggested to bear the multiple-defense-lines concept to keep the excavation work on the safe side.

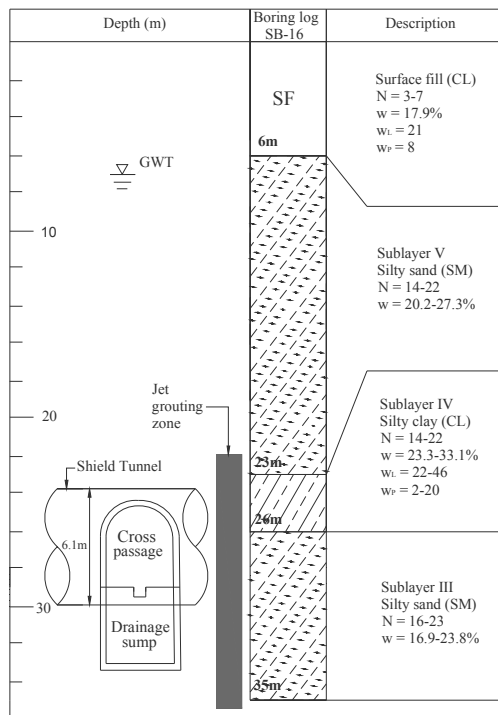
Figure 2. Geological profile for excavation of cross passage and drainage sump. (after Continental Engineering Corp., 2003)

1992), Figure 2 shows the geological profile adjacent to the cross passage. In the figure, the groundwater table was at about 7 m below ground level.

Figure 2 shows the cross passage was constructed at the depth of 24.7 to 29.3 m. Plus the 4.4 m-deep drainage sump, the excavation was extended to the depth of 33.7 m. Soils excavated for the cross passage included silty clay (classified as CL) and silty sand (classified as SM). Engineering properties of these soil deposits, such as the natural water content w , standard penetration test blow count N , liquid limit w_L and plastic limit w_P were indicated in Figure 2.

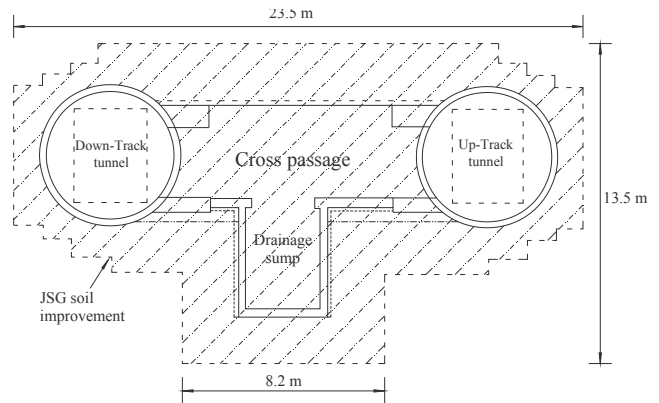
Figure 3. Section of JSG ground improvement for cross passage.

JSG (Jumbo Special Grout) operation was completed before the shield machine arrived. Based on the size of the cross passage and the recommendations of the Jet Grout Technical Information (JJGA 1990), the grouting zone was 13.5 m-high, and 8.2 to 23.5 m-wide as illustrated in Figure 3. Figure 4 shows a total of 168 1.4 m-diameter JSG piles were fabricated.

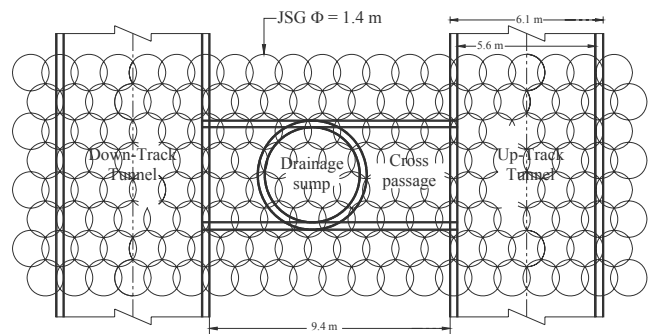
Figure 4. Plan of JSG ground improvement for cross passage.

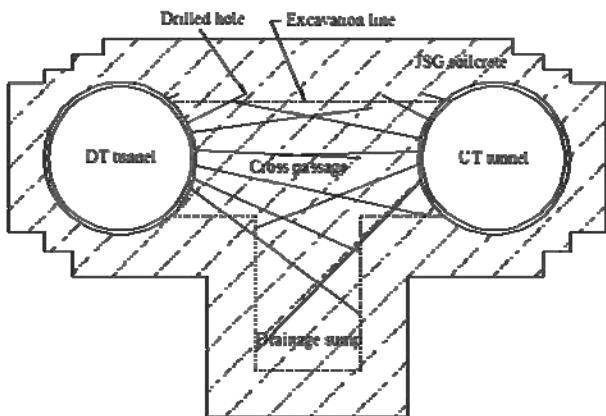
Figure 5. Holes drilled for water-leak test.

Due to the pushing, cutting and disturbing of the cutter disc of the EPB shield tunneling machine, cracks and discontinuities in the improved ground might be induced. As a result, the water-leak test on the jet-grouted body became necessary. Figure 5 shows holes were drilled from the tunnel to the soilcrete to investigate the quality of ground modification. The holes should not penetrate the improved ground as to create new intruding paths for groundwater. When a significant amount of water-leak was measured in the tunnel (see Figure 6), additional chemical grouting was conducted as indicated in Figure 7. Low pressure grout with a mixture of water-glass and SL reaction agent was injected to the improved ground to seal all water paths around the cross passage.

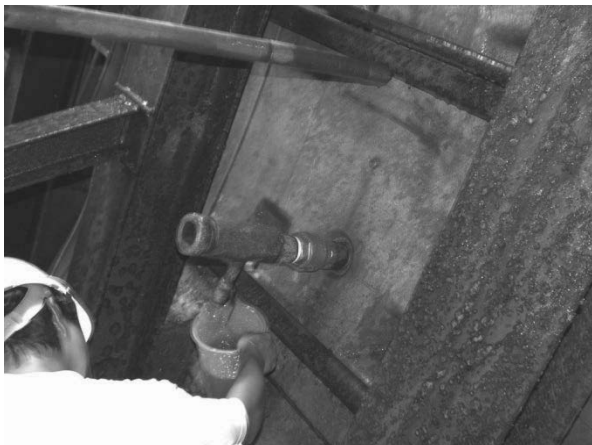
Figure 6. Water-leak test before cross passage excavation.

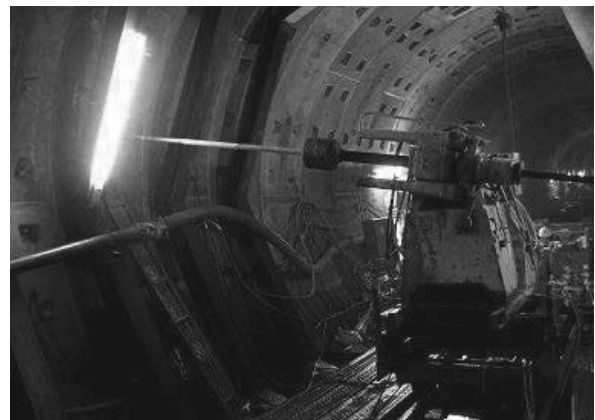
Figure 7. Additional chemical grouting in tunnel before cross passage excavation.

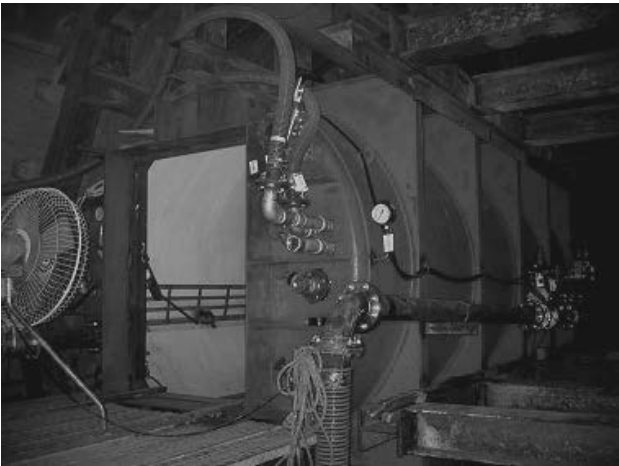
Figure 8. Air-lock of compressed-air operation for cross passage excavation.

To repress the inflow of groundwater at the face of excavation, and to increase the safety of construction, the compressed-air method was employed. The air-lock used is shown in Figure 8. For most of the working days, the air pressure was kept at 60 to 80 kPa, and the maximum air pressure used was about 180 kPa.

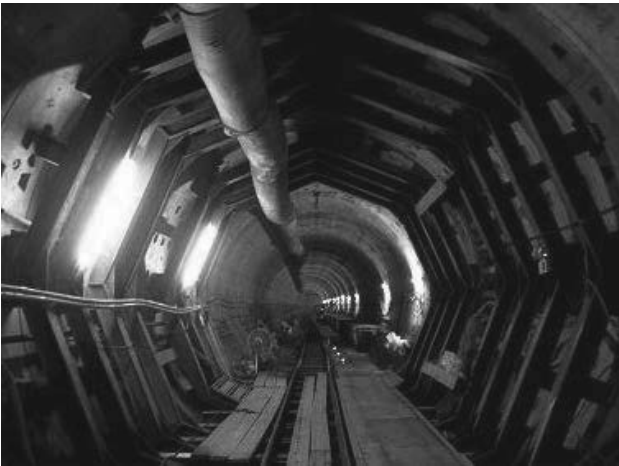
Figure 9. Octagonal steel-beam reinforcement inside tunnel.

For the mining of the cross passage, circular holes were cut on the steel segments of the main MRT tunnels. The load release on the opening would cause a redistribution of pressure on the tunnel lining, and a possible stress concentration on adjacent lining segments. For this reason, Figure 9 shows the contractor fabricated octagonal steel reinforcements on both sides of the opening in the tunnel for protection.

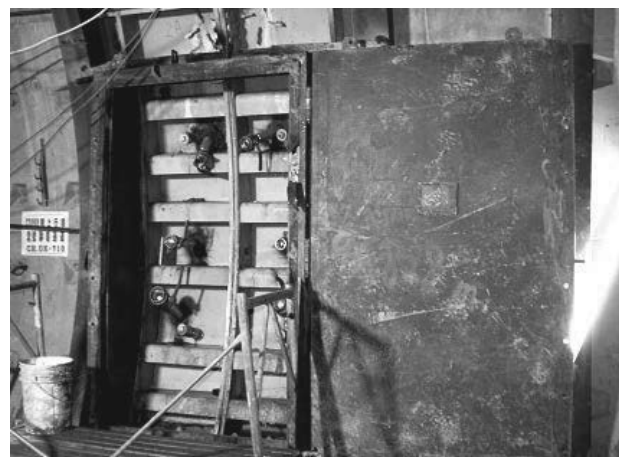
Figure 10. Steel safety-gates at the end of cross passage.

In case the jet grouting, leak-test and addition grouting, and compressed air methods all failed to resist the invasion of the groundwater, the fourth defense line could be activated. This simple and effective method is to fabricate three steel gates at the top of the drainage sump, and at both ends of the cross passage (see Figure 10). If the break in of groundwater appears irresistible, in the worst case scenario, the tunneling crew could simply shut the emergency gates. The flow of groundwater and loss of ground will be confined in a small and restricted zone. The contractor should never be overconfident as to give up this last line of defense.
