# Inspection of structural health of existing railway retaining walls

Nakajima S., Shinoda M., Abe K.

Railway Technical Research Institute, Japan

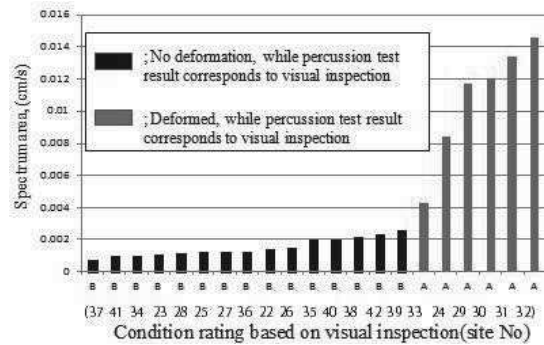
Figure 5. Relationships between condition rating by visual inspection and value of spectrum area (Ashlars wall)

spectrum area. In the cases of ashlars wall shown in Figure 5, the values of spectrum area Sa of retaining walls rated as “A(deformed)” were generally larger than the ones of retaining walls rated as “B(no deformation)”, which shows the validity of spectrum area for the condition rating of retaining walls.

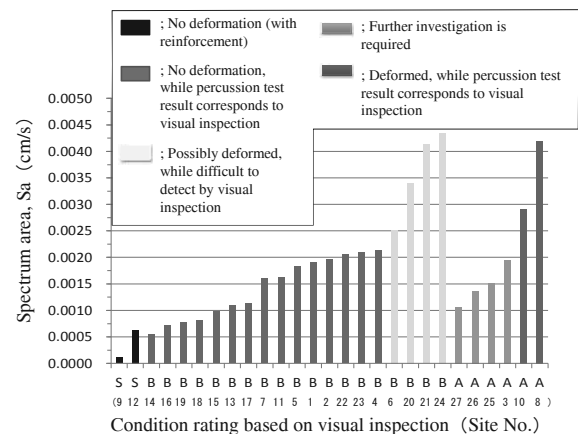
Figure 6. Relationships between condition rating by visual inspection and value of spectrum area (Leaning type retaining wall)

In the cases of the leaning type retaining wall shown in Figure 6, a good correlation between the result of visually inspected condition rating and the values of spectrum area could not be found. In the sites No. 6, 20, 21 and 24, the values of spectrum area was much larger than the other sites although they were rated as “B (no deformation)”, which might imply that the progress of the deformation at the part in which is difficult to detect by visual inspection (e.g. subsoil, backfill, etc.). On the other hand, at the sites 27, 26, 25 and 3, the values of spectrum area were not necessarily larger than the other sites although they were categorized as “A(deformed)”.

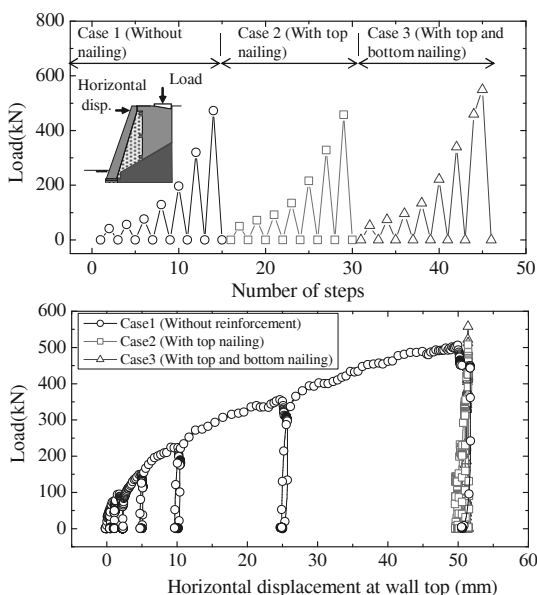
Figure 8. Loading process and load-displacement relationships

of loading process (Case 3). The loading and unloading processes in each case were summarized in Figure 8.

Figure 8 also shows load-displacement relationships obtained from the loadcell installed at the hydraulic jack and displacement transducer at the top of the retaining wall. As clearly shown in Figure 8, the increment of the wall top displacement was drastically reduced by adding the soil nailing although the same amplitude of loading processes were applied to the wall. Displacement increment during a set of loading and unloading processes in Cases 1, 2 and 3 were 50mm, 1.0mm and 0.5 mm respectively.

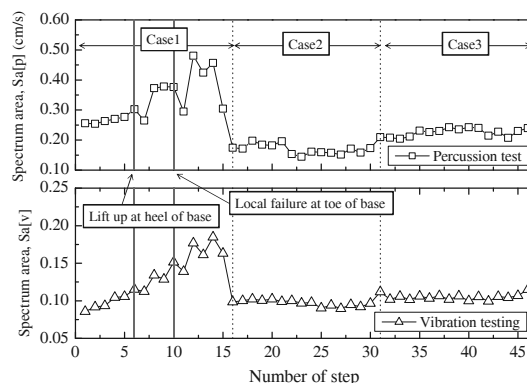
Figure 9. Cross section of model (unit in mm)

Figure 9 shows relationships between the number of step and the results from the percussion test and vibration test, while the values of spectrum area of frequency range of 3 to 40 Hz were plotted in the vertical axes. It should be emphasized that the spectrum area evaluated from the percussion test results Sa[p] has the dimension of velocity (cm/sec) because it was evaluated from the integration of the relationships between the Fourier's amplitude of velocity (cm/sec\*sec) computed from records of the velocity sensor at the top of the wall and the frequency

(1/sec). On the other hand, the spectrum area calculated from the vibration testing Sa[v] did not have any dimensions because it was evaluated from the transfer function of the top accelerometer against the input acceleration.

It was found from Figure 9 that the values of Sa[p] and Sa[v] increased with the number of step. Moreover, the effect of the nailing could be also detected as the reduction of the values of Sa[p] and Sa[v] in Cases 2 and 3 as compared with Case 1. The difference between Sa[p] and Sa[v] could be found especially in loading and unloading process. The values of Sa[v] increased in the loading process and reduced in the unloading process, which indicated that the spectrum area Sa[v] based condition rating using the vibration testing with the small scale exciter could detect a minor change of the stability of the retaining wall. The value of Sa[p], however, could not detect a minor change during single loading and unloading process, which was possibly because the input force could not be kept constant. It was found from the results of the site tests and prototype scale loading test that the percussion test and the vibration testing could be applicable, while vibration testing could detect a minor change of the stability of the retaining wall.
