Full-Scale Field Monitoring of a Rainfall-Induced Sliding Slope in Hainan, China

Li A.G., Qiu J.J., Mo J.F., Gao W.

Shenzhen Geotechnical Investigation & Surveying Institute Co. Ltd., Shenzhen, China

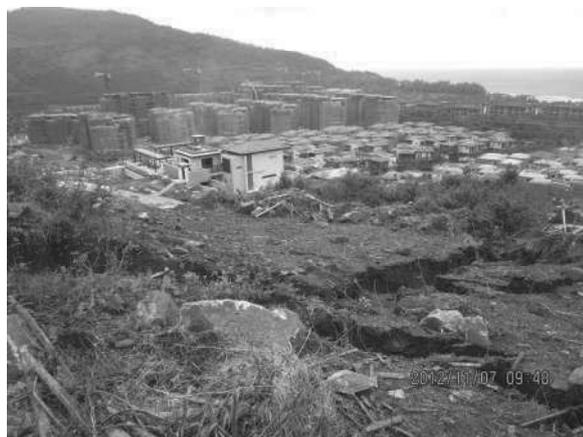
Figure 5. Failure of the sliding slope during a heavy rainfall on November 4, 2012.

There are several rows of piles needed to be constructed during the stabilization and furthermore, there are a lot of excavations before the stabilization. Though many warning letters had been issued to the Contractor by the Consultant, before the completion of the stabilization works, due to a heavy rainfall on November 4, part of the sliding slope had completely collapsed, which caused the fifth landslide for the site.

The investigation of the fifth landslides was carried out later. It was found that the main reason for the landslide was the improper excavation. Some of the excavation has an angle of 45° to 50°. As the Contractor believed that the wet season would end and there would be no heavy rainfall in November 2012 just as in November 2011, improper excavation was carried out for the sliding slope.

Another very important reason for the failure of the improper excavated sliding slope may be due to the significant increase of the volumetric water content and the dramatic decrease of the matric suction of the sliding slope. It may be proved that negative pore-water pressure (or matric suction) plays a crucial role in the stability of unsaturated soil slope. With rainfall infiltration, the matric suction in soils at shallow depth would partially or completely disappear. Consequently, a slope failure may occur.
