# Landslide stabilization by piles: A case history

Şengör M.Y.

**ABSTRACT:** During the foundation excavation of an industrial plant in Eskişehir, Turkey, a landslide occurred in the neighbouring slope, and consequently, the excavation had to be stopped. The instability occurred in a natural slope which had an average slope angle of 9-13 degrees. The aerial extent of the slide mass was 400 m by 115 m. The material in the slope was 7 to 20 meter-thick colluvium (slide debris), which constitutes a historic landslide mass, underlain by a gravelly sandy silty clay matrix containing limestone blocks, weathered tuff and tuff. Soil profile and location of the slip surface were determined through a site investigation program including nine boreholes and inclinometers. A back analysis was carried out and shear strength parameters of the slope forming materials were determined. Slope stability analyses were carried out, stabilization alternatives were evaluated and slope stabilization by piled retaining walls was considered as the most feasible alternative. The analyses and design procedure for the piles will be presented together with a summary of existing analyses and design methods for

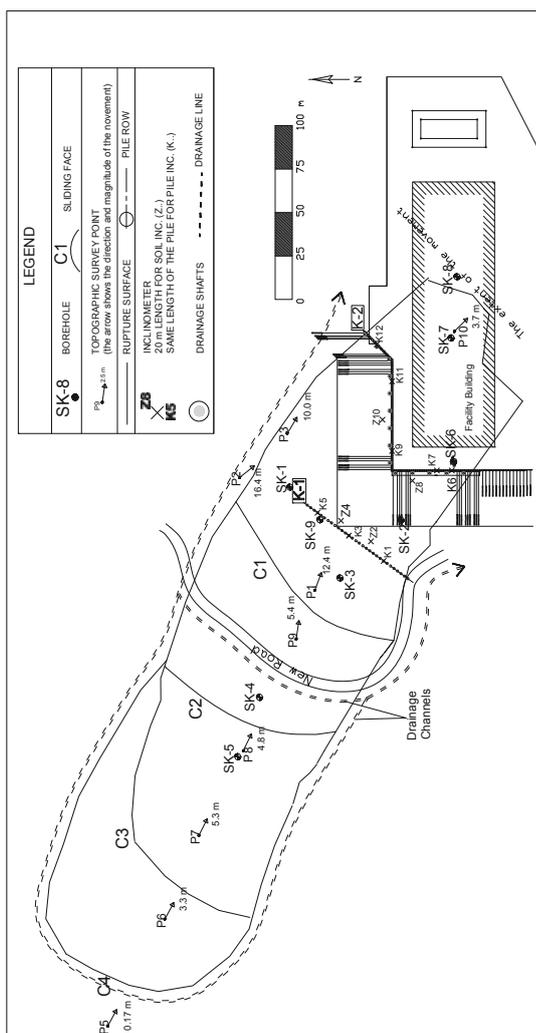
Figure 1. General layout plan

Instability occurred in a natural slope which had an average slope angle of 9-13 degrees, during excavation works near the toe. The aerial extent of the slide mass was 400 m by 115 m. The construction site was located at the toe of this sliding mass (Figure 1). The slope movement had a NW-SE direction. The material in the slope was 7 to 20 meter-thick colluvium (slide debris), which constitutes a historic landslide mass, underlain by gravelly sandy silty clay layers with limestone blocks, weathered tuff and unweathered tuff at different borehole locations. The colluvium was also composed of pieces of limestone cobbles and blocks in a clayey silty matrix.

In this stabilization program, one row of stabilizing piles are placed at an upper level (Pile Row K1 in Figure 1). The lower row of piles (Pile Row K2 in Figure 1) will also have a function of retaining wall for the facility. To decrease the moment and the displacements of the piles in this second row, permanent ground anchorages were planned at the top beam of the piles.

The place of the two rows of the stabilizing piles is shown in the plan view in Figure 1. In the analyses the construction stages were excavations for stabilization, the construction of the piles and the foundation excavations to the 1095 m elevation just in front of the K2 Pile Row. For the drained analyses of the K1 pile row it was found that the pile head displacement as 18 cm, the shear force as 468 kN/m and the bending moment as 1240 kN.m/m. The same values for the K2 pile row were 10.8 cm, 387 kN/m and 970 kN.m/m, respectively.

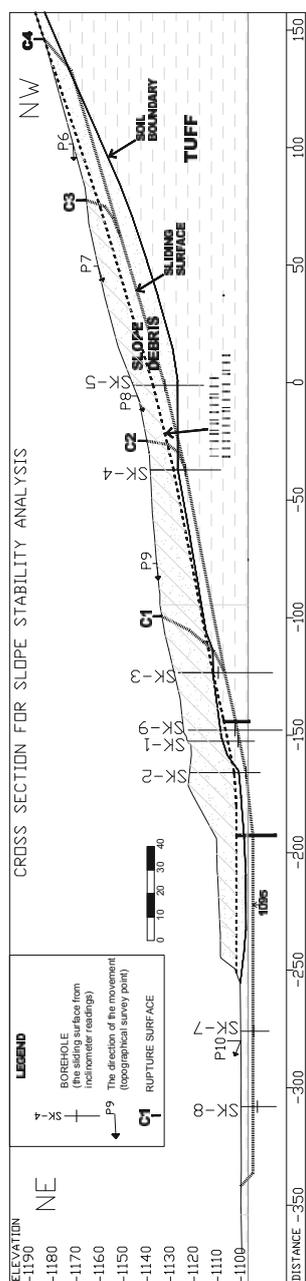
Figure 2. Cross section for the analyses

In all boreholes inclinometer readings were taken, and the depth of the slip has been determined. As it is a fast movement, all inclinometer pipes were sheared by the landslide (except SK-3 and SK-8) shortly after they are placed. These depths were considered as the depth of the slip surface. The cross section of the landslide were prepared according to the borehole data and inclinometer readings and the scarps of the progressive slips. The positions of the slope debris and tuff layers and also the scarps of the progressive failure slides are shown in Figure 2. The shear surface passes mostly through the colluvium material in the upper half of the sliding mass, whereas it passes near the contact between the colluvium and tuff (more within the tuff) in the lower half of the sliding mass. There was no groundwater level, however in stability analysis to be on the safe side some water level is considered.

As a result of the preliminary works it is understood that the diameter of the stabilizing passive piles should be 1.2 m and more than single pile row would be needed. The depth of the sliding mass was 20 m at the centerline. It was not possible to stabilize this amount of soil mass by two rows of piles only. So stabilizing excavations were needed to decrease the amount of sliding mass (about half of the sliding depth was removed-see Figure 2), and then the following piled analyses were performed.

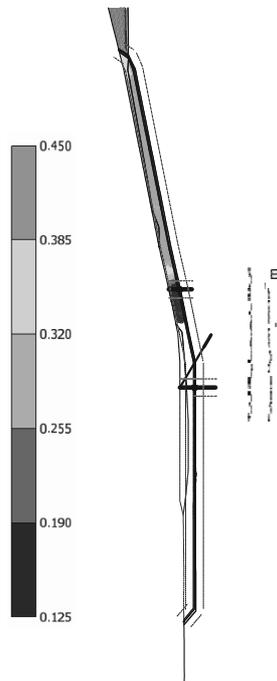
Figure 3. Total displacements plot of FE analysis

The most critical issue in the analyses were the excavation works for the foundation of the facility which would be performed after the stabilizing works were completed. Because of the excavations just behind the second row of the piles, the pile displacements and the moments were increasing for both row of piles. This critical concept was best configured in 2D finite element analyses (figure 3).

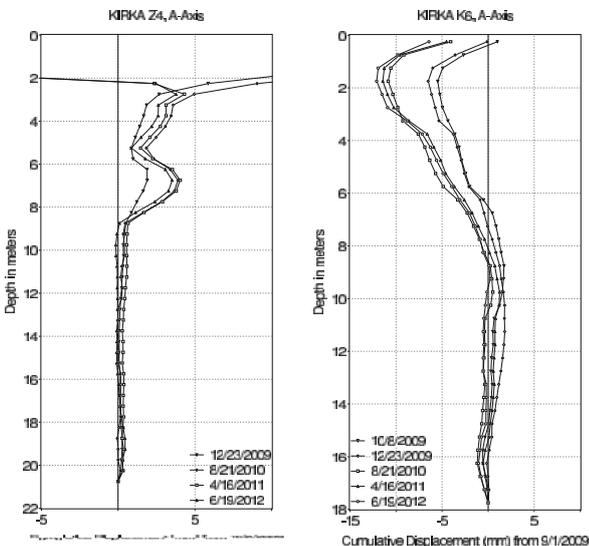
Figure 4. Cumulative displacements (mm) at Z4 (soil) and K6 (pile) inclinometers

The deformations of the system are controlled by the 12 inclinometers (8 in the soil, 4 in the piles) at each stage of the construction works. There are no displacements in three years (Figure 4).
