Study on field detection and monitoring of slope instability by measuring tilting motion on the slope surface

Wang L., Nishie S., Seko I.
Chuo Kaihatsu Corporation, Tokyo, Japan

Uchimura T.
University of Tokyo, Japan

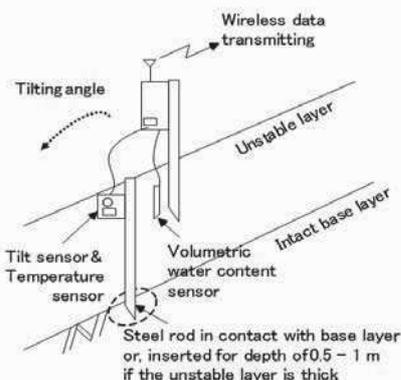
Figure 1. Wireless tilt sensor unit with water content sensor.

A simple and low-cost early warning sensor unit was developed that only two parameters of the volumetric water content of soil and the inclination of slope or landslide were focused, and its applicability and effectiveness were tested on model slopes under artificial heavy rainfall (Uchimura et al. 2009). The sensor unit works with batteries, and transfers real time data via wireless network, and installation is simple and easily to control so that non-expert residents in risk area can handle it by themselves, even in developing countries. Figure 1 shows the basic concept of the wireless monitoring unit using for early warning system.

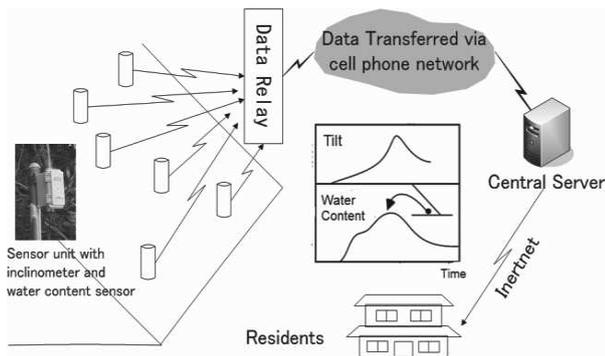
Figure 2. Outline of wireless monitoring units and early warning system for slope failure.

Figure 2 shows the outline of wireless monitoring and early warning system for slope failure. The system is designed to be wireless, that is, each unit works autonomously with

solar cells. Radio modems operated in the 429 MHz ISM band for Japan, 434 MHz ISM band for E.U. countries and China.

The sensor units measure the condition of the slope periodically every 10 minutes for example. The data is transferred to a gateway unit, which is also placed near the slope, by using low power radio communication modules. The data transmitting distance is 300-600 meters under typical conditions in the field. The gateway unit collects the data from all the sensor units, and sends them to a data server on internet through a mobile phone network. Thus, the data can be browsed anywhere and anytime on web site. The data is processed by the server, and any abnormal phenomena of the slope can be detected and used for a precaution of failure, and then issue an evacuation warning.

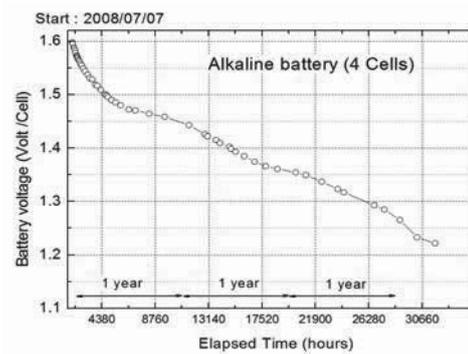
Figure 3. Sensor unit long-term power consumption test.

A long-term sensor unit power consumption test (not include Micro SD) was started on July 7, 2008, the interval time of data sampling and transmit was 10 minutes. 4 cells alkaline batteries were installed in the test sensor unit. Figure 3 shows the relation of battery voltage and elapsed time, the test unit has been worked for 3.5 years.

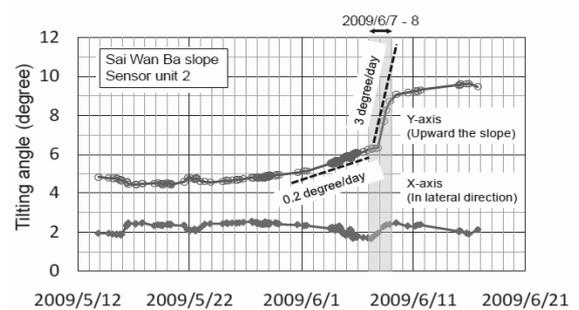
Figure 5. Time history of tilting angle & precipitation by sensor unit 2.

The time histories of the tilting angles in X-axis and Y-axis, the volumetric water content at a depth of 30 cm on the ground surface, and the record of precipitation are shown in Figure 5 and Figure 6 respectively.

A consecutive movement of a sliding block shown in Figure 5 was observed for a long period. A quick movement of tilt sensor was detected at a heavy rainfall event on June 6-7, 2009; a large scale of landslide disaster nearby observation point 2

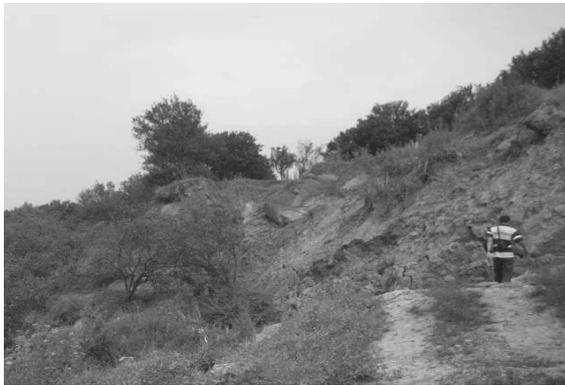
Figure 7. New landslide on June 7, 2009.

was happened on 8 June shown in Figure 7, and this landslide disaster caused the slope of observation point 2 inclined gradually at the same time. As a result, there was almost two day for taking refuge before the landslide happened.

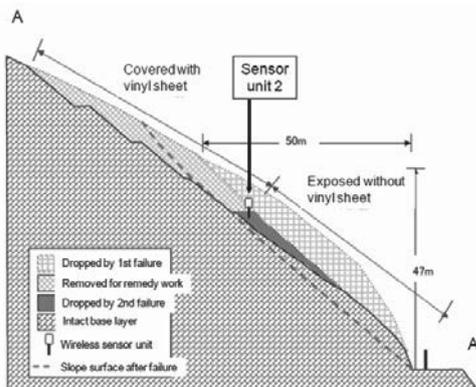
Figure 8. Sketch of failed slope along highway

Another field detection result of a slope failure site along a national road in Kyushu of Japan is shown in Figure 8. This slope consists of strongly weathered granite, and it was failed due to a heavy rainfall in July of 2009. The slope was excavated to have a gradient of 45 degrees for disaster relief work, and was monitored with three sensor units. Heavy rainfall caused a second failure, and a local part of slope including the sensor unit fallen down. Figure 9 shows the records of tilt sensor of the unit, in directions toward and laterals to the slope, respectively. Specially, the tilting in Y-axis (lateral direction) showed

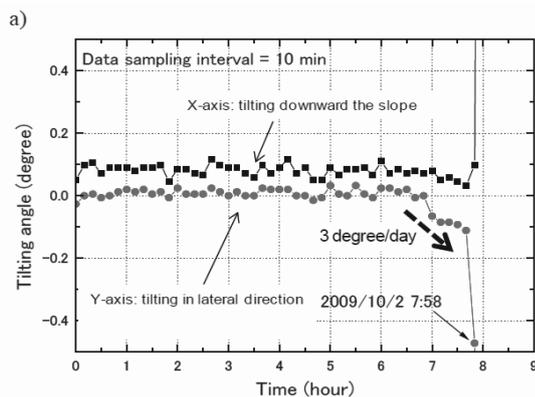
Figure 9. Tilt angle change just before the second failure.

extraordinary behaviors 50 minutes before the second failure.

Its tilting rate was around 3 degrees per day (0.12 degrees per hour). As this second failure took place adjacent to the location of the sensor unit 2, the behaviors of the slope before and after the failure was detected by the monitoring system. The site manager got aware of the extraordinary behaviors of the data from sensor unit 2, and he stopped the disaster relief work and the road service to avoid large loss successfully.

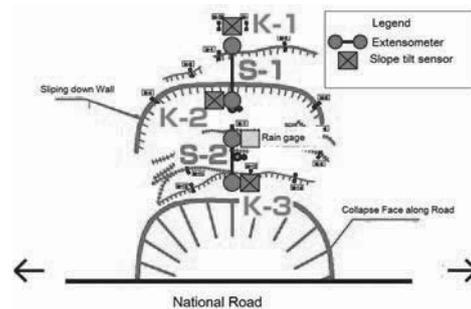
Figure 10. A field site of failed slope along national road in Japan

Another in-site measurement results were showed in Figure 10 to Figure 11a-e, a heavy rainfall on July 2011 caused a slope failure along local national road in Kyushu of Japan.

slope failure site. For validating developed tilt sensor with field extensometers data, the three tilt sensors were installed nearby

fixed pole of extensometers moving point shown in Figure 10. In this field site, other 4 boring surveys have been carried out and multiple borehole inclinometers were installed, two of the tilt sensors (K-2, 3) were just set up nearby the survey boring holes. According to the result of boring survey, a landslide slip surface, which depth was 17m, was found shown in Figure 12.

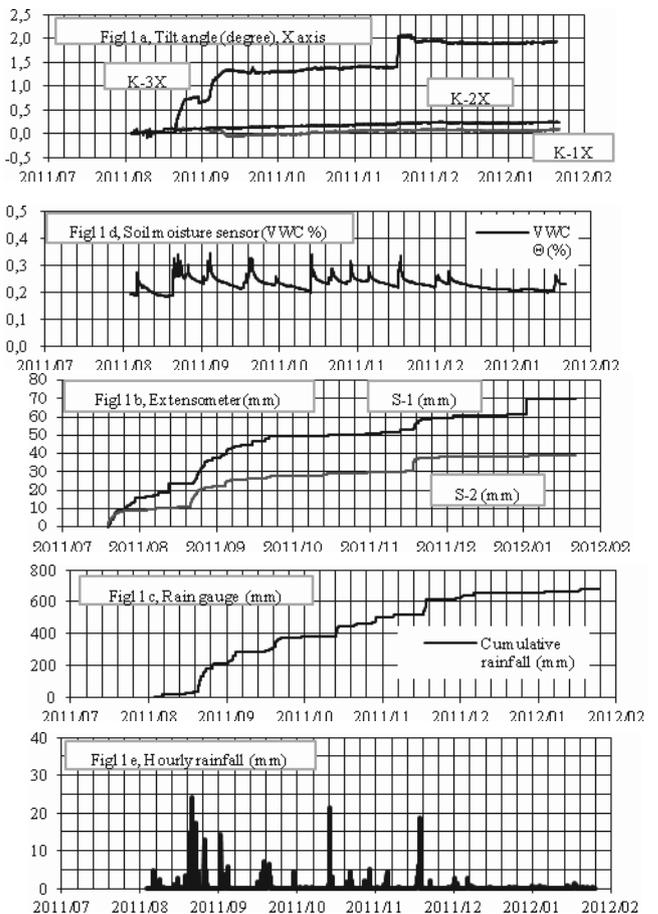
Figure 11. Time histories vs. measuring values.

Figure 10a-b show the time histories of tilt sensor inclination along extensometer wire direction (tilt sensor x axis) and the extensometer movement(S-1, S-2), Figure 10c shows the result of cumulative rainfall value by rain gauge. Figure 10d shows the result of volume water content by FCH2O water content

The normal case, the fix pole of tilt sensor was inserted into earth of slope surface at the depth of 1.0 meter, so that the inclination of tilt sensor means average movement of the slope surface. The inclinations of tilt sensors especially tilt sensor K-3, and movement of extensometers were increased with rainfall and showed a strong correlation each other based on the results of Figure 10a-e.

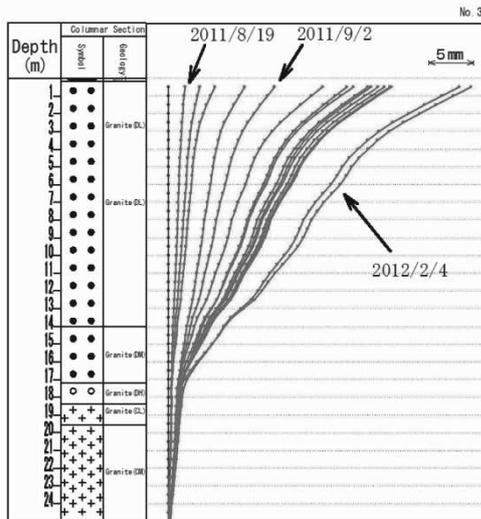
Figure 12. The result of multiple borehole inclinometers.

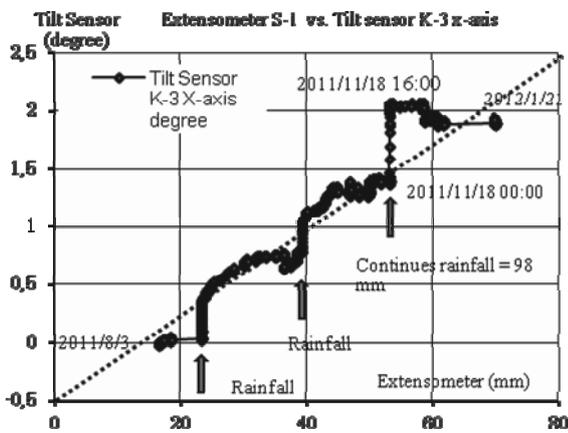
Figure 13. The relation of slope movement vs. tilt angle.

Figure 13 shows the relation of slope movement (mm) by extensometer(S-1) vs. inclination (degree) by tilt sensor (K-3). Based on the result, the almost linear relationship between extensometer and tilt sensor was obtained except for the storms period of August, October and November, 2011.

Another important result is that between heavy rainfall start and landslide initiation, the value of extensometer seems no any change but the tilt sensor inclination has reacted quickly, for example, the heavy rainfall on 18 November 2011, that hourly rainfall reached 20mm and continues rainfall reached 96mm, run continuously for 16 hours, during this period, the inclination of tilt sensor was increased but the value of extensometer

showed no any change (Figure 13). The tilt sensor measures a local change of slope surface, and the extensometer measures a whole movement of slope failure or landslide. The failure of slope starts from local and enlarges to whole area usually, so that this result should be considered as an important slope pre-failure phenomenon, which can let warning system to issue useful information to residents to avoid slope failure or landslide disaster in advance.
