Inspection and Capacity Assessment of Anchored Slopes

Yeh H.n-S., Wang C.-S., Wei C.-Y.
Taiwan Area National Freeway Bureau, MOTC

Lee S.-M., Ho T.-Y., Hsiao C.-A., Tsai L.-S.
CECI Engineering Consultants, Inc., Taiwan

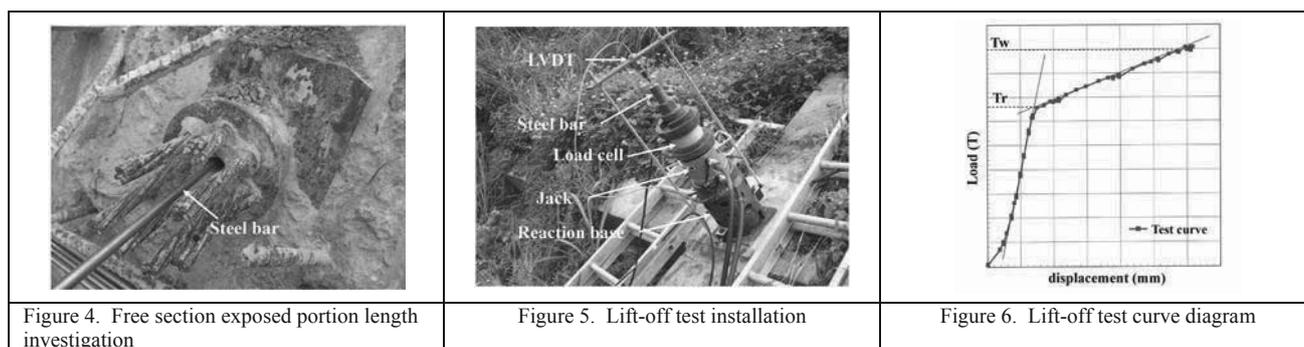
Table 1. Score of anchor capacity assessment

item	scoring	Content of inspection	Weight	subtotal
Exterior inspection	10	Buckled or detached.	0	
		Greater than 2mm separation from bearing plate or water corrosion is severe.	0.25	
		Anchor head protected seat and bearing plate separation is less than 2mm.	0.50	
		Anchor head protected seat surrounded by water seepage, efflorescence or anchor seat outside is slightly damaged or water corrosive level is moderate.	0.75	
		No observable anomalies or water quality is normal.	1.0	
Anchor head assembly inspection	15	Assembly came apart(clamp became loosened, steel tendon shrinkage or broken)	0	
		Anchor head surface appeared rusted and cracked, spread over 50% of the surface, steel tendon section is deformed due to corrosion.	0.25	
		Anchor head surface appeared rusted and cracked, but spread less than 50% of the surface.	0.50	
		Slightly corroded or water seepage. Anchor head appeared rusted, but the depth of the rust is quite thin, not measurable or lesser than 0.1mm.	0.75

No corrosion or water seepage is present.	1.0	
Endoscopy inspection	30	Steel tendon broken or steel threads became loosened and completely rusted.	0	
		Steel tendon appeared dark brownish, the surface already appeared corral-like or lumpy or rusted surface spread over 90%.	0.15	
		Steel tendon appeared dark brownish, the surface is rough, but not appearing corral-like or lumpy or rusted surface is between 50~90%.	0.45	
		Steel tendon appeared light brownish, but the surface is smooth and shining or rusted surface is between 10~50%.	0.75	
		No anomaly presence or rusted surface is below 10%.	1.0	
lift-off test	45	Detached, steel tendon broken or $Tr=0$.	0	
		$Tr > 1.2Tw$ or $Tr \leq 0.2Tw$	0.33	
		$0.2Tw < Tr \leq 0.5Tw$	0.67	
		$0.5Tw < Tr \leq 0.8Tw$	0.75	
		$0.8Tw < Tr \leq 1.2Tw$	1.0	
Single ground anchor capacity assessment(β)				
Total score of anchor capacity assessment(α)

inspection, endoscopy inspection and lift-off test. The findings based on Table 1 distribution is point based. The total score will then be carried to Table 2 to evaluate (β) and classification. Sloped terrain performance and ground anchoring total capacity shall be classified based on Table 2 standards. Ground anchoring total performance assessment classified as A or B grade, respectively, will be given corresponding effective rehabilitation to ensure the full and reliable capacity of the ground anchors.
