# Dynamic Pile Testing at the Mesa A Rail Bridge

Cannon J.G.

**ABSTRACT:** The paper will describe high strain and low strain dynamic pile testing that was used to assess the foundations for this bridge and how the results led to an innovative decision during construction to change from a bored pile foundation to a driven pile foundation. The revised construction used minimal extra equipment and materials. The foundations originally comprised permanently cased bored piles socketed into rock. Dynamic pile testing identified significant problems with the concrete early in the project. A number of attempts were made to correct the problems but to no avail. In addition, the down-the-hole hammer system being used to install the casings was causing delays. The steel tube casings being used were substantial and a large hydraulic piling hammer was on site for dynamic testing. A decision was made to drive the casings into soft rock far enough to generate the required compression and tension resistance and to delete the concrete sockets. Dynamic pile testing was used to verify that the required resistances were achieved.

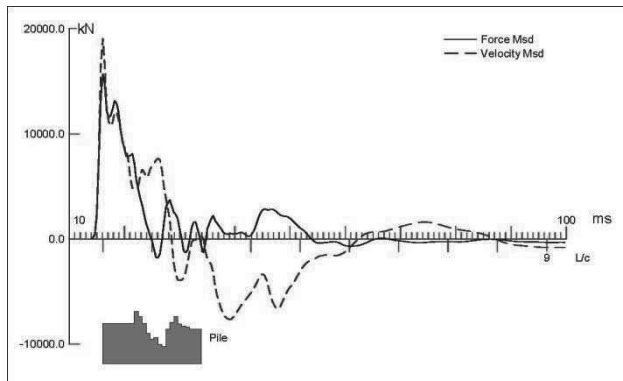
Figure 5 - PDA measurements Test Pile 2

Dynamic pile testing was also conducted and confirmed concrete problems. Gauges were attached to the concrete through windows in the steel casing. Results suggested there was a significant defect 15-20m down the shaft. The steel was also not contributing to the pile. Transfer of load by steel to concrete bond seemed unreliable. (Figure 5).
