# Identification of Test Pile Defects in a Super-tall Building Foundation

Poulos H.G., Badelow F.  
*Coffey Geotechnics*

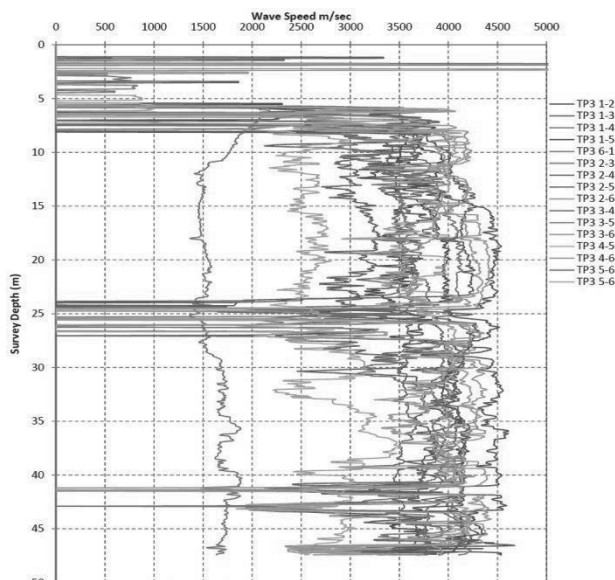
Figure 2 Measured wave speed versus depth along pile

A sonic logging survey was carried out for TP-03 on 28 May 2010, 6 days after concreting of the pile was completed. An assessment of the survey results could not be carried out using the standard sonic report sheets as poor correlation was observed with apparent changes in wave velocity (“artefacts”) associated with subsequent observations of irregular pipe spacing, poor pipe verticality and possible de-bonding. The summary wave trace files were therefore obtained from the testing sub-contractor and are summarized in Figure 2, which indicates the large range in wave speed measured and variation thereof over short and long depth intervals.
