# Cavity remediation for pylon foundation of the Transrhmel Viaduct in Constantine

Steenfelt J.S., Schunk M.  
COWI A/S, Denmark

**ABSTRACT:** The geology of Constantine, Algeria is highly influenced by previous seismic activities and the erosional feature by the river Rhumel. The Transrhmel Viaduct is a new river crossing featuring a 749 m long cable stayed bridge with a main span of 259 m and 80 m clearance. The soil/rock deposits are dominated by Marls of different strength underlain by Marlstone and very competent Limestone. However, exploratory boreholes for the foundation piles of Pylon P4 indicated the presence of possible cavities of up to 1 m high within the Limestone at the base of the upper weathered zone. To save 15 m of time consuming drilling of the 14 Ø2 m foundation piles into competent Limestone it was decided to end the foundation piles above the possible cavity feature in the Marlstone. The paper describes the innovative remedial measures carried out to safeguard the capacity of the individual foundation piles and ensure acceptable individual and overall displacements. The cavity feature was pressure grouted and transfer of axial load across the cavity into Lim

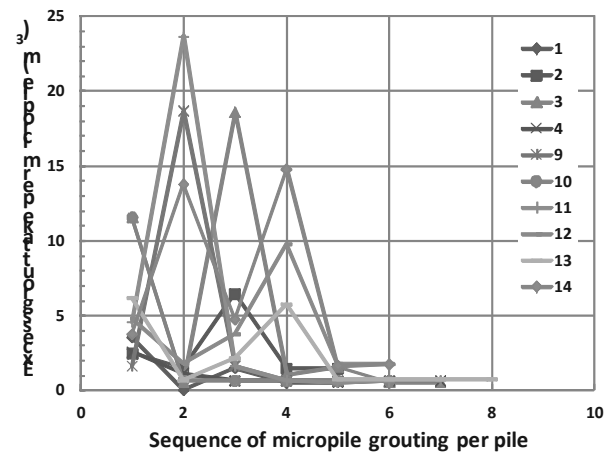
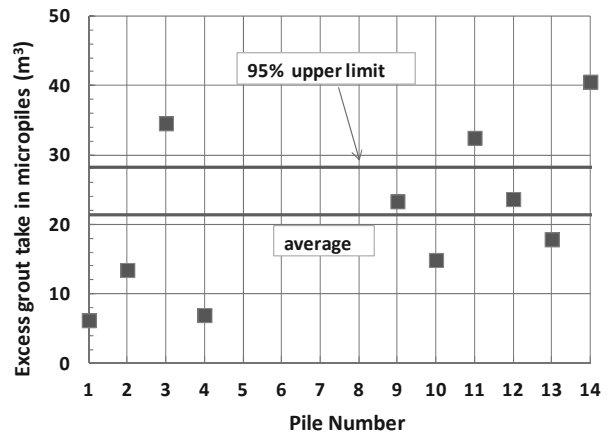
As the Ø178 mm holes were re-drilled it seems likely that actual nominal consumption would be 115% of the theoretical consumption. Using this as baseline the excess grout take from the five reinforcement-holes below each of the ten Ø2000 mm piles are shown in Figure 6. In some cases re-grouting of the holes took place and hence a sequence number in excess of five occurs for some of the piles.

Although there is considerable scatter the excess grout take decreases by and large as a function of the sequence as would be expected as any cavity feature will be more readily filled during the initial grouting. Piles 3, 9, 11, 12 and 14 show grout take above average which is interpreted as a more persistent cavity feature at these locations.

Figure 6. Excess grout take in "micropile" holes; (a) as function of sequence (2-6 weeks from grouting of fist to last pile); (b) accumulated values per pile location

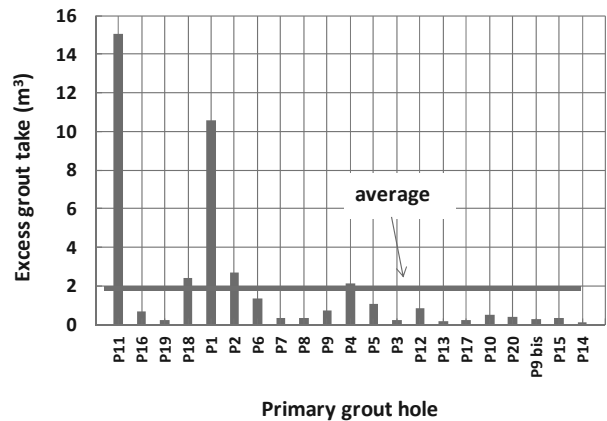
Figure 7. Excess grout take versus sequence for primary grout holes

The actual sequence of the subsequent pressure grouting in primary (Figure 7) and secondary (Figure 8) deviated slightly from the sequence in Figure 5 but followed the principal intent. The theoretical grout take was based on the nominal drilling diameters but with reference to the considerations for the piles and pre-drilling holes this may entail some 15% underestimation of take.

As seen in Figure 7 and Figure 8 the excess grout take was very limited in the majority of holes.

The excessive grout takes over the average value are by and large concentrated in areas where a cavity feature had already been indicated by the "micropile" grouting. Furthermore, it is clear that the grout take during primary grouting ( $1.9 \text{ m}^3 \pm 3.8 \text{ m}^3$ ) compared to the secondary grouting ( $1.1 \text{ m}^3 \pm 2.6 \text{ m}^3$ ) is an indirect confirmation of the success of the grouting scheme.

Excluding the seven values exceeding the average value the excess grout take is  $0.6 \text{ m}^3 \pm 0.5 \text{ m}^3$  for primary and  $0.4 \text{ m}^3 \pm 0.3 \text{ m}^3$  for secondary grout holes compared to the minimum theoretical grout take of  $0.5 \text{ m}^3$ .

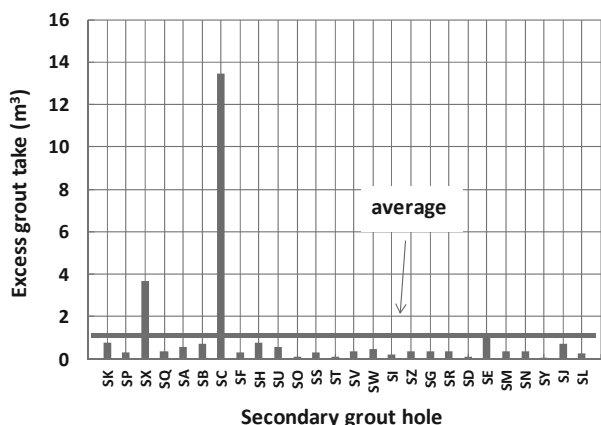
Figure 8. Excess grout take versus sequence for secondary grout holes

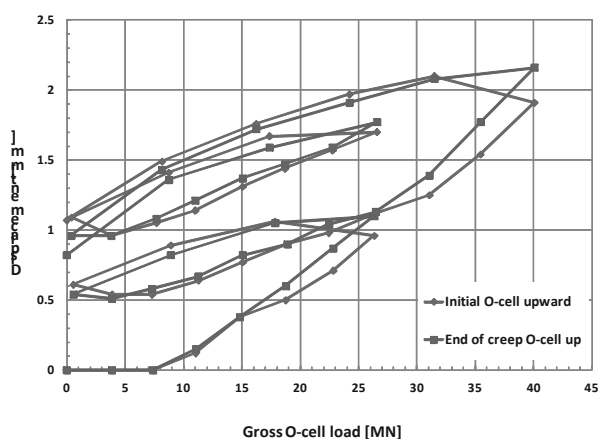
Figure 12. Displacement of upper O-cell plate versus applied upward gross O-cell load

Considering, that the major part of the load below the O-cells is taken by toe bearing the creep rate is acceptably low. The corresponding creep rates for the top plate of the O-cells are an order of magnitude smaller and hence insignificant.

The load-displacement curve for the upward O-cell displacement is shown in Figure 12. The upwards displacements are significantly less than the downward displacements (Figure 11) and they are only initiated at an O-cell load of 7 MN after which the load-displacement curve is essentially linear. It is apparent that shaft stresses are locked into the system at unloading resulting in a non-recoverable displacement of approximately 1 mm after unloading from the gross O-cell load of 40.1 MN (net load 38.8 MN after subtraction of pile weight).

The maximum toe and shaft design loads for pile P4/3 are 4.5 to 4.9 MN and 21.0 to 26.5 MN, respectively. The range reflects upper and lower bound soil stratification and soil spring assumptions. As seen from Figure 11 and Figure 12 the load test indicates much higher values even within near elastic load-displacement behaviour.

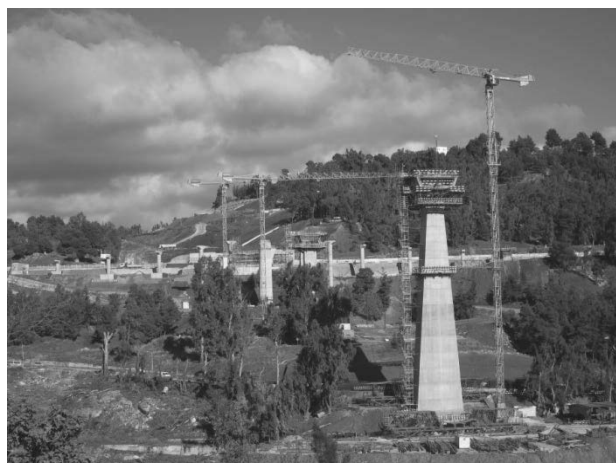
Based on the thorough investigation of the cavity feature and the closely monitored remediation work it was possible to successfully conclude the foundation works for the Pylon P4 and start the casting of the Pylon as seen in Figure 15.

Figure 15. Status of P4 construction December 2012
