# Geotechnical Assessment for the Restoration of Garandoya tumulus with the Naked Stone Chamber

Mimura M.

Yoshimura M.

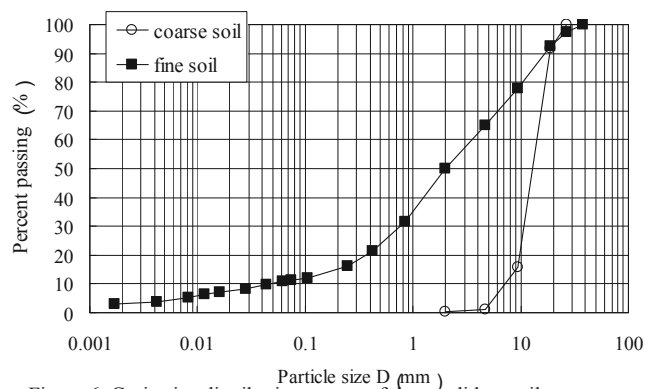
Figure 6 Grain size distribution curves of the candidate soils

The soil with which the present experiment is conducted is the candidate material of the tumulus restoration that is the graded grain material extracted from the quarry in the proximity of the tumulus. The coarse gravel is also extracted from the same quarry. The particle size distribution of the materials is shown in Figure 6. The candidate material is a well-graded sandy soil. The initial water content of soil was adjusted as natural water
