# Analysis of ettringite attack to stabilized railway bases and embankments

Ramon A.

Alonso E.E.

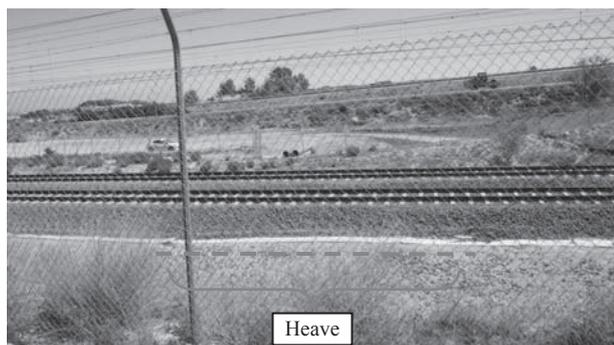
Topographic levelling of the caisson didn't show any vertical displacement of the structure. This indicated that the vertical displacements measured at the rail tracks were a result of the behaviour of the material placed above the concrete caisson. A convex surface, centred in the caisson axis, was also visible in the field (Figure 5). In addition, the thickness of the ballast layer was noticeably lower in the bulging area, because of the necessary periodic ballast thickness correction. Two high precision ( $\pm 0.003$  mm/m) vertical continuous extensometers (SL-1 and SL-2), 10 m long, were installed in boreholes located in the caisson backfill material, close to the concrete structure. Both extensometers recorded the development of vertical strains at both backfills within the upper 4 m (Figure 6 and Figure 7). A maximum heave rate of 1.33 mm/month was measured between 17<sup>th</sup>, February 2012 and 19<sup>th</sup>, April 2012. A heave rate of 0.91 mm/month was recorded during the same period at the same depths in the other backfill (SL-2).

Figure 5. Bulge of the surface above the caisson. Observe the reduced thickness of the ballast layer

The solution of the heave problem above the caisson requires the removal of the cement treated layer and its substitution by a stable compacted granular material. This operation will not impair the circulation of trains.
