Physical modeling of slope failure during slope cutting work

K. Itoh, S. Timpong & Y. Toyosawa

National Institute of Occupational Safety and Health, Tokyo, Japan

Keywords: Centrifuge model test, field test, slope cutting, slope failure

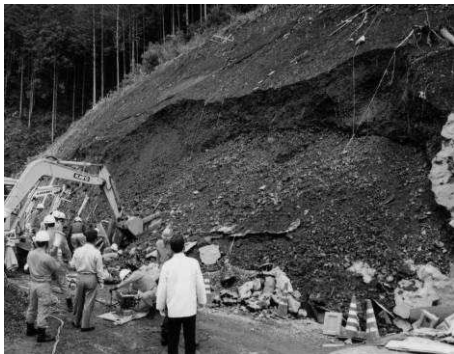
Figure 1 Typical example of labor accident during slope cutting works

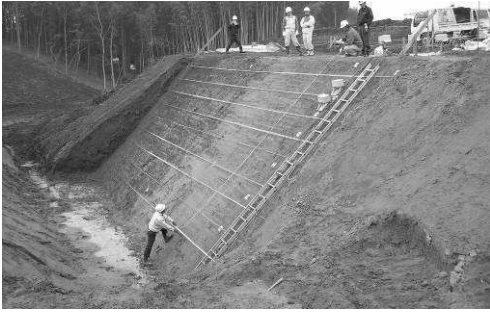
Figure 2 Field test setup

In the field tests, full-scale model slopes were prepared by placing Narita sand on natural ground (Kanto loam), where the average height of each filled layer was about 0.5 m with the inclination of about 1:1.5 (33°). In case of the model slope with loose ground condition (Case-F1), additional compaction was not applied to each filled layer. However, for the model slope with dense ground condition (Case-F2), each filled layer was compacted by five passes of a small bulldozer (7-ton, with a bearing pressure of 25.5kPa). The final shape of the full-scale model slope was trimmed by a backhoe, in which the height, width and slope angle of each model slope were 5m, 3.5m and 45 degrees, respectively. Figure 2 shows the typical setup of the model slope in the field. In-situ tests were also conducted on the slope to determine the physical properties. Table 1 shows the physical properties of the model slope.

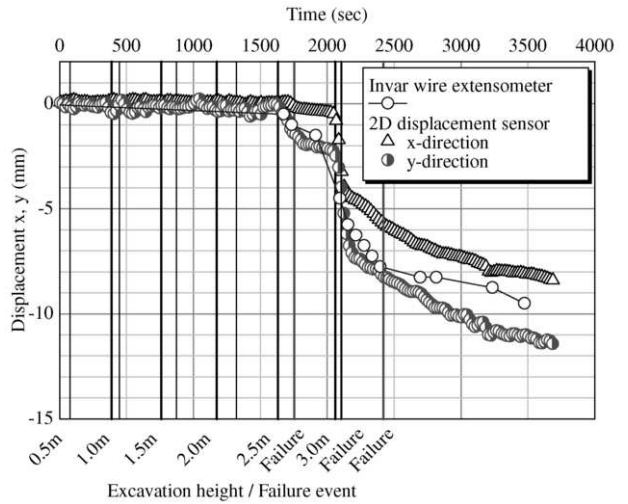
Figure 4 Slope movements in the model slope Case-F1

Figure 4 shows the slope movement with elapsed time measured by the invar wire extensometer and the 2D displacement sensor for the model slope Case-F1 (loose ground). The excavated heights and slope failure events are also indicated in the same figure. Figure 5 shows photographs of the typical slope failure. During the 5th excavation (excavated height of 2.5m), slope movement of about 2mm was detected by the invar wire extensometer and 2D displacement sensor (y-direction), and a local slope failure occurred immediately after the last scoop at the 5th excavation (Fig. 5(a)). Thereafter, gradual movement of the slope was observed by the 2D displacement sensor (x-direction). During the 6th excavation (excavated height of 3.0m), rapid movement was observed in all sensors just before the second slope failure (Fig. 5(b)). The excavation was stopped to observe the collapsed shape, and during this observation the third collapse of the slope occurred as shown in Fig. 5(c).

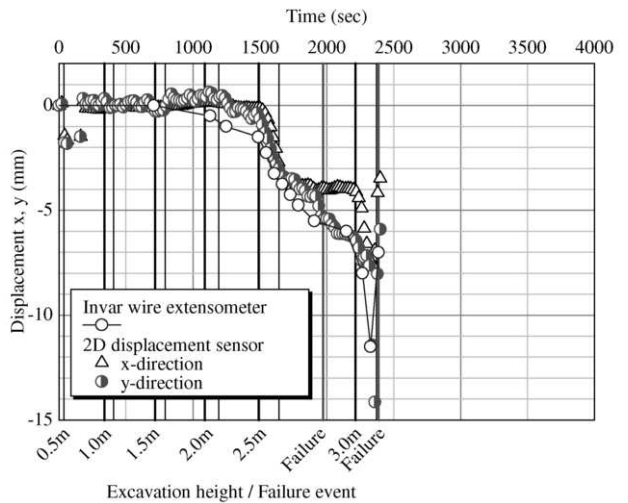
Figure 6 Slope movements in the model slope Case-F2

As shown in Fig. 6, in case of model slope Case-F2 (dense ground), about 3mm of slope displacement was observed at all sensors during the 5th excavation (excavated height of 2.5m). After the excavation, the slope deformation continued to increase and local slope failure was observed as seen in Fig. 7(a). Finally, a large-scale collapse from the slope crest occurred immediately after the 6th excavation was conducted, as seen in Fig. 7(b).

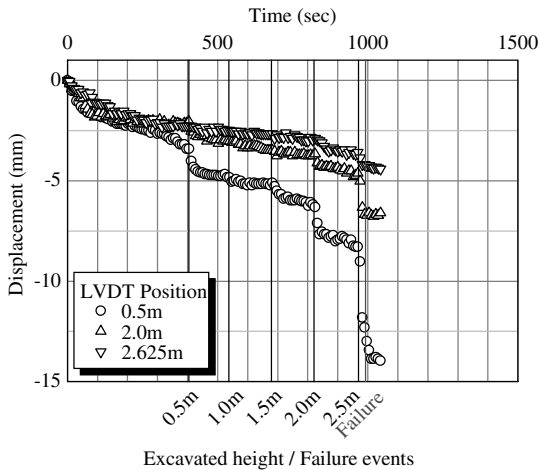
Figure 11 Slope movements in the model slope Case-C2

Figure 11 shows the slope movement with elapsed time for the model slope Case-C2 (dense ground). The displacement gradually increased with the increase of excavated height. It should be noted that a larger increment of displacement was observed at the displacement sensor located near the slope face (0.5m) than those at the other sensors. At the 1st excavation

(excavated height of 0.5m), large displacement was observed at the sensor located near the slope face. It appears that the large displacement was caused by the bedding error of the displacement transducer. The local collapse in the slope occurred immediately after the 5th excavation (excavated height of 2.5m) as shown in Fig. 12. Figure 13 directly compares the measured displacement caused by each step of slope cutting between the field test and the centrifuge model test. In case of model slopes Case-F1 and Case-C1 (loose ground condition), when the excavated height was less than 2m, large displacement was only observed in the centrifuge test and the displacement observed at the collapsing excavation stage in the centrifuge test was about 1.5 times that observed in the field test. This is probably attributed to the difference in the condition of slope failure observed in both tests. On the other hand, in case of model slopes Case-F2 and Case-C2 (dense ground condition), the deformation behavior and condition of slope failure agreed well between the centrifuge model test and the field test as seen in the figure. The difference of the collapse condition and deformation behavior observed in the centrifuge model test and full-scale slope model test in the field test was probably due to many factors, such as the difference in compaction density, water content, boundary condition in both tests and the scale effect of the soil particle size presented in the centrifuge model test. Further research considering all of these factors may be needed in order to attain a better simulation of the field test using the centrifuge modeling technique.

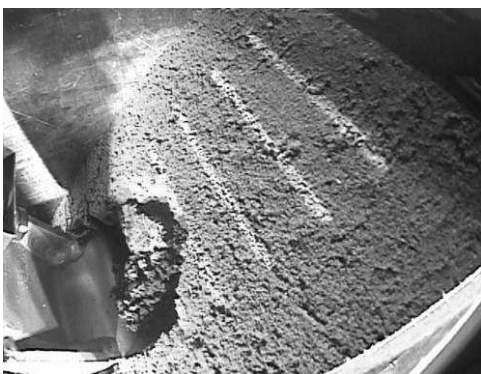
Figure 12 Slope failure event in the model slope Case-C2

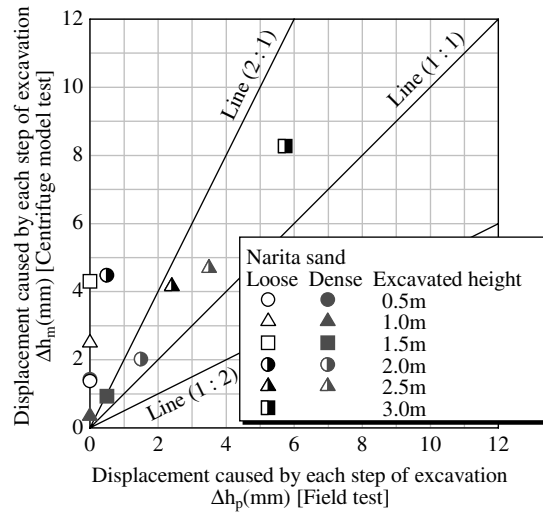
Figure 13 Direct comparison of the measured displacement caused by each step of slope cutting in the field test and centrifuge model test
