# Assessment of field stabilization methods to prevent recurring surficial failures

A. J. Puppala

University of Texas at Arlington, USA

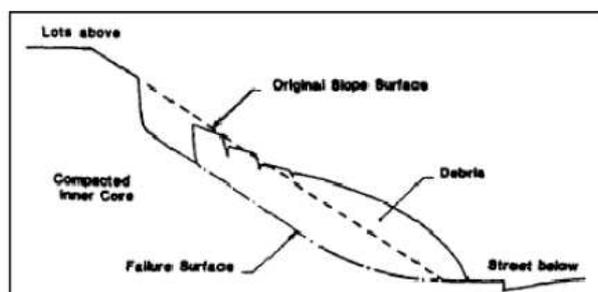
Figure 1. A Sectional view of a surficial failure (Day, 1996).

Surficial failures are shallow slope failures with an average depth of failure ranging from 0.30 m to 1.20 m and in many cases the failure surface is parallel to slope face (Day, 1996). One of the predominant causes of these failures has been observed to be desiccation cracking followed by rainfall events (Dronamraju, 2008). A schematic showing the surficial failure is shown in Figure 1.

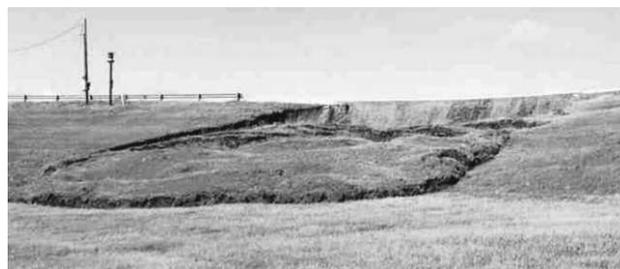
Figure 2. A typical surficial failure at Joe Pool Dam.

Several rolled earthfill dams of the United States Army Corps of Engineers (USACE) experienced numerous surficial failures with repair costs above hundred thousands of dollars (McCleskey, 2005). A typical surficial failure occurred at the Joe Pool Dam, USA is shown in Figure 2.

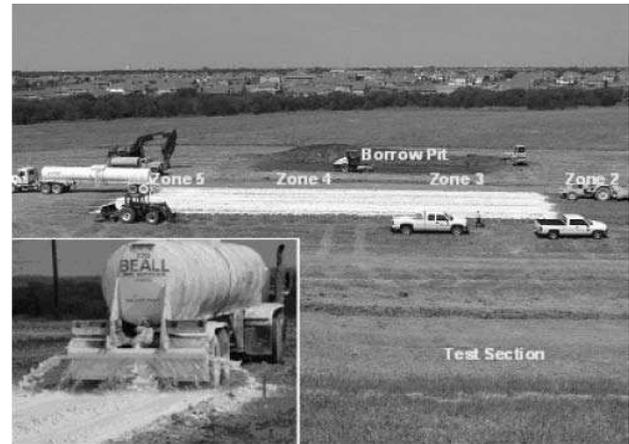
Figure 3. Construction of test sections (view from crest of dam) (Inset: Spreading of lime slurry).

The construction began during September 2007 and completed in three weeks. The slope was mowed and all the vegetation cover was removed. The top soil was initially excavated followed by excavation of the slope soil of the dam. The soil excavated was transported to a level ground called level pad. The soil was spread uniformly on the level pad and pulverized with the help of pulverizers. The soil was divided into five zones. The soil in the zone 1 was earmarked for control section. Zones 2 through 5 are shown in Figure 3 where the soil was mixed with admixtures. Soil in the zone 2 was mixed with 20% compost consisting of wood fibers and yard trimmings. Soil in zone 3 was mixed with 4% lime and soil in zones 4 and 5 was mixed with 8% lime. After mixing the soil with lime with the help of rotary mixer, 0.30% and 0.15% of polypropylene fibers were added to the soil in zones 3 and 4 respectively. The fibers were mixed thoroughly with the soil.

After completing the mixing of admixtures with the soil, the treated soil was transported back to the slope and placed in layers of 23 cm thick and compacted with the help of a sheepsfoot roller. Proper Quality Control and Quality Assurance measures were taken during construction. The soil layers were compacted on wet side of optimum moisture content with a targeted dry density of over 95% of maximum dry density. The desired compacted density and moisture content were achieved by monitoring with nuclear gage. Soil mixed with admixtures was tested for all basic properties in the laboratory and confirmed that the construction was carried out to the desired standards and as per specifications.

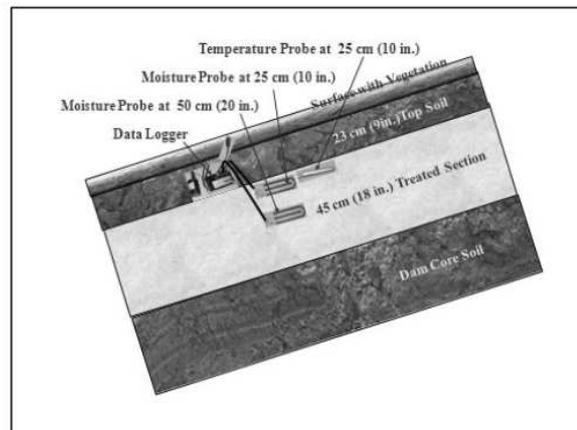
Figure 4. Location of moisture probes and temperature probe.

shown in Figure 4. Two TDT (Time Domain Transmission) type moisture probes were installed at a depth of 25 cm and 50 cm from the surface for each test section to monitor the moisture fluctuations continuously. One temperature probe was installed at a depth of 25 cm from the surface for each test section to monitor the soil temperature continuously. Two vertical inclinometers were installed to a depth of 4 m at each test section to monitor the lateral displacement of test section. In addition, 125 survey pegs were installed at the site to monitor the vertical movement of surface by regularly conducting elevation survey with the help of total station.

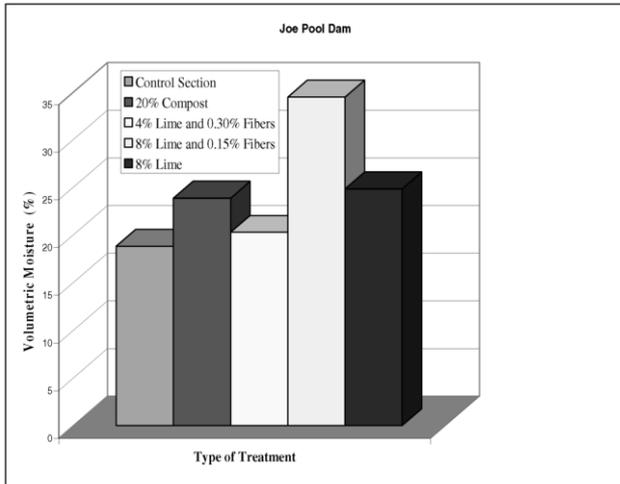
Figure 5. Average annual moisture content of top probe.

The volumetric moisture content recorded by the top and bottom probes for each section was downloaded from the data loggers to a laptop at regular intervals. The data was analyzed typically to see the response of treated sections to various weather conditions and compared with the performance of the control section. During the period of observation there was a total annual rainfall of 89 cm against the average annual rainfall of 94 cm for Dallas, Texas. The average ambient temperature varied from 10° C to 27° C. The average annual volumetric moisture content of each treated section for top probe located at a depth of 25 cm from the surface is shown in Figure 5.

It can be seen that the treated sections hold higher moisture content than the control section. Compost and polypropylene fibers are hydrophilic in nature and hence absorbed higher moisture content than the control section. Of all the sections, 8% lime with 0.15% fiber section is found to be holding higher moisture content than the other sections.

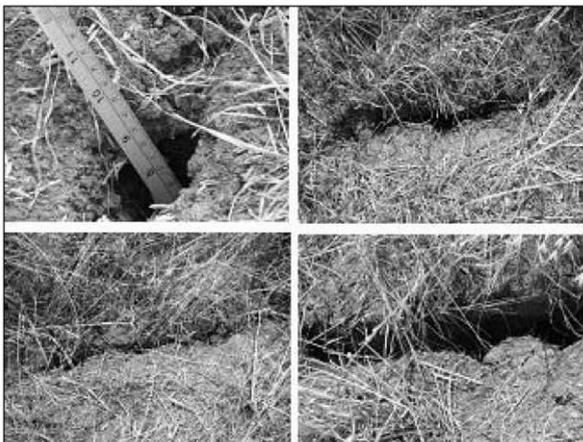
Figure 6. Desiccation cracks along construction joint.

Prominent cracks were noticed along the construction joint at the top of test sections as shown in Figure 6.

A number of desiccation cracks were noticed on the surface in the control section and fewer cracks were noticed on the compost section. However, the cracks appeared along the construction joint were wider in compost section. Digital image analysis showed that the percentage of desiccation cracking in control and compost section excluding the crack at construction joint was 0.20% and 0.03% respectively. There were no signs of any distress in the other three sections which were treated with lime and polypropylene fibers. No other kind of failure of any test section was noticed during the period of monitoring.

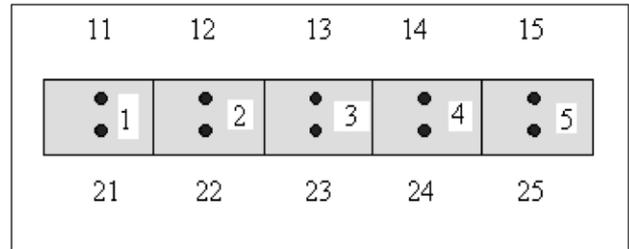
Figure 7. Notation used for inclinometers

Two vertical inclinometers were installed for each test section and the notation used is indicated in Figure 7.

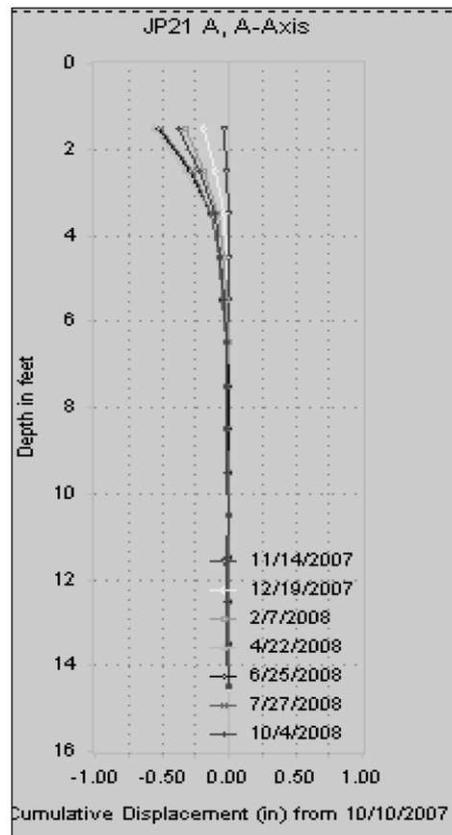
Figure 8. Inclinometer profile for control section.

Sections 1 to 5 are in the same order as shown in Figure 5. The vertical profile of the inclinometer casing was regularly recorded with the help of inclinometer probe at every 30 cm interval. The profile recorded for control section is shown in Figure 8 for the inclinometer installed at the bottom of test section. The cumulative displacement shown is with respect to the initial observations of 10/10/2007. The profile indicates that there is a lateral movement of the control section. The profile of other treated sections also showed lateral movement in the direction of slope as indicated in Table 1.
