# A bridge foundation resisting sliding soil mass

A. Szavits Nossan & V. Szavits Nossan  
*University of Zagreb, Croatia*

Two viaducts for a new motorway in northwestern Croatia were constructed over a very gently sloping valley. Soil investigations indicated a long landslide consisting of a medium to highly plastic clay layer slowly sliding over very gently sloping and stable marl. The foundation of each viaduct pier was designed as a parallel pair of reinforced concrete diaphragm panels extending through the sliding mass into the stable marl bedrock to resist the thrust of the sliding soil. During the construction of the viaduct foundations, several instruments were installed and readings taken on a regular basis. Almost two years after the viaduct completion, no measurable movements of foundation piers were recorded, although the slope did not yet reach its equilibrium. A three dimensional soil-structure interaction analysis was performed, using a simple elastic-plastic soil model, to verify the stability of the deep foundation. The results of the analysis generally comply with recorded measurements.

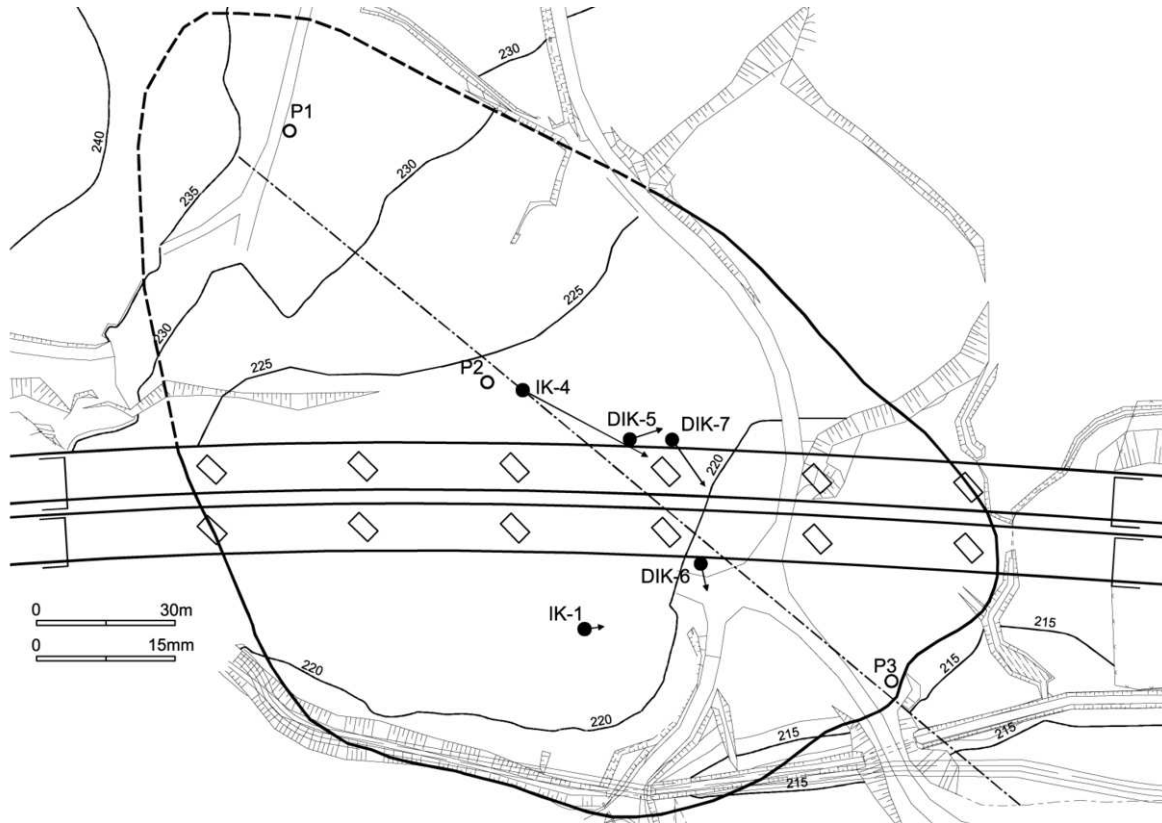
Figure 1. Viaducts, pier foundations, contours of the landslide, positions of inclinometers (IK), deformaters + inclinometers (DIK), piezometers (P) and total horizontal displacement vectors at ground surface measured by inclinometers up to February 2009

Figure 1 shows the general layout of the sliding area, the position and orientation of the barrettes and the positions of measuring devices. The recorded horizontal displacement vectors at the ground surface are plotted to indicate the directions of movements.

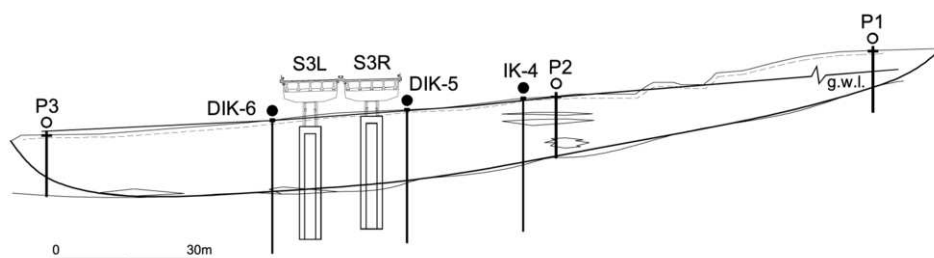
Figure 2. Cross-section down the middle of the sliding mass (shown as dash-dot line in Figure 1) with pier S3

Figure 2 presents a vertical cross section down the sloping valley, positioned approximately along the greatest clay layer thickness. The position of the viaduct is close to the slide toe. The ground surface of that area has a gentle slope of about  $11^\circ$ , whereas the slope approaches  $20^\circ$  at the head of the slide. The contact surface between the sliding mass and the underlying marl is generally steeper than the ground surface. Several small springs in the upper part of the sliding mass indicate a high phreatic surface of the ground water. Piezometers close to the viaduct area confirmed a small artesian pressure.

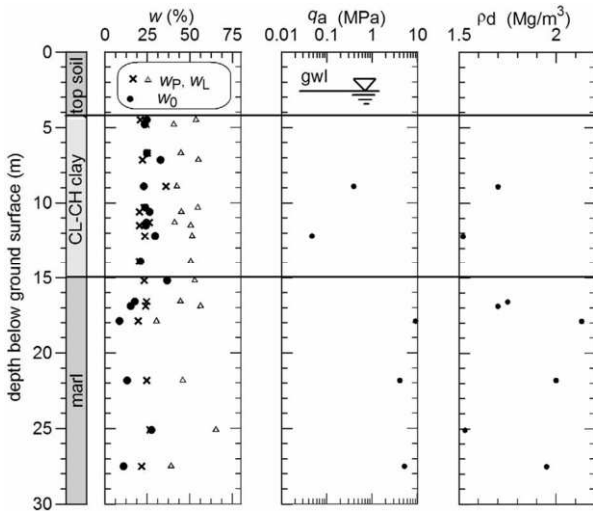
Figure 3. Atterberg limits, natural water content, unconfined compression strength and dry density measured from samples adjacent to the deep foundation

Figure 3 shows Atterberg limits, natural water content and unconfined strength data from soil samples taken from a 28 m deep borehole adjacent to pier S3. These data are more or less typical for the whole sliding area.

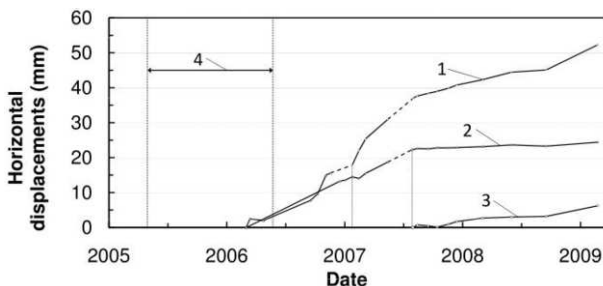
Figure 4. Time history of horizontal displacements of the ground surface as measured and interpreted by inclinometer measurements: inclinometer IK-4 (1), IK-1 (2) and DIK-7 (3); (4): barrettes construction period

almost two years after the completion of the structure. The general history of the movements may be followed in Figure 4. This figure presents the down slope horizontal displacement time history of the ground surface measured by several inclinometers in the vicinity of pier S3: IK-1 on the down slope side, IK-4 and IK-7 on the upslope side. The following may be observed from Figure 4:

- The horizontal displacement rate in the down slope direction was about 15 to 20 mm/year during construction activities;
- After the completion of the structure, the displacement rates remained generally unaltered or even slightly increased for another six months;
- After the six month period upon the completion of the structure, the displacement rates slow down to about 7 mm/year on the upslope side, and to 1 mm/year on the down slope side, indicating a much more pronounced slow down of displacement rates on the down slope side than on the upslope side.

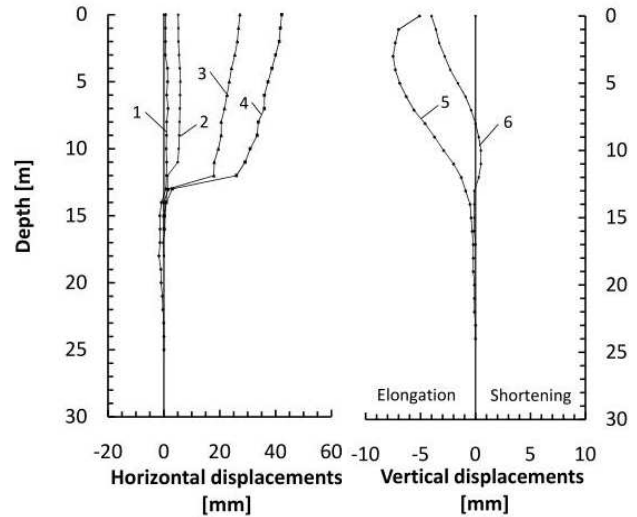
Figure 5. Horizontal displacements vs. depth below ground surface: inclinometers IK-5 (1) and DIK-7 (2) from Aug 2007 to Feb 2009, IK-4 (3) from Mar 2006 to May 2007 and IK-4 (4) from Mar 2006 to Feb 2009; vertical displacements along deformer axis: DIK-5 (5) and DIK-7 (6) from Aug 2007 to Feb 2009.

Figure 5 shows horizontal displacements down the slope for several inclinometers and vertical displacements along vertical lines measured by two sliding deformaters (Kovári & Amstad 1982) in front of the deep foundation. Inclinometer measurements indicate the depth of the sliding mass, while deformer measurements indicate the bulging of the sliding body in front of the deep foundation.

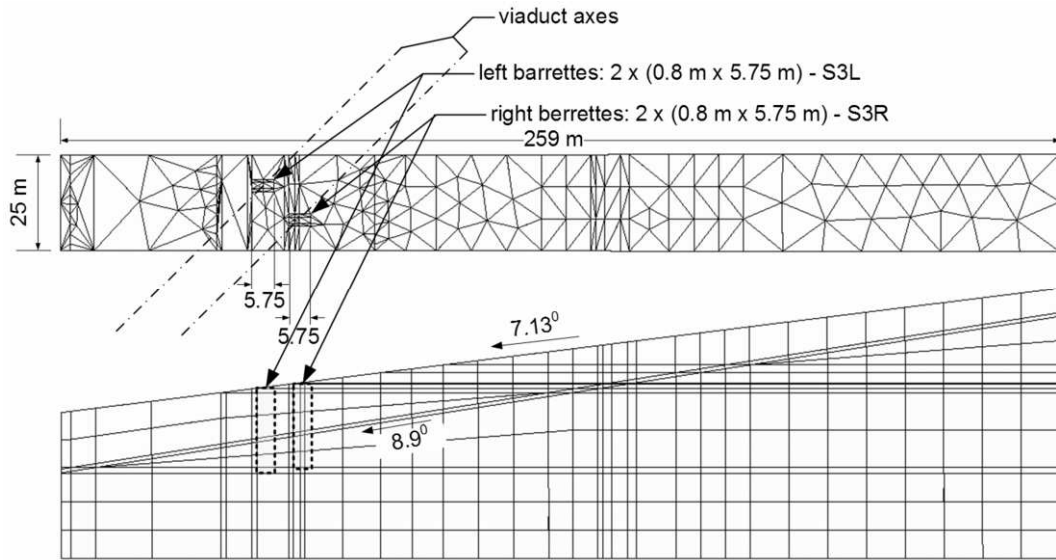
Figure 6. Three-dimensional finite element mesh used in the analysis and the position of foundation barrettes

A three dimensional finite element analysis of the soil structure interaction for the sliding mass, firm base and the deep foundation of pier S3 was conducted. The principal aim of the analysis was to verify the stability of the deep foundation under the earth pressure from the sliding soil mass. The complex geometry of the slide and the foundation were simplified, as shown in Figure 6. The width of the sliding mass of 25 m corresponds to the projected length of the viaduct span onto the anticipated direction of sliding. A thin inclined soft soil layer, separating the upper clay sliding mass from the stiff and firm marl base was included in the model. The phreatic surface was at the ground surface.

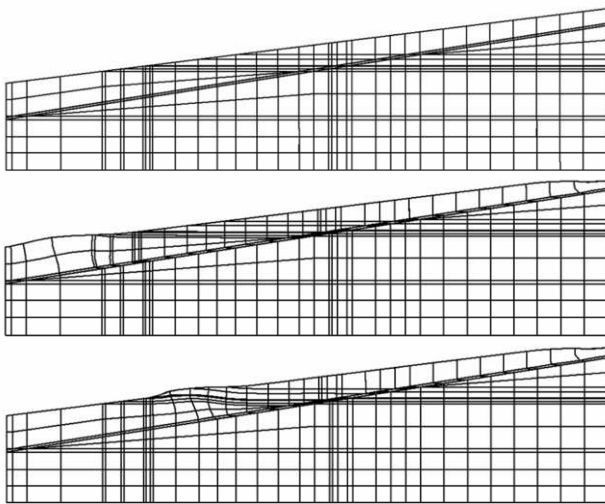
Figure 7. Finite element mesh (top); Deformed mesh - plastic equilibrium without barrettes (middle); Deformed mesh - plastic equilibrium with barrettes (bottom)

The top part of Figure 7 shows the original finite element mesh in the vertical plane along the analysed slope. The middle part of Figure 7 shows the deformed mesh after the first phi-c reduction, which corresponds to plastic equilibrium of the sliding mass prior to foundation embedment. The sliding of the upper clay layer and the bulging of the sliding mass at the toe of the slope are apparent. The bottom part of Figure 7 shows the results of the second phi-c reduction analysis, which corresponds to sliding resisted by embedded barrettes. The bulging of the sliding soil upslope of the barrettes is now apparent. It is compatible with extension deformations measured by sliding deformaters.

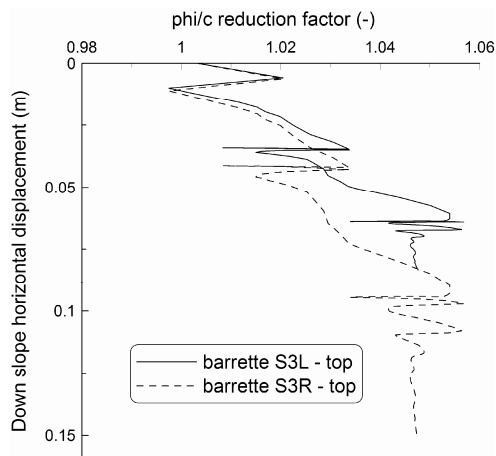
Figure 8. Phi-c reduction analyses with embedded barrettes

Figure 8 shows the development of horizontal displacements of the top of two adjacent barrettes vs. phi-c reduction factor during the iteration process of this analysis. The plastic equilibrium is reached with an increase of the factor of safety (phi-c reduction factor) of only 4.5 %. Such a small increase of the factor of safety of the sliding soil mass might explain the very gradual and slow decrease of the rate of soil movement measured by inclinometers. Nevertheless, this analysis should provide the maximum lateral soil thrust on the foundation barrettes against which they should be designed. The corresponding bending moments in foundation barrettes calculated for this design situation are shown in Figure 9.

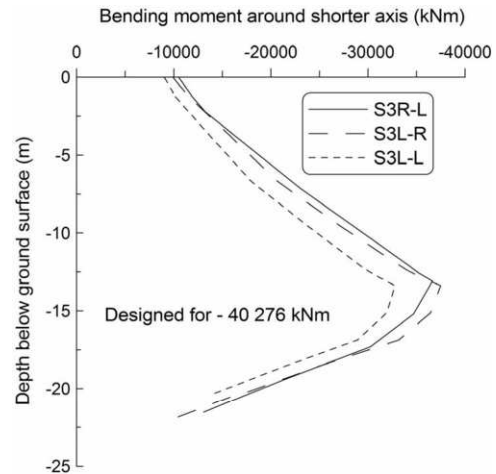
Figure 9. Bending moments in foundation barrettes for the case of plastic equilibrium of the sliding soil mass
