# River Nile bank protection – German-Egyptian cooperation in analysis, design and quality control

V. Rizkallah

M. Achmus

M. Nadar

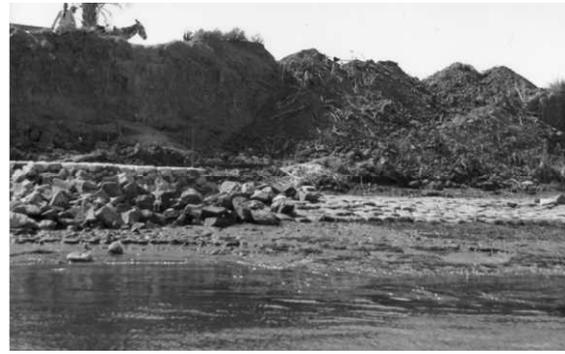
Figure 4. Stone toe atop sandbags under construction.

Both the stones of the stone toe and the sandbags serving as a filter layer underneath were constructed by dumping in the water or, if possible, by hand-laying (Fig. 4). Subsequently, the section behind the toe was backfilled. The backfill material was usually taken (with the landowners' permission) from soil material stemming from the fields behind the river bank. It was placed in layers about 25cm thick and compacted either by hand tamping or by vibratory plates.

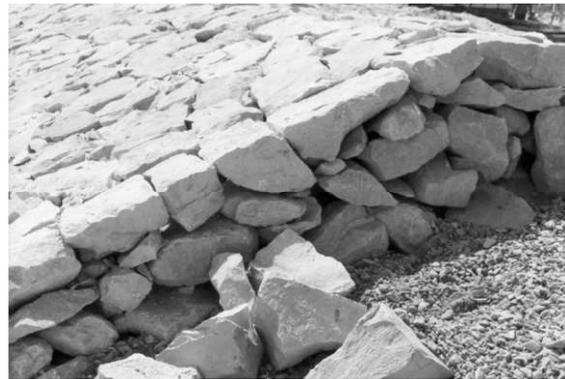
Figure 5. Detail of the stone revetment atop gravel filter layer.

Subsequently, the filter layer was installed with the desired inclination. The stones of the revetment were placed on top of the filter layer (Fig. 5).

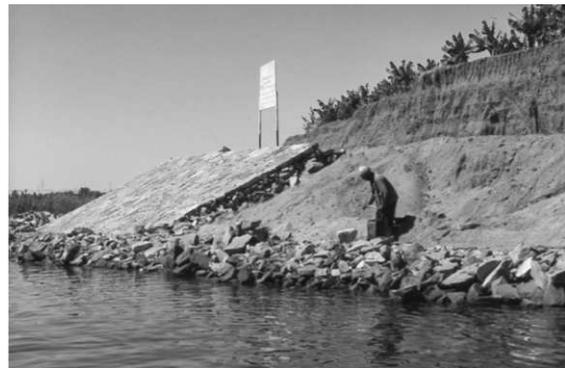
Figure 6. Partly completed river bank protection.

Figs. 4, 5 and 6 show details of the construction of the river bank protection.

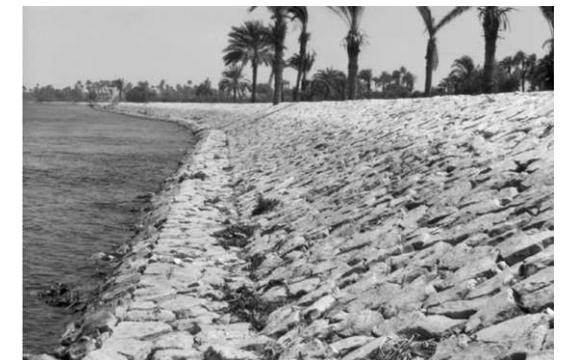
Figure 7. River bank protection two years after construction.

The results of the project were very satisfactory. On a final visit two and a half years after the start of the construction work it was found that the river bank protection was in very good condition on the whole (Fig. 7). Only at a few sites was a need for minor maintenance works identified, since some stones of the revetment had loosened and moved. However, this was not a result of erosion or sliding, but of the intensive usage of the banks by the local people. It was possible to repair the damage easily and at little cost.
