Monitoring the Working Performance of Soil Reinforced Mine Tip Walls in Africa: A series of Case Studies

J.F. Meadows

M. Pauselli

4.1 Marikana Platinum Mine – South Africa

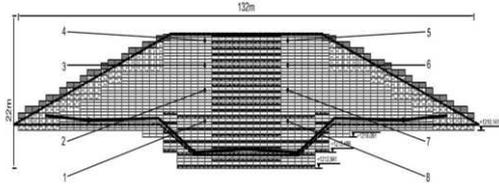
At Marikana Platinum mine, north west of Johannesburg, where the annual monitoring of the primary crusher tip wall settlement, is done on specific targets for the 22.5m high TerraMesh structure. See figure 1 below.

Figure 1: Marikana tip wall – targets to monitor settlement / movement

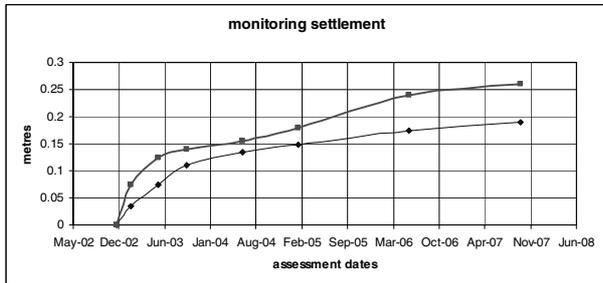
Figure 2: an envelope of the measurements over a period of 7 years

The graphs above demonstrate the range of values obtained over a period of 7 years to measure the settlement and movement away from the crusher. The measurements indicate a flattening off of change that will probably move towards zero in the next year or two.

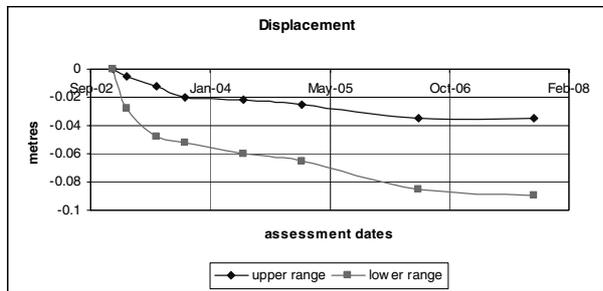
Figure 3: an envelope of the measurements over a period of 7 years

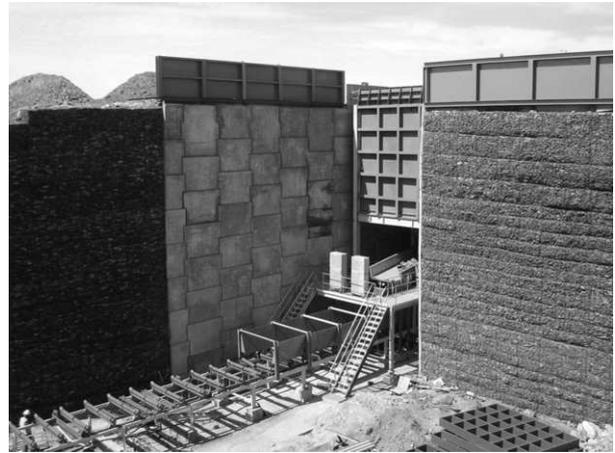
This project demonstrates a TerraMesh combined with a MacForce solution that uses ParaWeb soil reinforcement for the retaining tip wall at Optimum Coal mine South Africa.

The speed of construction for this 1673m² tip wall on a coal mine was 11 weeks, which although it met the mines speedy construction program, has prompted an immediate need to monitor the geotechnical aspects of, settlement and consolidation of backfill, with attention to possible displacement of cladding. Some baskets were placed out of true alignment during the construction phase and these needed to be identified as such, rather than be regarded as a result of subsequent changes in the backfill or facing. Monitoring this

structure is important to the client as an asset and also to the reassurance of safety for work staff on site. Targets at specific points and checked off control stations help assess the situation and maintain records for future management. So far the results indicate no significant movement or significant changes. Monitoring continues every 6 months until the end of 2009, thereafter annually.

Figure 4: A combination structure of Terramesh™ and Macforce

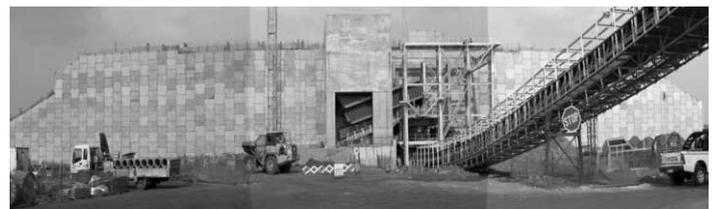
Figure 6: 4000m² Macforce walls at Klipspruit coal mine west of Johannesburg

This structure is 21m in height with retaining walls covering 4000m². The backfill was of good quality and the entire wall has a drainage layer behind the panels to prevent pore water

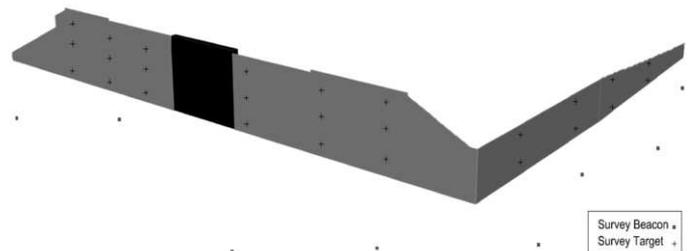
Figure 7: an isometric view indicating the monitoring points on the walls

build up. External beacons assist to measure the targets on the front and side walls must to show results of behavioural changes. Two positions, have post construction, shown panels that are displaced and will need to be monitored.

Targets and measuring stations are in place and the survey system is similar to that which is used at the other tip wall sites. So far the measurements indicate minor movement with some localised changes. The first six months post construction and prior to the operation of the tip wall is considered a base date status from which subsequent changes are compared.

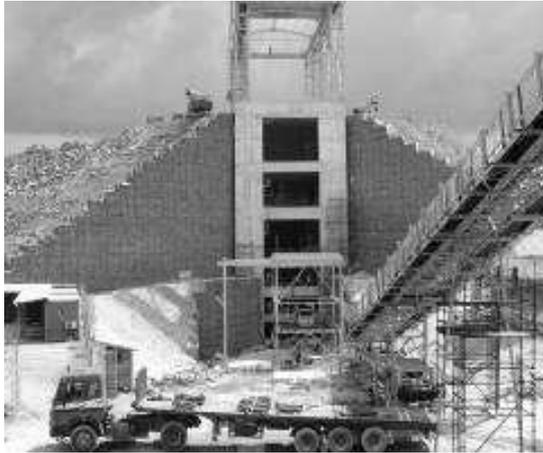
Figure 8: A Terramesh™ retaining wing walls for a tip wall on a Gold mine

The TerraMesh™ retaining walls (17m high) adjacent to the concrete structure have been placed well and the installation procedure followed was strictly according to the installation manual. Regular measurements by the surveyor have indicated the settlement and/or consolidation has been small and not enough to affect the aesthetics of the walls at this stage. The structure is now into the second six month phase, post construction but has as yet not become operational. So far no significant movement or change has taken place. The lower walls adjacent to the main wing walls have shown displacement

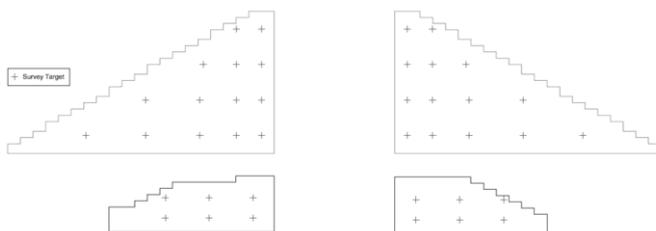
Figure 9: Monitoring targets to maintain records of performance

during construction which needed to be reconciled before new readings could be monitored for subsequent change. It is estimated that a slow and small amount of consolidation of the fill and insitu material should take place as the materials insitu and backfill used where of good quality. Compaction density test results are all above the designed minimum of 95% mod Aashto
