Monitoring of shear strain in shallow sections of slopes to detect increased risk of slope failure

S. Tamate and K. Itoh

National Institute of Occupational Safety and Health, Japan

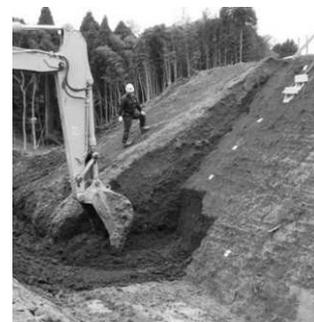
Figure 5. Overview of cuttings in prototype model test

The SPS was installed in a position 1m below the slope shoulder. A backhoe cut a distance of 0.5m from front to back during each step of the cutting process, as shown in Figure 5. An interval of 5 minutes was allowed between cuts, to observe possible slope movement.
