Backfill materials for Mechanically Stabilized Earth (MSE): African Experience

Andrew C. S. Smith

Reinforced Earth (Pty) Ltd Johannesburg, South Africa

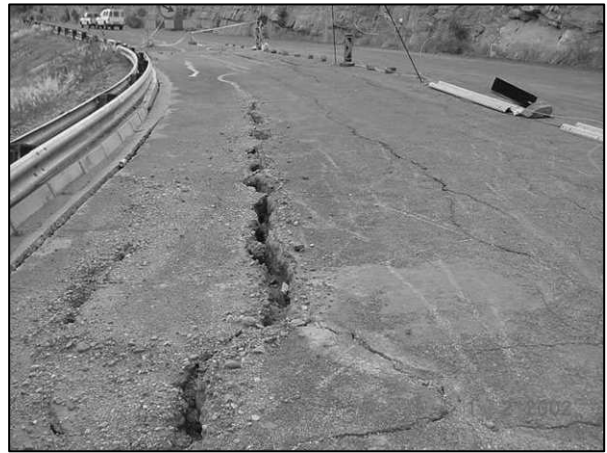
Figure 2. Kloofpass bridge approaches

The backfill properties were those of an intermediate backfill with 20-30% less than 20 microns and angle of internal friction of the order of 36 degrees for both rapid and slow saturated shear tests at 93% Mod AASHO. Construction was almost complete when a severe rainstorm struck the site and ingress of water into the MSE mass led to progressive collapse settlement,

which is defined as the additional settlement and stress changes that a soil undergoes when its moisture content increases. It is postulated that the clay bridges in the inadequately compacted backfill collapsed as they became saturated and progressive failure of the MSE ensued (Figure 2). Piles have subsequently been driven through the failed MSE embankment and support bridge decks replacing the approach embankments.

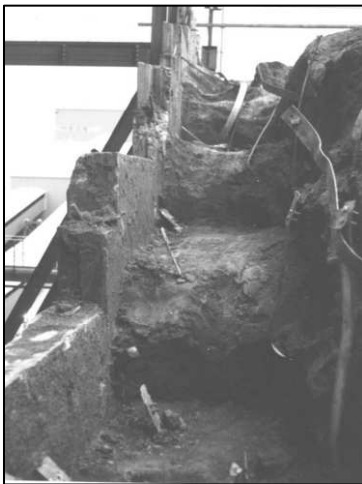
Figure 4. Grootegeluk

Aeolian soils of the interior, are sandy soils which have undergone redistribution by wind action and cover almost half of Southern Africa. Grading envelopes of these sands may be uniform except for varying amounts of clay. They could well be intermediate with clay content above 20%. When used in MSE structures care should be taken to compact the backfill adequately to prevent future collapse settlement. Figure 4 shows failure of an MSE structure in Limpopo, South Africa, due to inadequate compaction and subsequent collapse settlement.

A durable shale backfill has also been successfully used at the Grootegeluk Mine – Limpopo RSA.

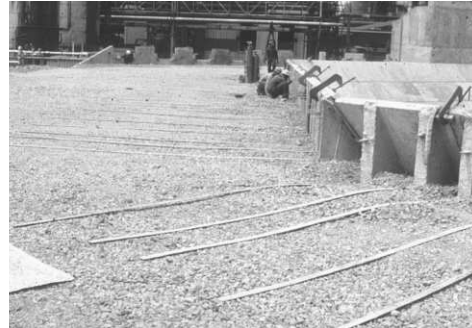
Figure 5. Vanderbijlpark

Blast furnace slag has been successfully used on 3 contracts: Faerie Glen, constructed in 1980; a structure inside the Iscor Steel Works Pretoria, constructed in 1978; a storage structure at Iscor Vanderbijlpark, constructed in 1983. The properties of the slag were consistent with pH 10.7, chloride content 35ppm and sulphate content 1680ppm. The material is an even-graded free draining gravel with 100% passing 70mm and 5% the 0.075. The electro-chemical properties fall outside the standard specifications for steel reinforcements. Sample strips were placed in the Faerie Glen backfill during construction in 1980 and extracted 14 years later in 1994. Tests showed only a small loss of zinc and no measurable loss of strength. This was also the case for test strips extracted from the Vanderbijlpark structure in 1995 after 12 years. These excellent durability results are attributed to the free draining nature of the backfill. (See Figure 5.)

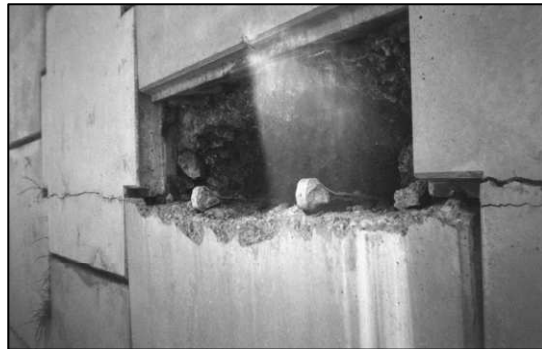
Figure 6. Dunswart

Steel slag was used for the Dunswart bridge complex constructed using galvanized steel reinforcing strips in 1987. The properties of the slag were as follows.

Mechanical: granular with 100% passing the 75 mm sieve and 2% the 0.075; grading modulus 2.71.

Electro-chemical: pH 8.2-12.4; chlorides 7-28 ppm; sulphates 432-1229 ppm; sulphides 0-1992 ppm.

Test strips were extracted in 1992 after 5 years and again in 1998 after 11 years. A sample of backfill was also removed in

1992. Durability of the strips has proved satisfactory with little loss of mass and no measurable loss of strength.

In 1998 however, RESA was alerted to cracking of the panels. Investigation determined that the problem arose because of expansion of the backfill caused by reaction of lime in the fill to ingress of water. The overall structural integrity of the structure is not affected, but the cracked panels are unsightly and ongoing repairs are necessary. The use of expansive backfill cannot be entertained in MSE structures and the material is not recommended. (See Figure 6.)

5.4 The use of steel slag and RAP (unless it is mixed with other acceptable material) is not recommended for MSE backfill.

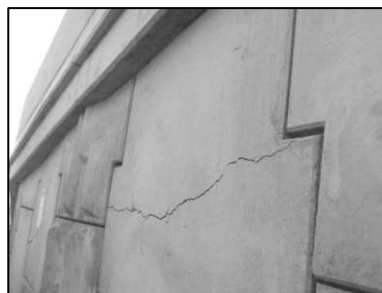
Figure 7. Western Freeway, Durban

RAP was taken as backfill on the Western Freeway Durban structure constructed during 2006. The internal angle of friction was 30° degrees. 100% passed the 20 mm sieve and zero passed the 75 micron sieve. The interlock of the binder coated aggregate fragments are subject to significant residual viscous behaviour resulting in time delayed post construction creep and consolidation of the fill. In the case of the Western Freeway this led to rotation of the crash barrier during the construction process and consequent bursting of the cladding. The settlement of the fill was monitored and once it became negligible the cracked panels were repaired and the structure was brought into service. RAP, mixed 50:50 with sandstone has been successfully used on another project. RAP should not be used on its own however and should be mixed with approved backfill for use as backfill in MSE structures. (See Figures 7 & 8)

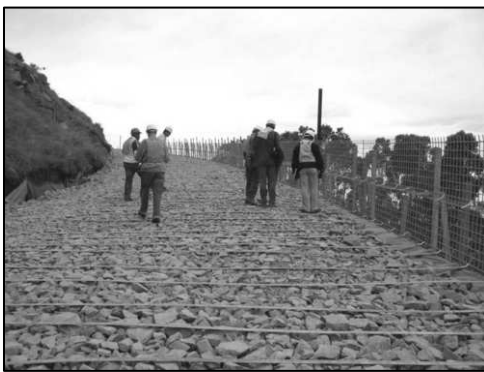
Single sized rock or stone resistant to weathering is an ideal backfill material for MSE structures. This type of material is free draining, construction can proceed in all weathers and the need for subsurface drains is eliminated. Compaction is not necessary and the material can be used to backfill areas inaccessible to compaction plant. It could also be used for backfill of structures in or under water. On the Ugie to Langeni Road (E Cape, RSA) rockfill has successfully been used with galvanized steel reinforcing strips, while 50mm stone was used with synthetic reinforcing strips.

Figure 10. Langeni –galvanized steel reinforcing strips

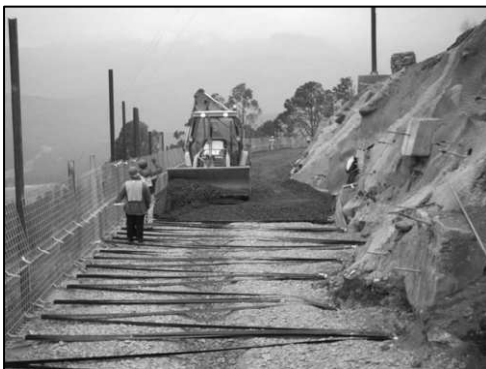
Figure 11. Langeni – synthetic reinforcing strips
