Mass stabilization – a method for the reuse of TBT-contaminated sediments as a part of the harbour field in Helsinki, Finland

J. Havukainen, M. Leppänen & A. Piispanen
Ramboll, Finland

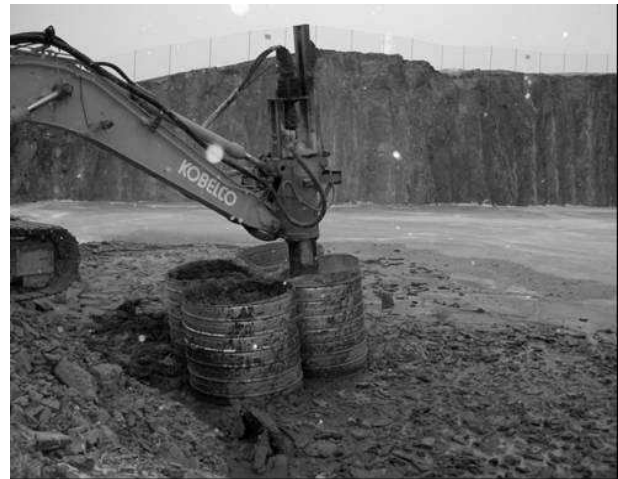
Figure 1. Mass stabilization test in the temporary storage basin of TBT-sediment..

The mixtures were also tested in field conditions to ensure the applicability of the mass stabilization technique and the performance of the mixtures in practice, see Figure 1. The results were considered carefully together with designers, environmental experts and the project owner. Two types of cement were selected to the final testing in the beginning of the coming mass stabilization work.

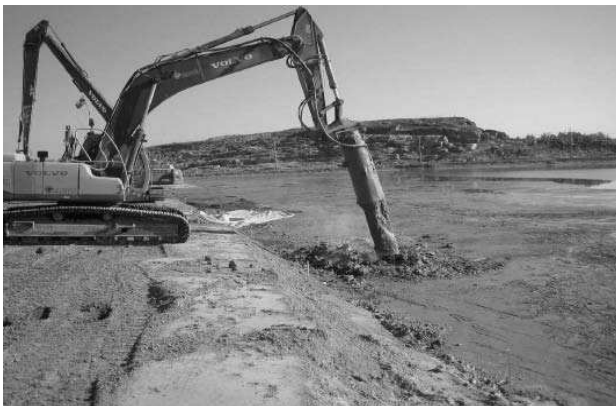
Figure 4. The mass stabilization of dredged TBT -contaminated sediment.

Mixing was carried out by an accurate mixing tool which was installed on an excavator machine. Mixing was done both in horizontal and vertical directions so that a homogeneous hardening soil slab was formed, see Figure 4.

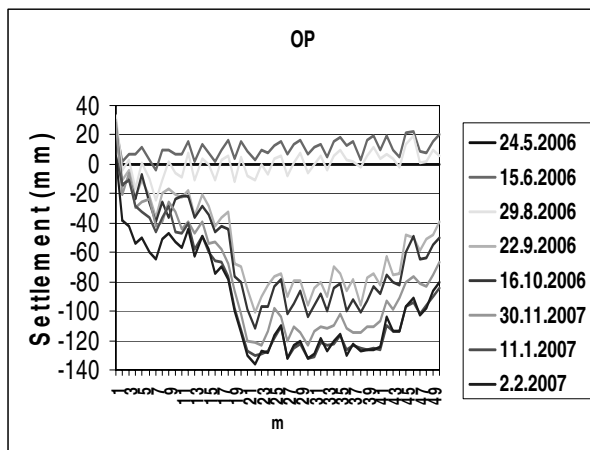
Figure 8. An example of the results of settlement observation hose OP on the stabilized field in the lagoon A1.

The first metres of the hose OP show lower settlements than in the middle of the hose, Figure 8. This is caused by the fact, that the sediment layer has been thinner upon the slope of the embankment than farer away in the lagoon. Furthermore, the area near the slope has been stabilized several weeks before the other parts of the field. Anyway the observed settlements measured in every hose were less than 200 mm.

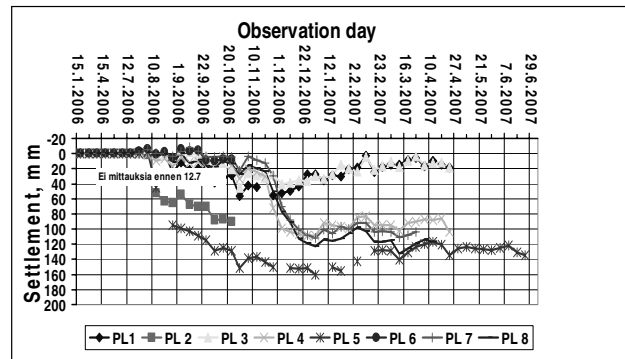
Figure 9. The settlement observation results of 8 plates installed on the lagoon A1.

The settlement plates were installed about 0.5 m above the surface of the stabilized field. So the compression of the embankment did not falsify the results. The results from the settlement plates were equal with the results of the settlement hoses, Fig 9.
