Innovative high capacity anchors to secure a motorway in Austria

E. Falk

Keller Group plc, Vienna, Austria

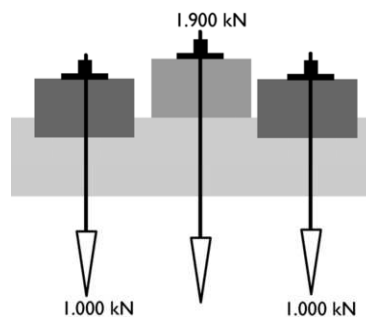
Fig. 4. First design of position of new beams

Specifications of the public tender considered the above listed requirements. The price for more than 400 anchors with a length up to 125 m and a working load of 1.900 kN (Fig.4)each was extremely high, because guided drilling had to be involved in order to overcome the problems due to expected drilling deviation (serious deviation was observed during the execution of a trial). Thus exceeding of the available budget at that time became the last threat of the project being already under extreme time pressure.

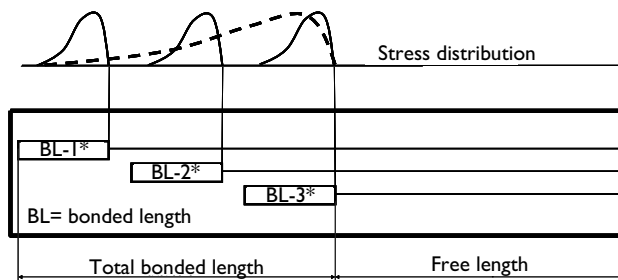
Fig. 6. Schematic function of a Single Bore Multiple Anchor

- Reduction of the number of elements using considerably higher anchor forces (doubling the allowable drilling deviation)
- Reduction of the maximum anchor length using the SBMA principle (Fig.5 and Fig.6)

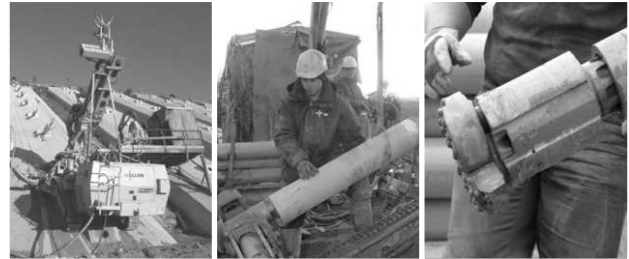
Fig. 8. Drilling situation and used tools

- Anchor head scheme with three separate anchors (six strands each but with different free length)
- Automatic registration system for three different anchors to be tensioned at the same time
- Improved PVC coating
- Sophisticated post – grouting system in order to become more independent from local weak zones in the ground using grout based on CEM 42,5R
- Combined water – air – flash for 85 m long boreholes in order to minimise the impact to the soil (Fig.8)

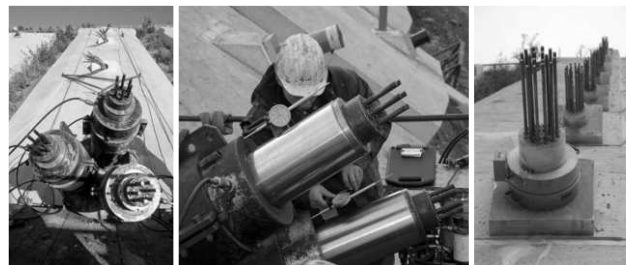
Fig. 9. Stressing the Anchors

All acceptance tests were executed according to the load steps described in EN 1537. Additionally every strand was tested separately up to a single load of 167 kN (Fig. 9).

Load steps were maintained for 1 hour. The anchor head was specially designed with distance rings to allow the later release if necessary.

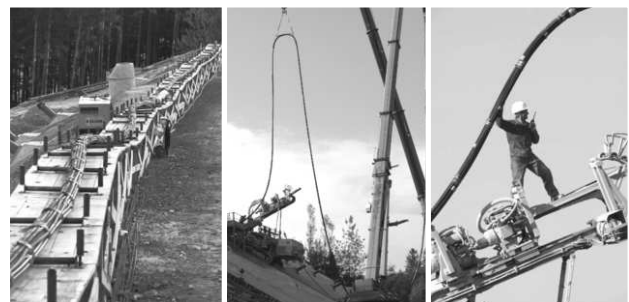
Fig.10. Assembly and installation of anchors

A powerful drilling rig had to be assembled for this project, able to work at the maximum inclination of almost 45° (rubber tracks, empowered erection mast support, enhanced rotary heads). Safety was provided in all phases using radio – controlled winches and mobile cranes for all manipulation steps. A modular setup was developed which comprised separate mobile platforms for drilling equipment, monitoring, operation and data registration to be moved by 100 ton mobile cranes. (Fig.10 and Fig.11)

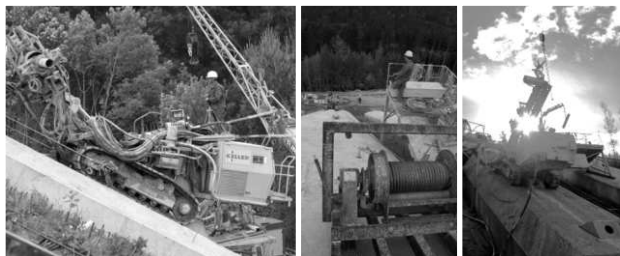
Fig. 11. Steps to move the rig to the drilling position

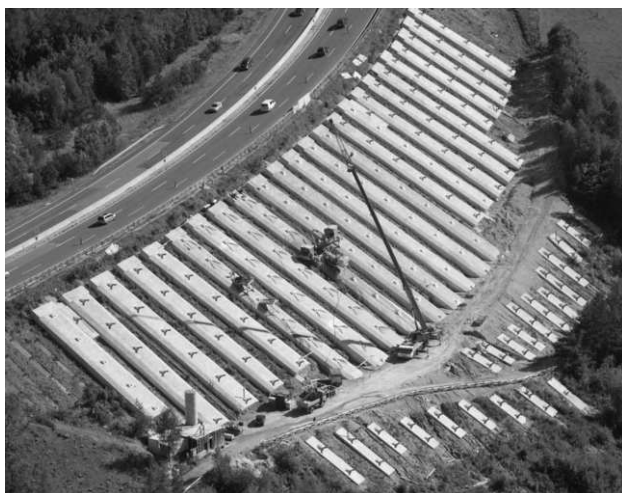
Fig. 12. Actual view of the site

More than 200 anchors with a working load of 3.800 kN could be installed regularly in the years 2008 and 2009 (Fig.12). Full stabilisation of the slope was reached in this period. Anchor loads could be reached in soft and weak rock conditions using the Single Bore Multiple Anchor method combined with new elements like high resistance strands, high quality wedges and pressure resistant post grouting devices.
