# Innovative restoration of medieval city walls of 's-Hertogenbosch by soil nailing

J. Steenbergen-Kajabová\*, R. Steenbrink & H.A.A. Habib

Department of Maritime structures, Tunnelling and Geotechnics  
Grontmij Consulting Engineers, De Bilt 3730-22, The Netherlands  
e-mail: [jana.steenbergen@grontmij.nl](mailto:jana.steenbergen@grontmij.nl)

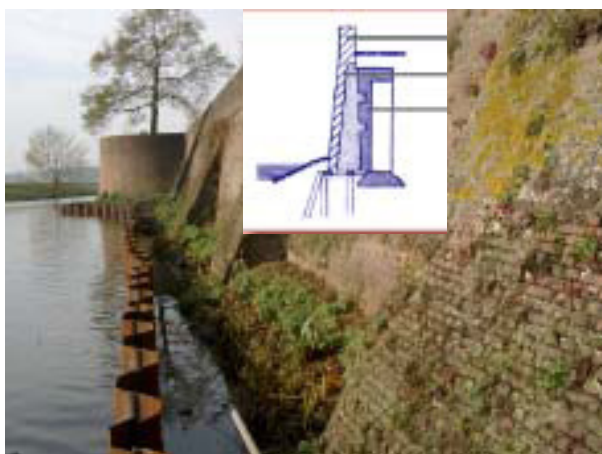
Figure 1.1 View at City wall

The city of 's-Hertogenbosch situated in south of The Netherlands has a rich history throughout the ages. Due to its strategic position in the area it has been inhabited by the Romans and further on through the Middle Ages until the modern times. The city is surrounded by a brickwork city wall. The wall was built already in Roman time and greatly extended in Middle Ages. From then on the wall was strengthened in every new era. This was done by new layers of brickwork, locally with buttresses and in later period also by making a supporting embankment behind the wall consisting of sand, clay and a waste material of antropogenic origin.

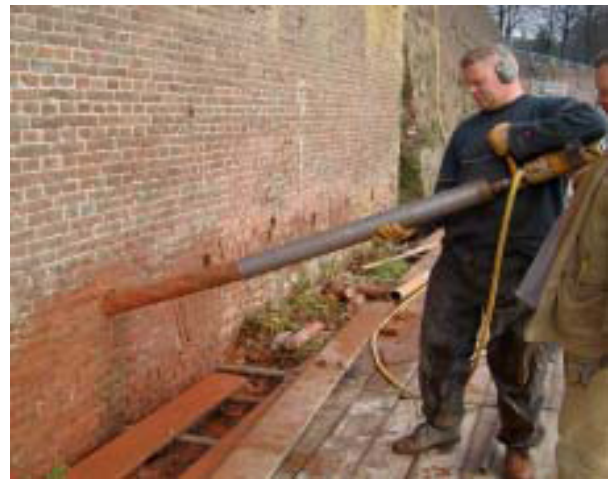
Figure 4.1 Drilling of the cors

The Catholic University of Leuven (KUL) performed a geophysical investigation on the thickness and the true condition of the mortar in the brickwork by borings in the wall performed at the several levels. The borings had shown the real thickness of the wall and very often the poor condition of the brickwork with gaps between several layers. The thickness of the wall varied from approximately 0.6 m at the top of the structure (NAP +7.0 m) and increased to 2 `a 3 m of thickness of the structure at the foot of the wall.

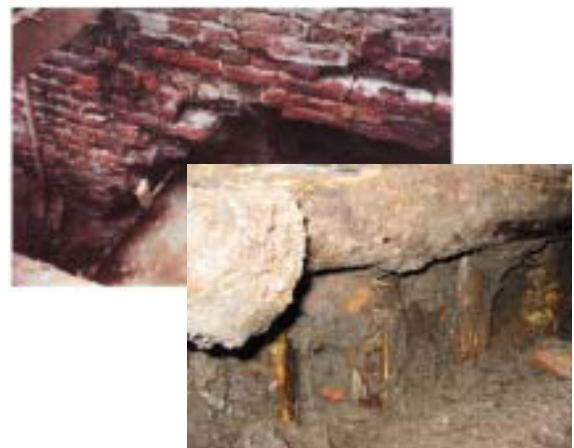
Figure 4.2 Example of wall foundation

Further investigation by means of trial pits had shown parts of the wall with a wooden pile foundation as well as parts of the wall with shallow foundations on the sand layer. There were great insecurities about homogeneity of the brickwork and the depth of the foundation (top of the pile foundations approximately at NAP +2.95 m and shallow foundation at NAP +1.0 m). The presence of the trees and cables behind the wall made a restoration with help of a auxiliary sheetpile behind the buttresses a non-desirable and technically not a feasible option.

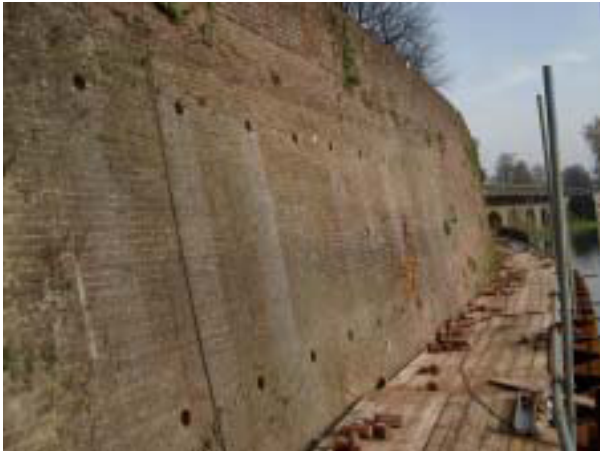
Figure 7.1 Removal of the brickwork for the nailing

Soil nailing protects the weak parts of the wall. The structural strength of the wall is regained by injection of mortar. The injection mixture is chosen such that this is not harmful to the vegetation.
